Restoration of Bulle Clock Serial Number 174475.

Early Battery Clock Parts & Restoration

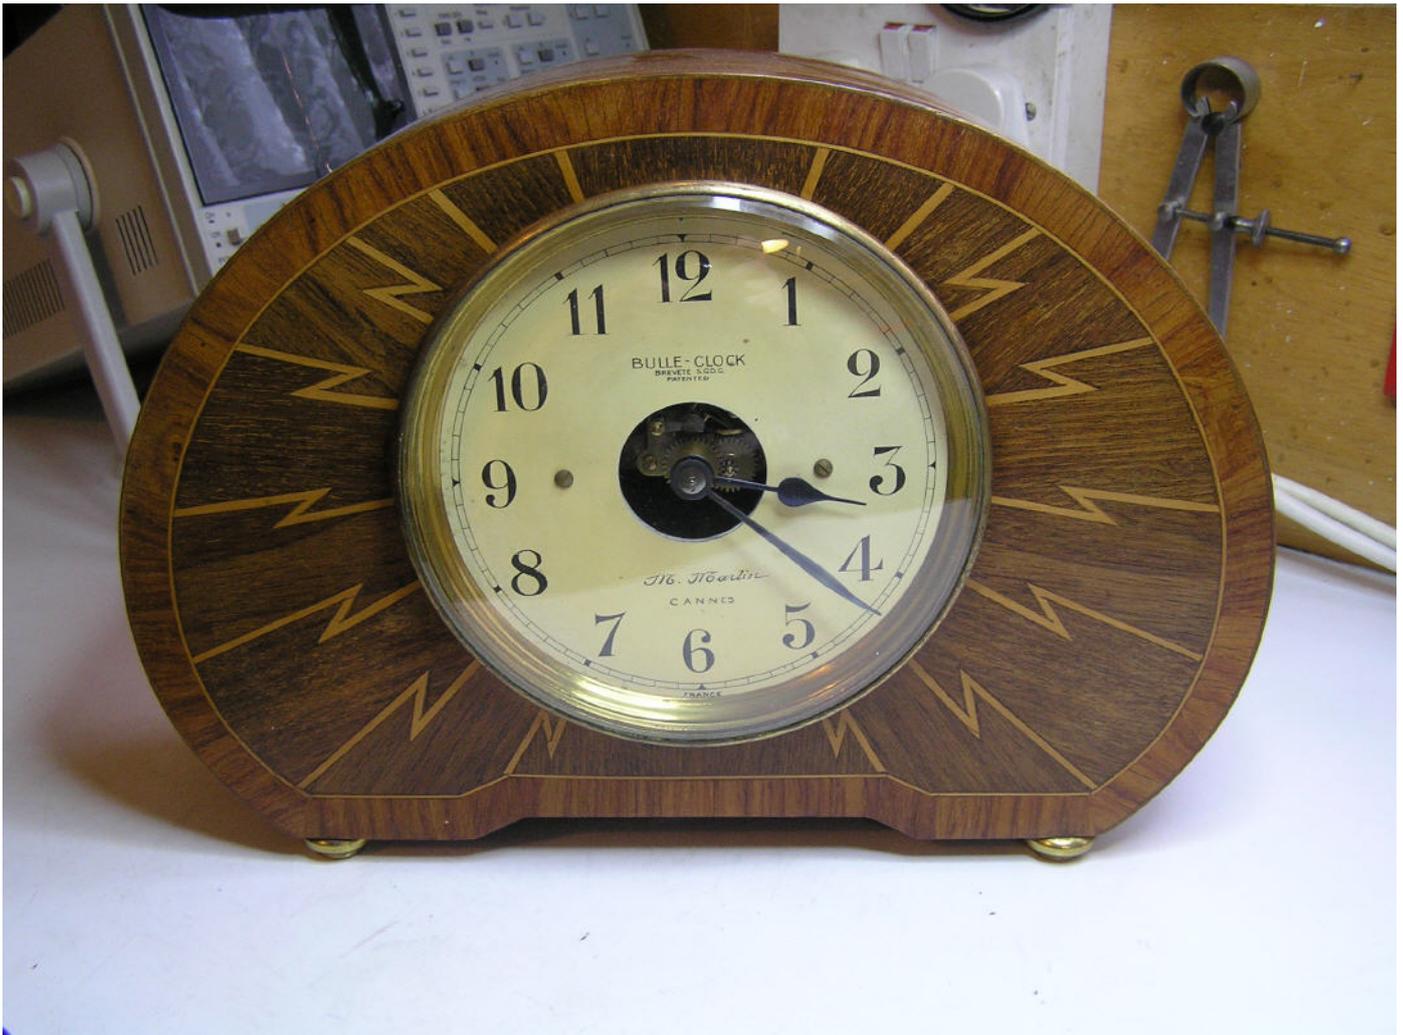
This clock is a model XA in a wooden "Lightening" case. The movement will be shown undergoing restoration by kind permission of the owner. As can be seen from this photo the casework and brass fittings are all in very good condition and other than a good wax polish will no require any remedial work. The brass still retains most of its original gilding and any heavy polishing will remove it. The glass will be removed and cleaned.

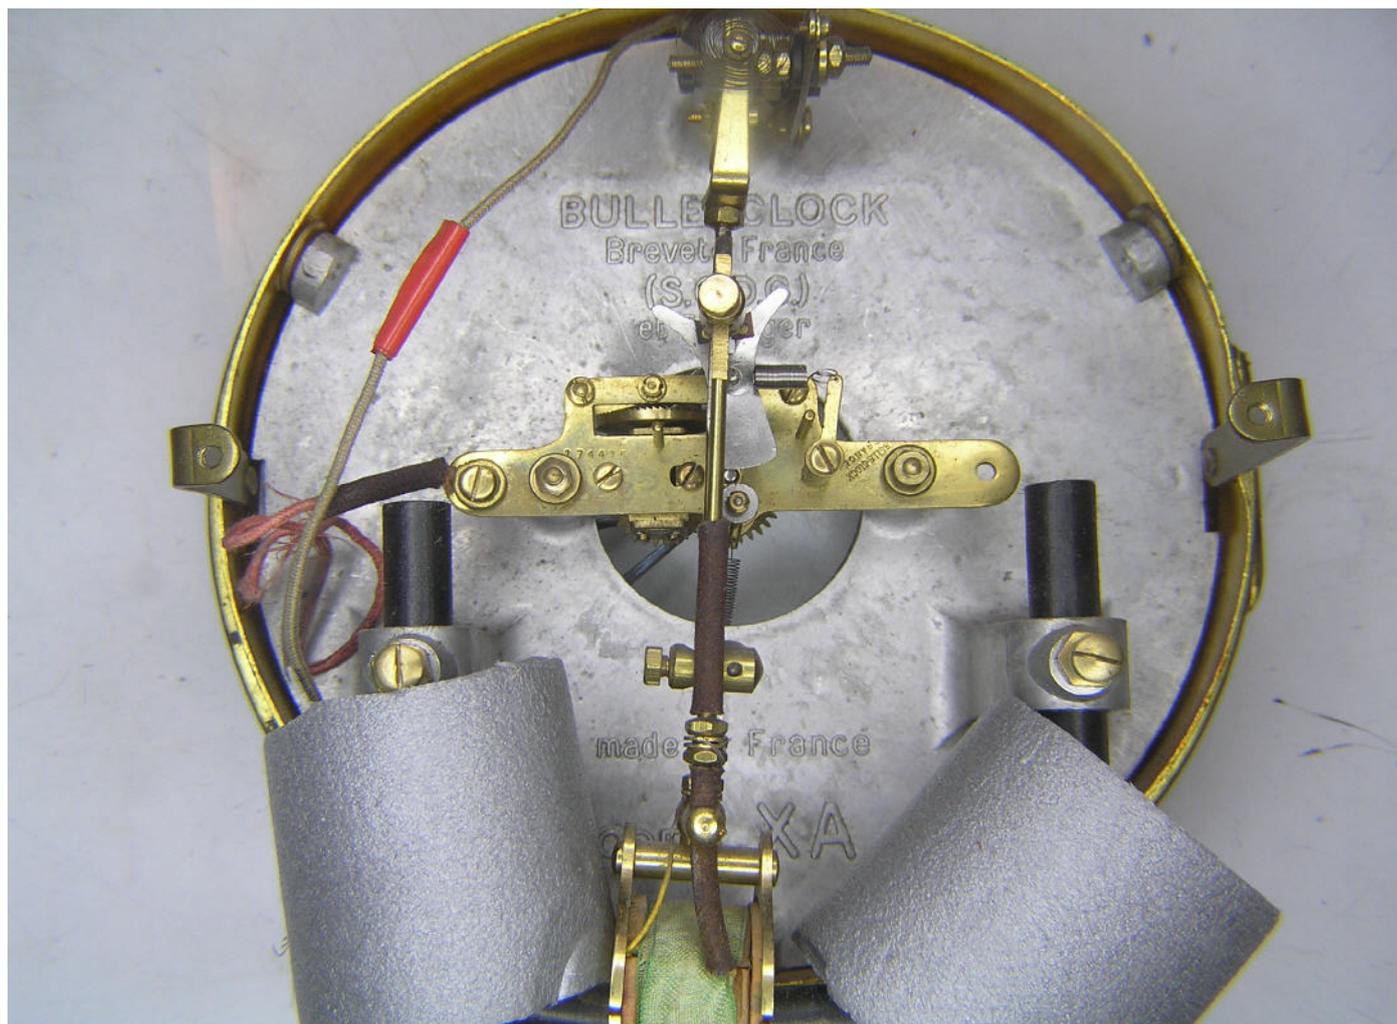
As can be seen here, the clock movement also appears to be in very good shape. Nothing at first glance seems to be missing or damaged. This should be a dream to restore. The coil is reading a steady 1190 Ohms and all the insulation is intact. These “Insert” movements differed from the clocks under domes in that they had no need to have fancy brass support columns or cord wound bobs that were esthetically pleasing because they were completely hidden inside the case. The only way to see it at all was by lifting the clock completely and looking up through the bottom of the case. Hence the whole movement was simplified by having a single aluminium plate that served as dial support, pendulum bracket, movement bracket and magnet support. Very practical, efficient and inexpensive to produce.

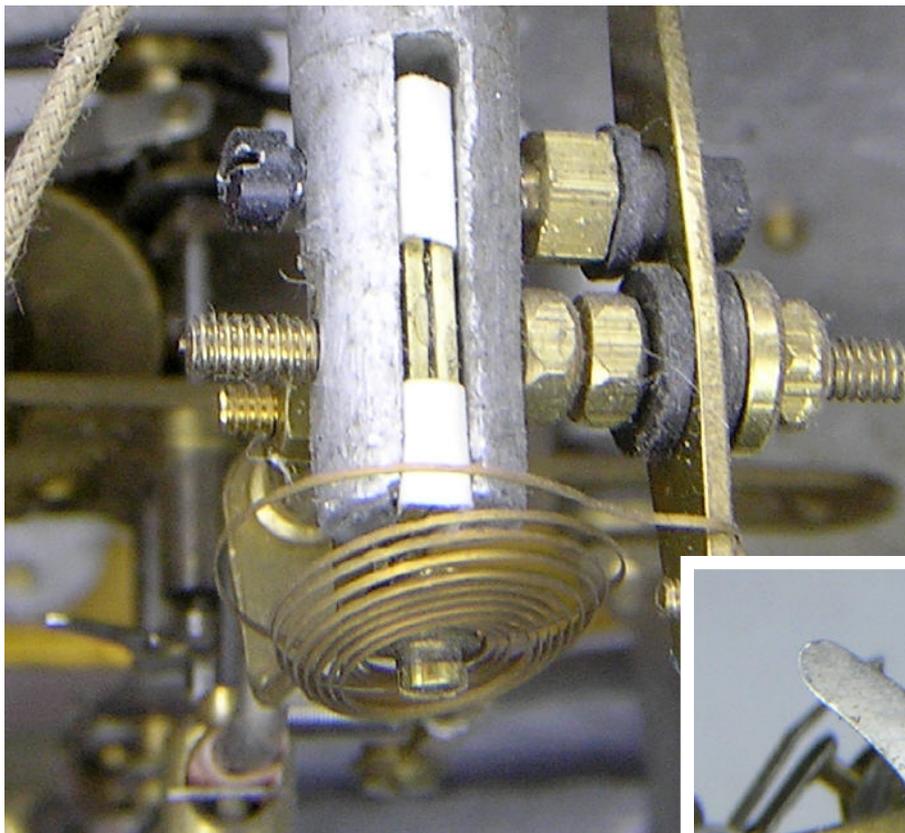
The top of the clock showing that the suspension is held together with white insulation tape. The photo also shows the mangled balance spring. The use of such springs on Bulle clocks is purely for electrical continuity between the frame and the pendulum. So, as long as it doesn't interfere with the swing of the pendulum it doesn't really matter that it is twisted in such a way. But for aesthetic reason we'll replace it anyway.

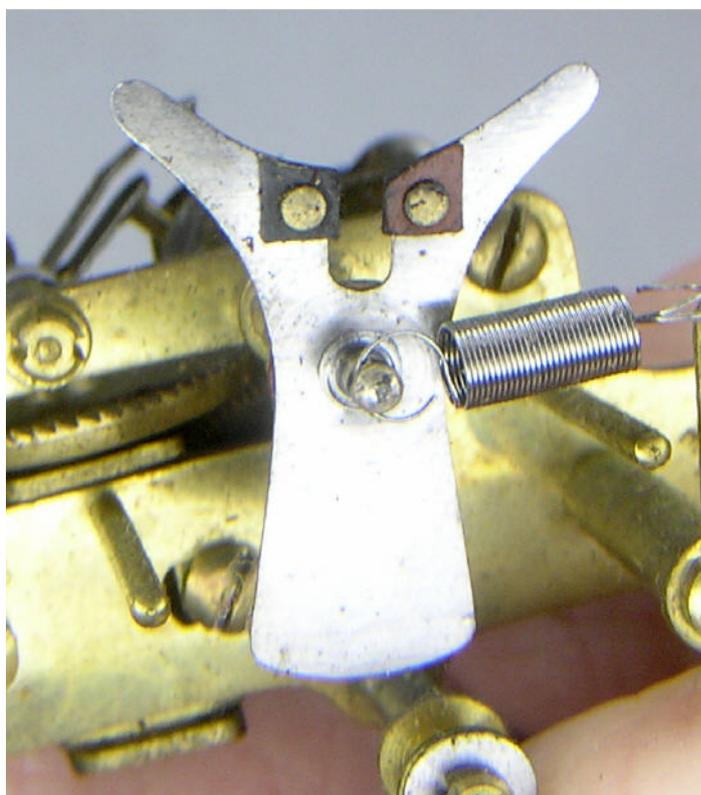
The fork contacts were found to be well worn right down to the steel of the fork itself. There is also evidence of oil embedded in the fibre. So we will replace both it and the silver contact. Note the steel contact spring in this photo. I have come across this type on quite a few later clocks. It is a lot stronger than the original silver springs found on earlier clocks so that too much tension will impede the action of the fork. So they need to be set up very carefully with the slightest of tension being exerted. But being so much stronger they are much less prone to stretch and corrosion..

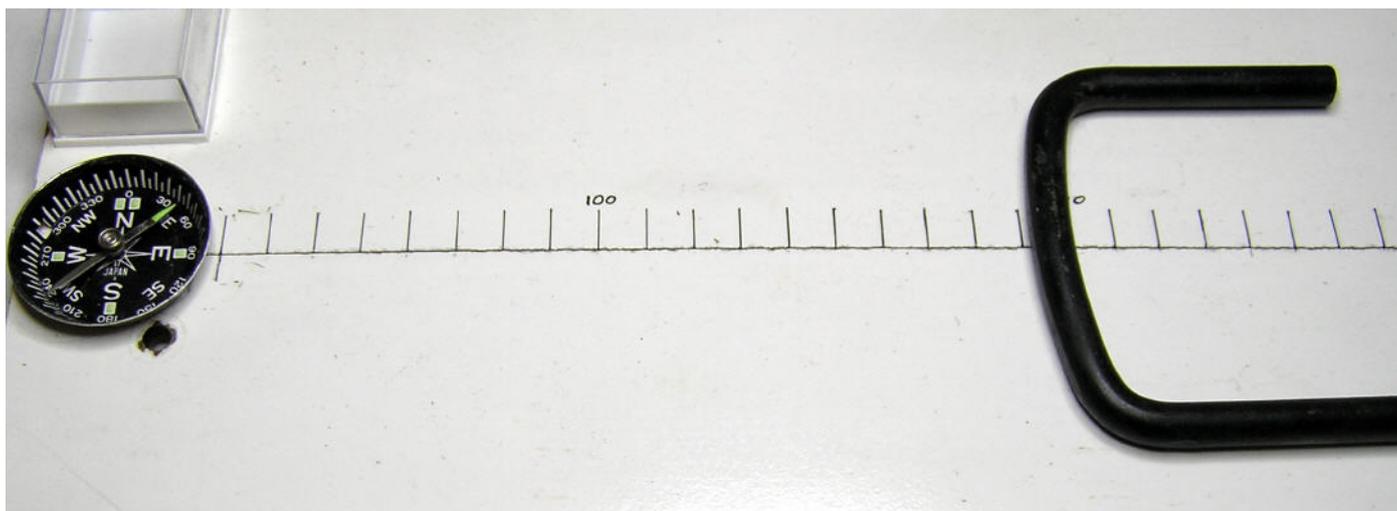
The magnet on this clock was a little weak and was showing only 160 on the magnetometer. So it has been regenerated and now shows a healthy 193mm. For those not familiar with my home made device I'll just expand a little. The board to which the compass is attached is turned until the needle points North. After allowing it to settle and with no other metal close enough to influence the reading the magnet is introduced from the right hand side. It is slid along the calibrated line until the needle is deflected to 45 degrees. It is then at a point where it equals the pull of Earth's magnetic field. The scale, which is marked in 10mm units, is then read to see how far the magnet is from the centre of the compass. The further away the magnet is when the compass needle is deflected to 45 degrees then the stronger the magnet is. This reading is then used to compare the strength of the magnet. I have found that a magnet that reads less than about 170 mm is a little weak for the Bulle clock and should be regenerated.

The device is simple but good enough to show how strong the magnet is and how effective the regeneration has been. It also tells us whether the magnet has the correct polarity. Some clocks I have come across have been wrongly regenerated in the past, showing only two poles. The Bulle clock must have three poles., South at both ends with North in the middle; although it doesn't really matter which way round they are, South-North-South or North-South-North so long as there are three. The battery connections will just need to be reversed..

The common view is that all Bulle clocks were originally South-North-South.

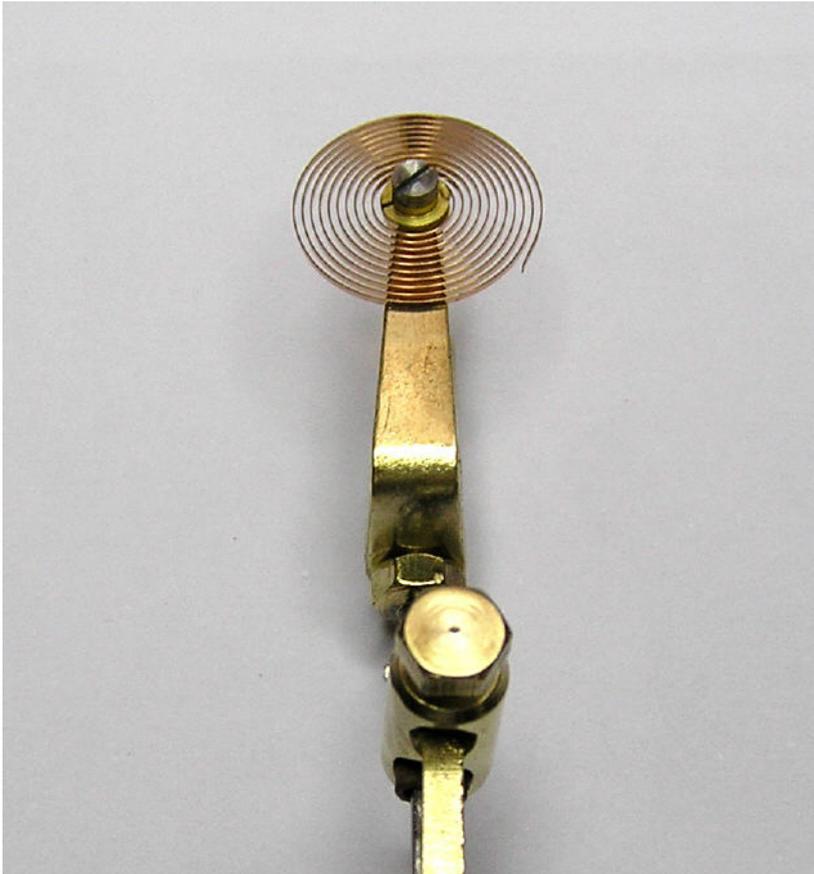
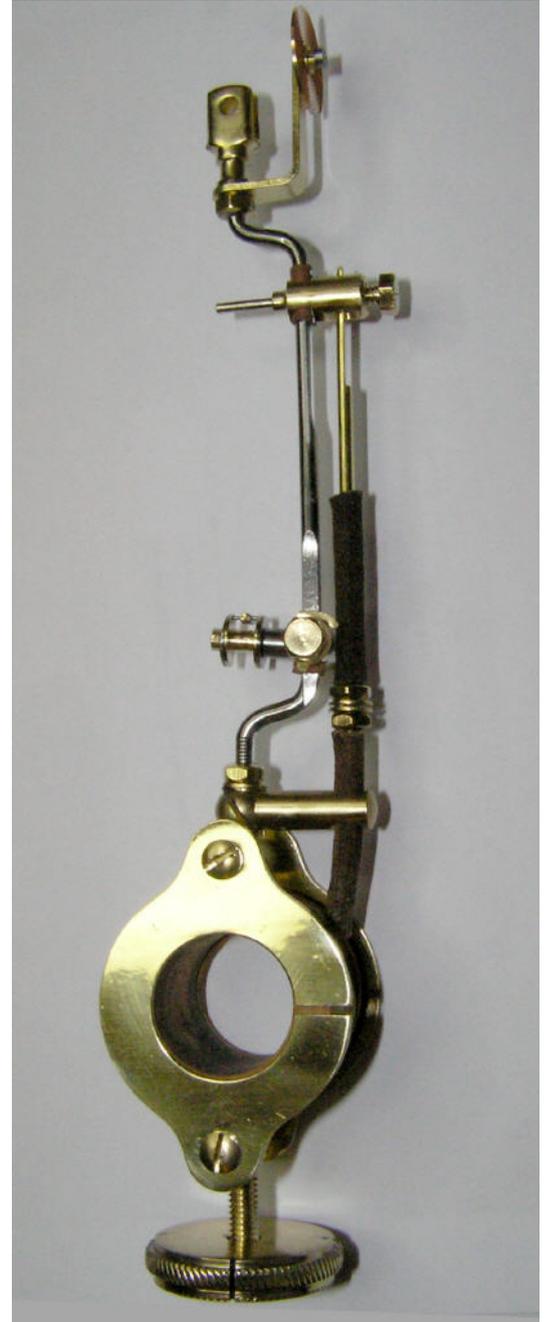
As I first suspected on seeing this clock very little was damaged or missing. So apart from the Balance contact spring and the Fork contacts the rest of the clock was in good order and just needed a strip and clean. These photos show the new spring and the finished pendulum about to be re-united with the dial plate.

One thing to note here is that the pendulum looks back to front! The balance spring is on the back of the pendulum. This is because the movement, pendulum and magnet all use the aluminium dial plate as the clock frame.

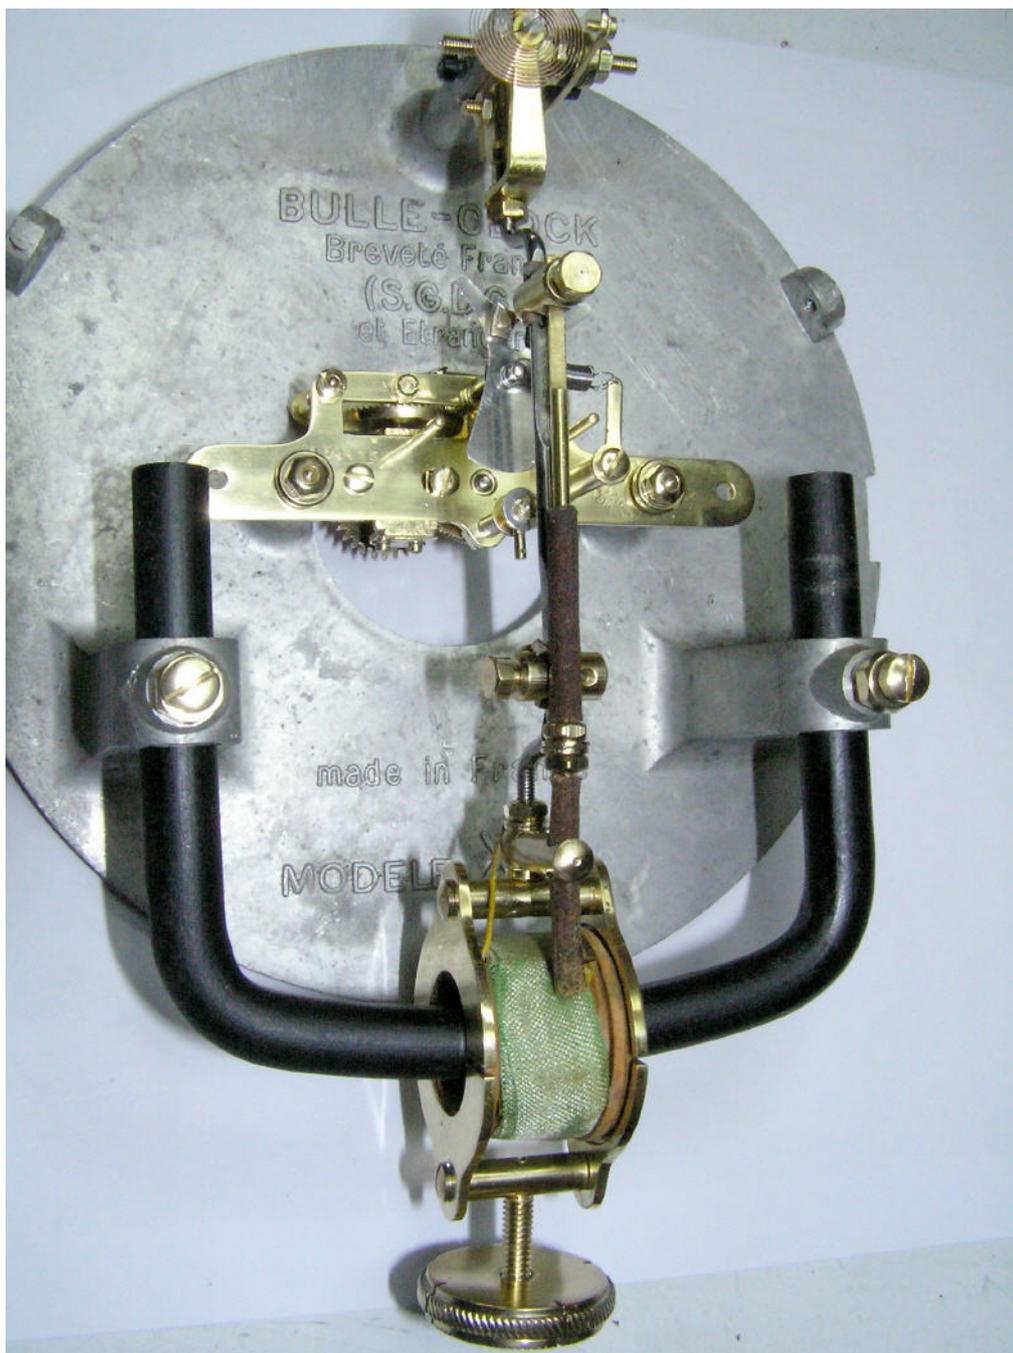
The clock reassembled ready for testing.

A difficulty with this type of clock is where to hold it while the testing takes place. You could of course put it back in the case but that would be a real problem if you have to adjust the pendulum length, pawls or contact pin entry height. The best way is to either make a frame to screw the dial plate to or use some clamps to grip the plate on the side.

The clock will be left on test for a week to check that the Isochron spring, when re-fitted, is correctly tensioned so that the pendulum rating nut is fully effective in causing the clock to run slow when fully lowered and fast when fully raised.

All that's now left to do is polish and fit the hands, clean the dial in warm soapy water and polish the case.

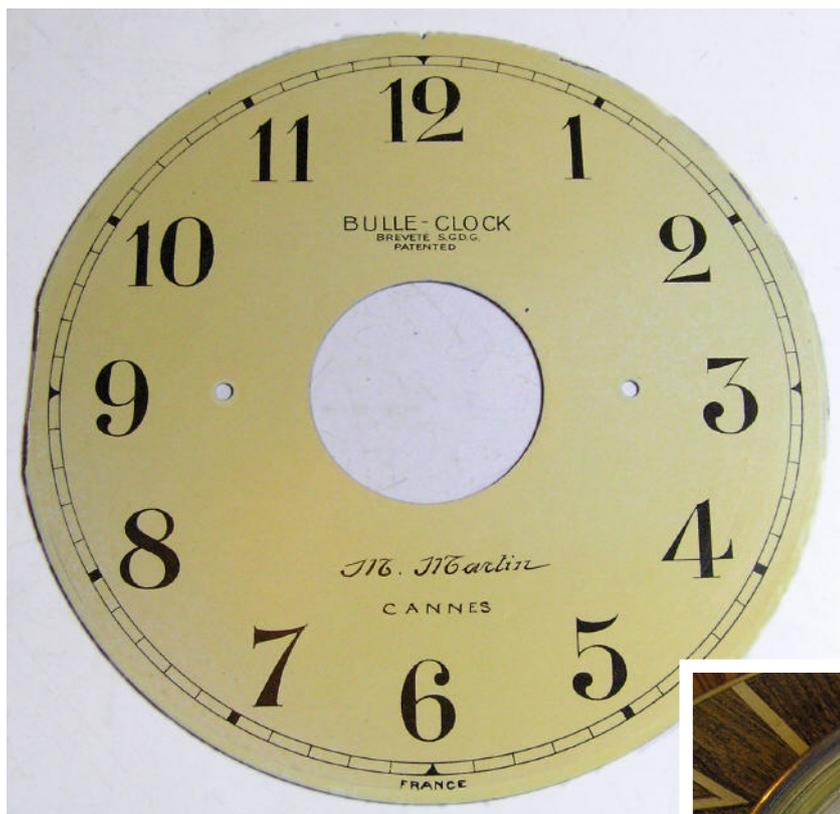
The dial is generally in good condition and suffered only from a grimy surface. This was easy to remove with just a little warm soapy water. It is difficult to tell whether the yellowing is caused by smoke or whether it was originally this colour.

It certainly suits the case and wood patination.

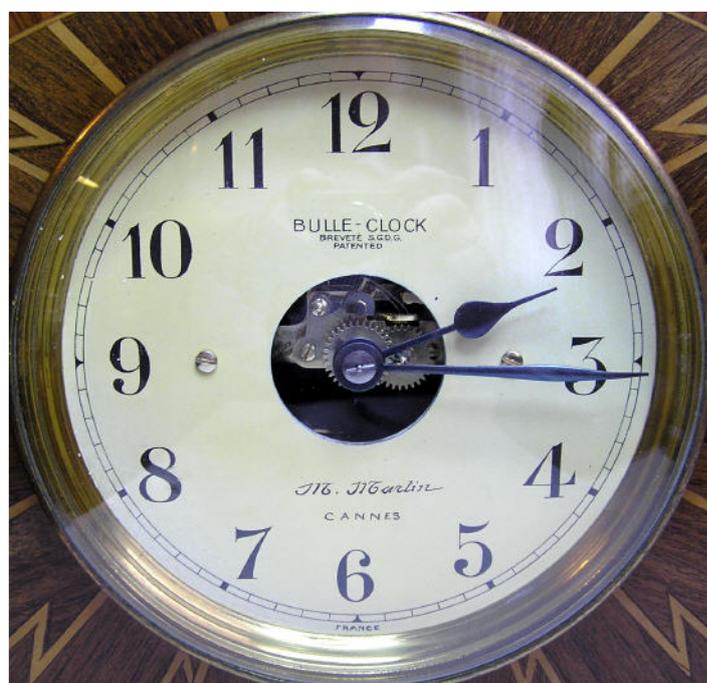
The finished movement, dial and hands refitted to the case. The glass and bezel have also been cleaned in warm soapy water. The hands have been cleaned and then waxed polished to bring out the Blueing.

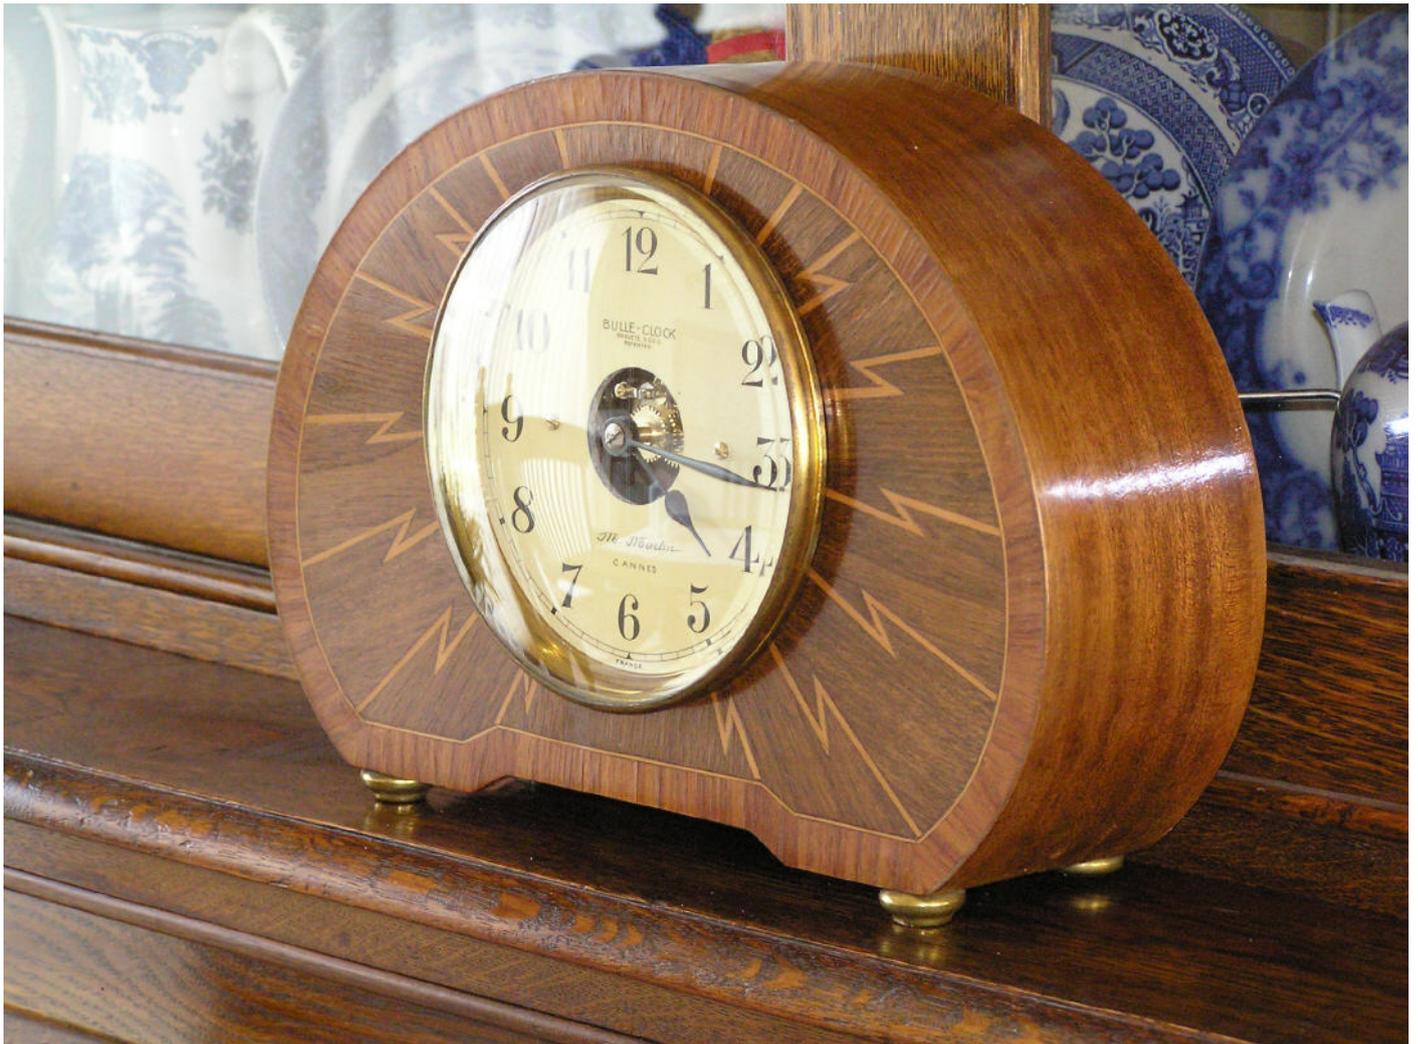
The completed clock.

The case has just had a buff with wax polish to bring out it's lustre.
