## *Restoration of Bulle Clock Serial Number 6448.*

Early Battery Clock Parts & Restoration

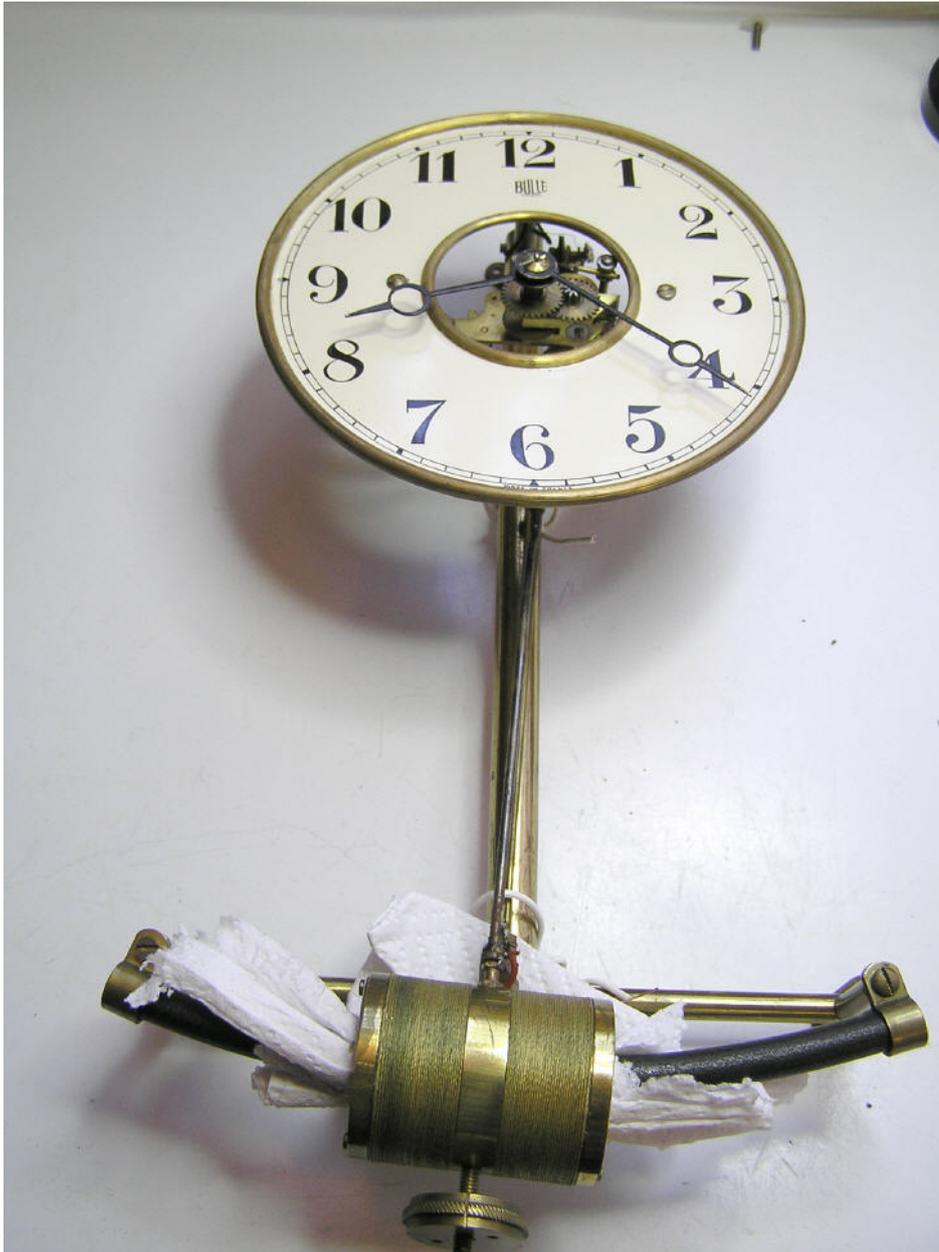
*This clock is a customers clock in for a full restoration. The case (not supplied) is of the Lancet type.*

*At first glance it looks to be in reasonable condition but in fact has many faults including some missing and non original parts.*

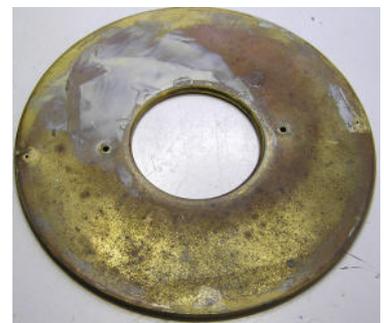
*The dial has been re-painted to a very good standard and would require more than a passing glance to show its origins. (Note the character 6 is slightly askew). The biggest giveaway though is the splurge of white paint on the back. Why make a good job of the front only to leave the back in such a mess? This will need to be cleaned off as one of the final jobs.*

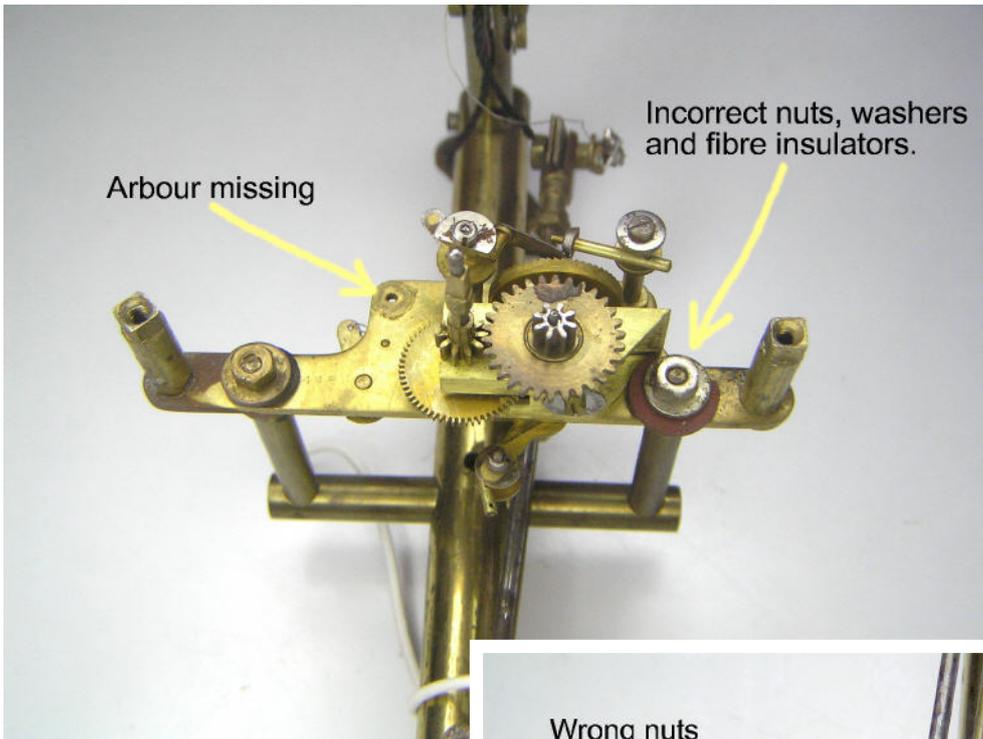
The arbour that holds the damper and forward motion stop is missing. This will need to be manufactured or replaced from original parts if I have any.

There seems to be a lot of the original nuts and washers missing and replaced with odds and bods as can be seen here.

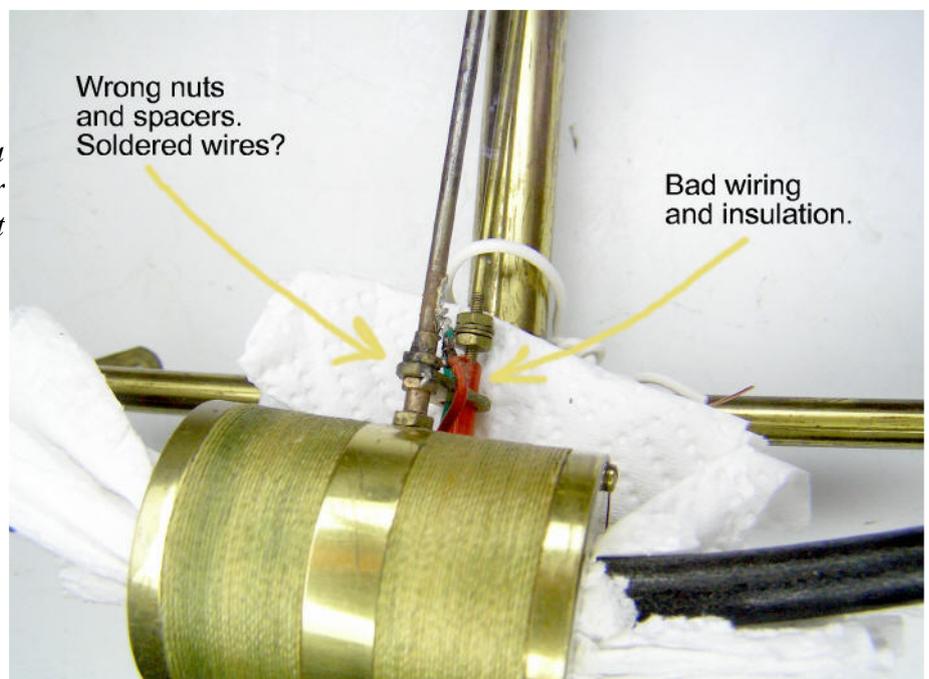
The coil connections look to be in a bad way. This does not bode well for the coil. It will need to be looked at and checked for resistance.

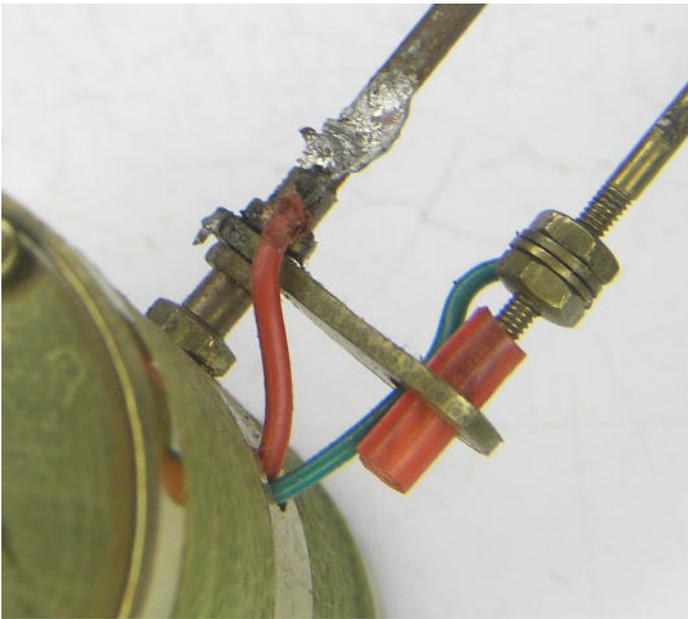
*The terrible wiring to the pendulum can be seen in more detail to the left.*

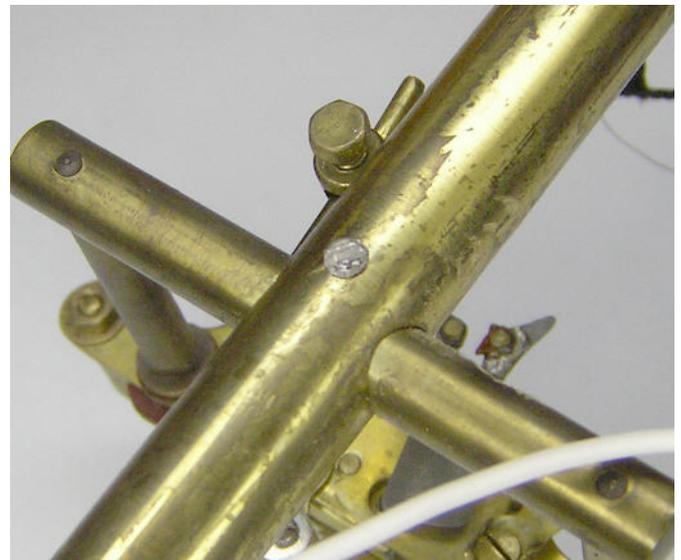
*The frame cross members were very loose. It was found that both of them were badly riveted when they were both refitted in the past. It looks like a nail was used!*

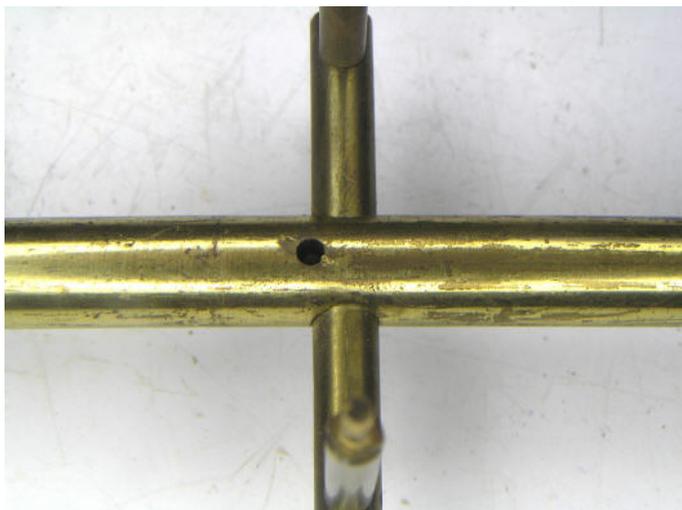
*This photo shows the reverse side to the arm above. The nail rivet doesn't quite reach the other side!*

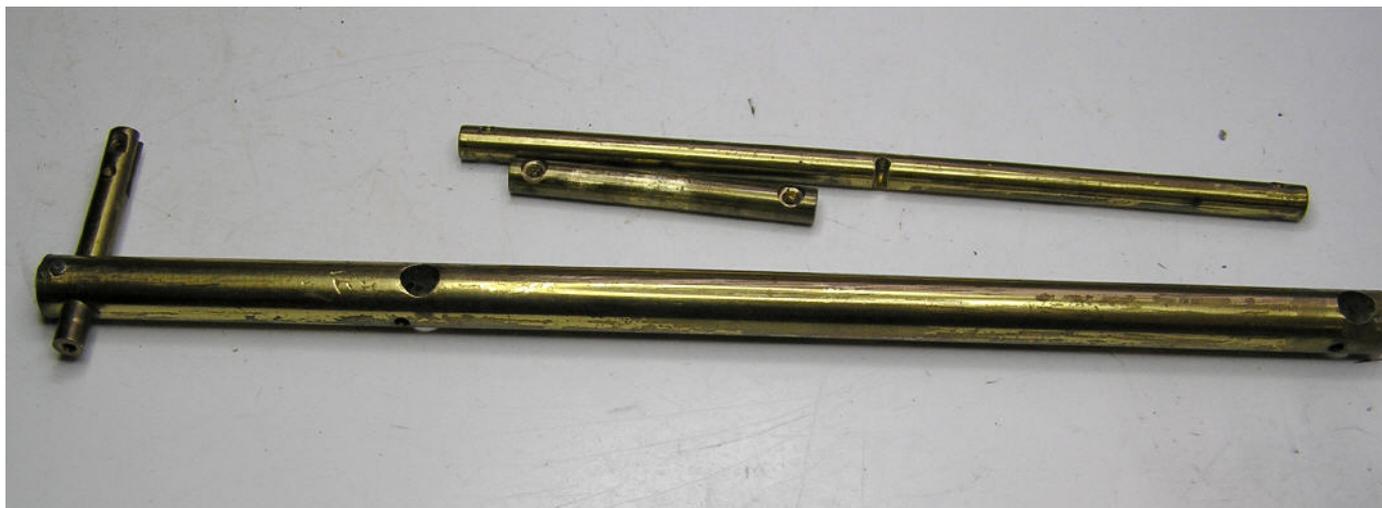
*The frame disassembled ready for new rivets which will be turned up on the lathe.*

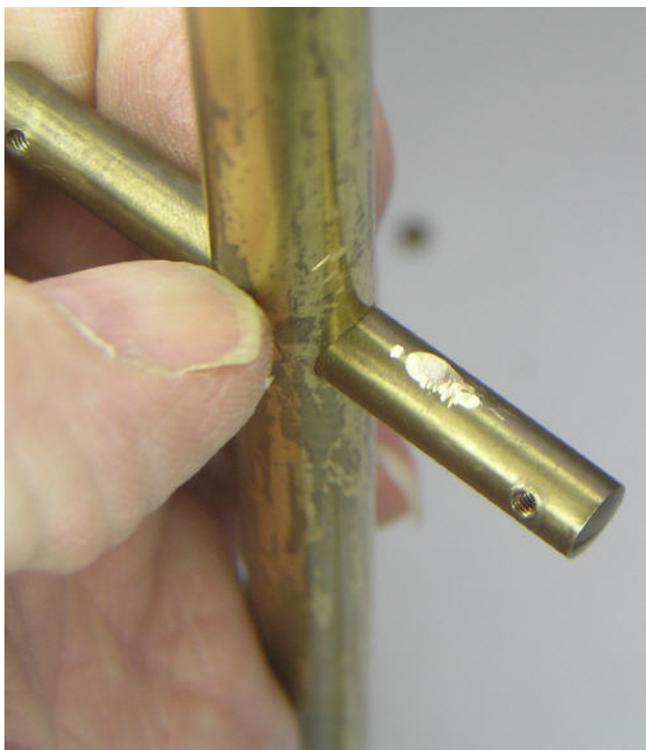
*The top cross member also had some abrasion marks which are still quite bright inferring that they were recently made. It may be possible to fit the member the opposite way round with the damage on the underside. It will not show too badly when the frame is polished and lacquered.*

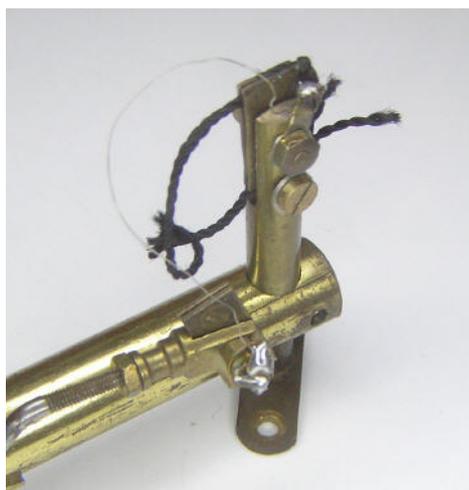
*The photo on the left shows the attempt at re-creating a Bulle suspension with two pieces of Black string!*

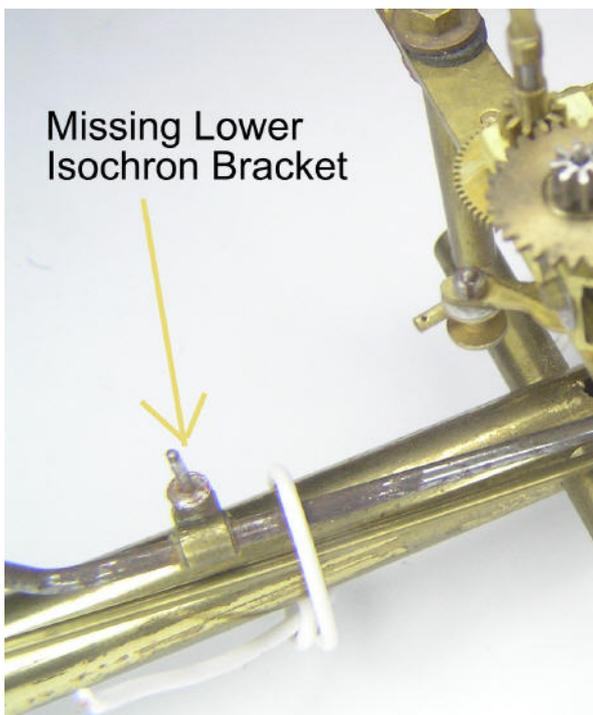
*The lower Isochron bracket attached to the pendulum is missing. The arbour is still there but the T-piece assembly and nut are not. I should have some replacements to hand from a partial pendulum assembly. If not a new set will need to be made.*

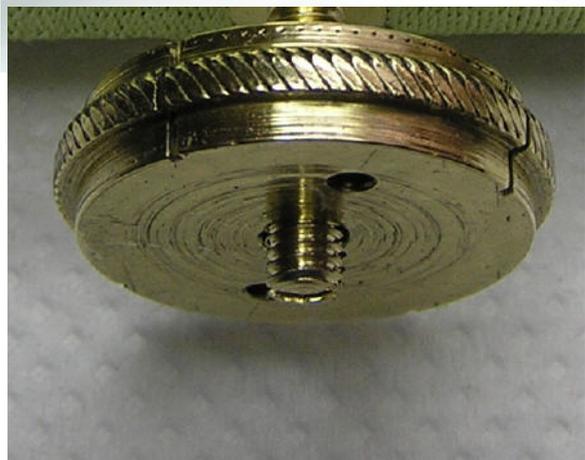
*For some reason the rating nut has been drilled with two holes. Maybe they were trying to light the nut to shorten the pendulum?*

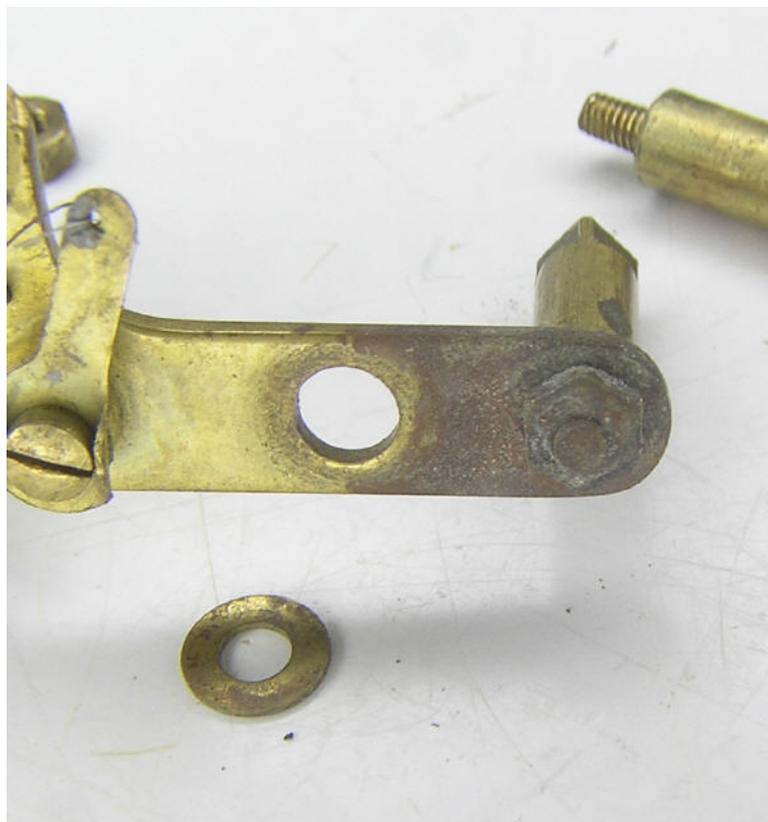
*This photo above shows the corrosion to the movement frame. This looks as though it's an acid burn.. How the acid got there we'll never know. Twenty or thirty minutes in the ultrasonic tank with Horolene followed by Bicarbonate of Soda should make a difference.*

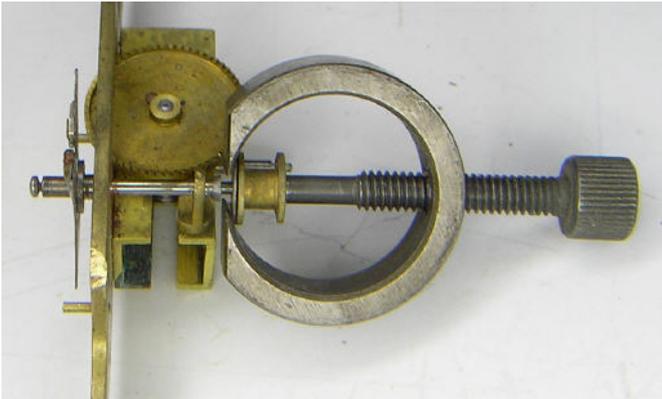
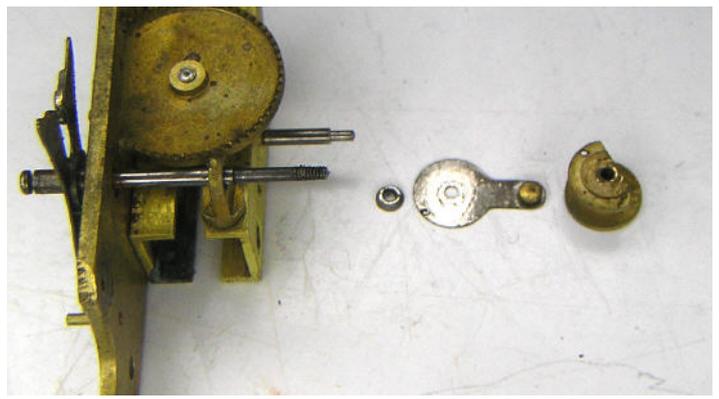
If the driving pawl assembly is hard to remove then use a hand remover as shown above. Do not try and force the assembly off the arbour by any other method as the arbour is hardened steel and fractures easily. Protect the screwed end of the arbour with the retaining nut. Loosen it to give enough clearance for the pawl assembly to pull free. Note the two parts that are between the pawl assembly and the frame. The small ring is very small and easily lost but is vital to the correct working of the pawl. It butts up against a ridge on the arbour so that the pawl assembly does not bind against the frame. The steel washer with the brass button is a counterweight for the pawl and on re-assembly it should be positioned on the opposite side to the pawl.

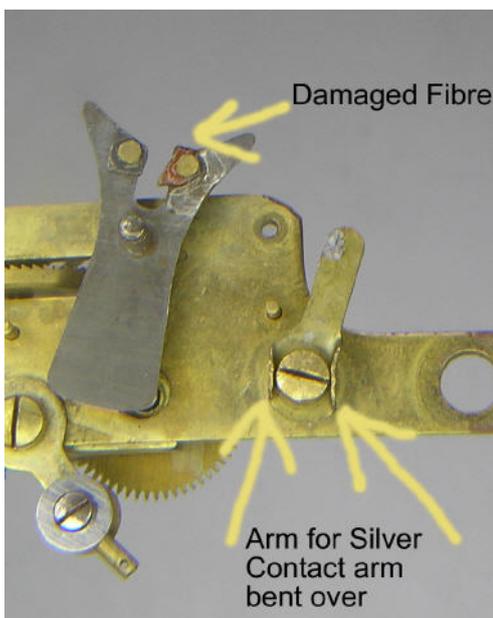
This next photo shows the contact fork and the arm that holds one end of the Silver contact spring. The fibre on the fork is damaged, Someone has tried to reposition it to present a face to the contact pin. That will need replacing. I'll check the wear on the silver contact on the opposite face. This may also need replacing.

The arm for the silver contact has been forced up in two areas. I am still trying to figure out why. Perhaps it was to try and keep the arm in a single position. But that is the function of the screw! Ah well... I guess I'll have to manufacture a new one if I can't straighten it cleanly.

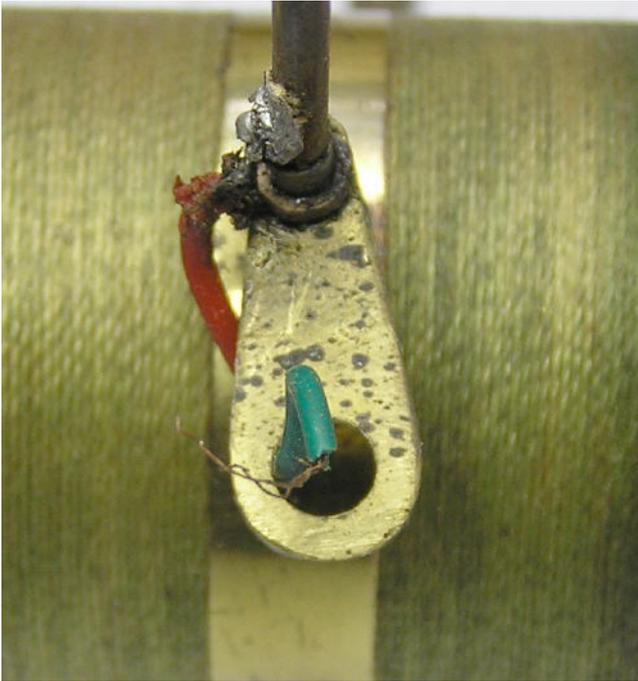
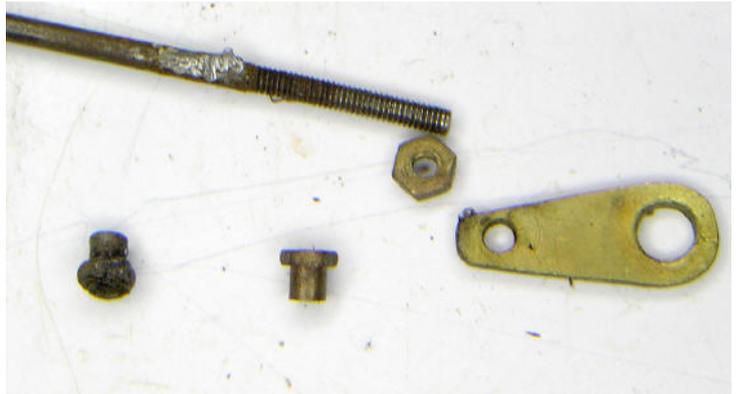
These two photos show the arm that secures the pendulum to the steel rod and also allows the negative wire from the coil to pass through via an insulated sleeve to the brass rod that attaches to the Silver contact pin at the top of the pendulum. This arm is completely wrong and seems to be made up from various bits and pieces that are no part of a Bulle clock. Note also the solder on the

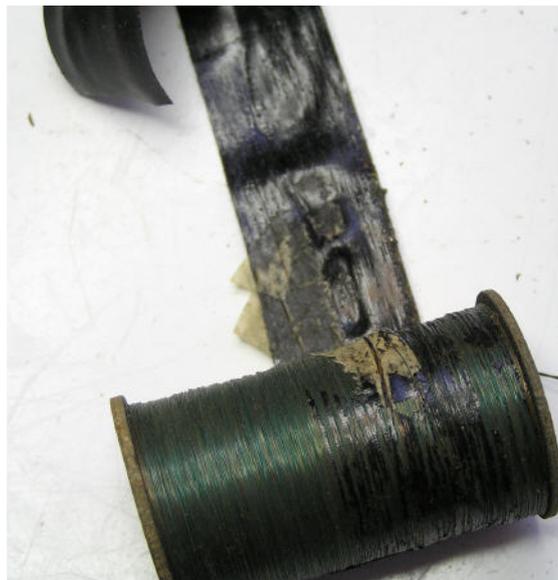
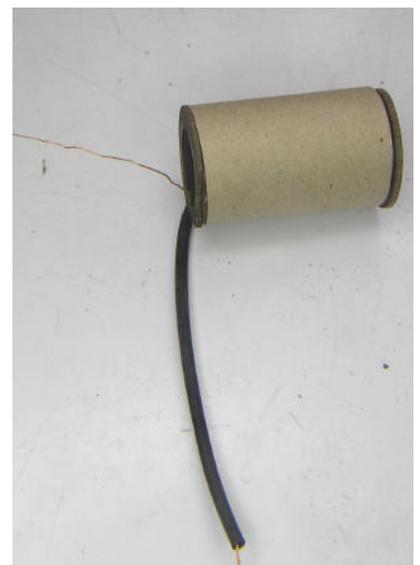
The photo on the right shows the condition of the coil. It has been repaired in the past with Insulation tape which has left a gummy deposit on the wire. I have removed what I can and recovered the coil as in the photo on the far right. I have also fitted new insulation.

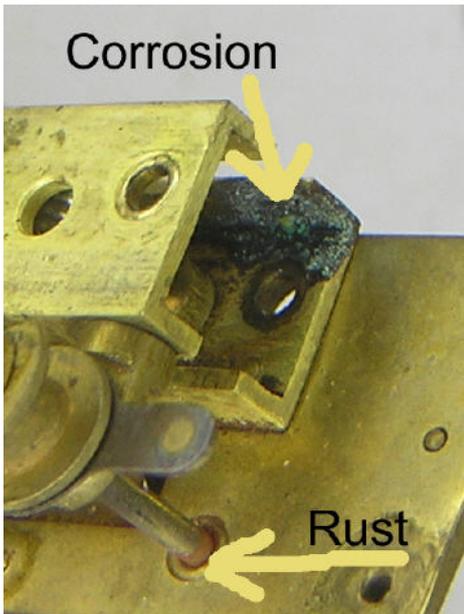
The photo to the left shows the corrosion to the movement which again looks to be caused by battery acid. The brass can be cleaned up quite well using the methods described previously but it has to be said that there will be some pitting in the metal. In this case it will not normally be visible as it is on the inside of the plate.

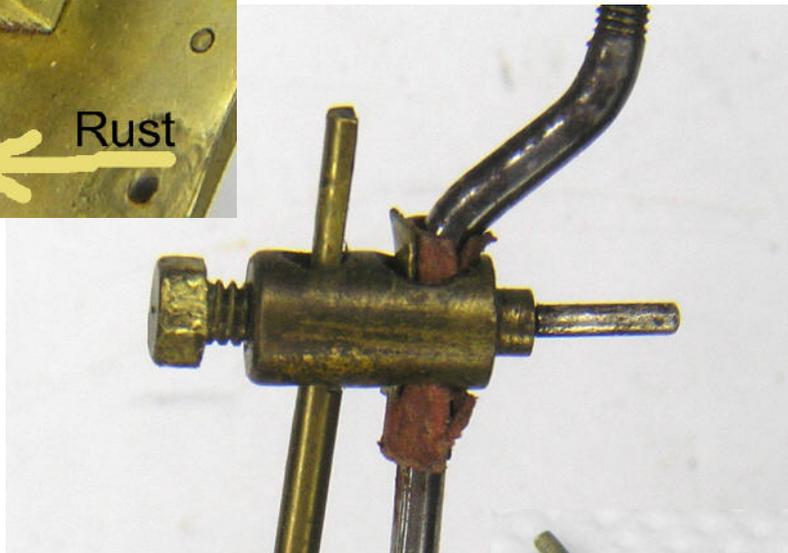
The contact assembly is missing the "T" piece steel strip and has been replaced with a thin strip of brass. The original would have been thicker and the "T" shape would have prevented it slipping out. This will have to be replaced otherwise the screw could cut through the thin brass and fibre, thereby shorting the circuit.

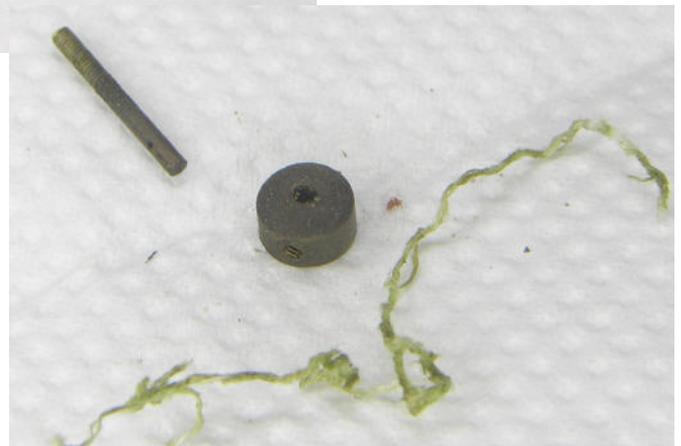
I have found a few parts for the missing arm assembly. This piece is part of the damper and is normally filled with the same cord as is used on the outside of the coil casing.. On a working clock this shell is filled with the cord well oiled for lubrication. The 0.5mm cross pin is also missing and will be made from Piano wire. The whole assembly is shown later with the new parts needed to complete to arm.

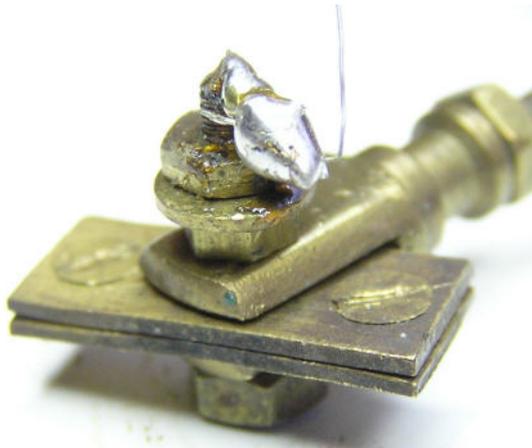
*This was meant to be the top contact for the wire that jumped the gap in the circuit caused by the silk suspension unit. I didn't need to do much to dislodge the lump of solder. Just a quick flick with my finger nail was enough to send it flying.*

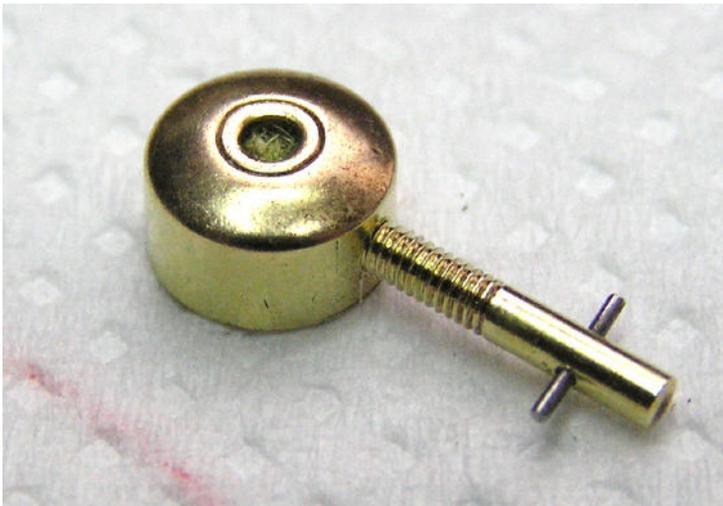
*This photo shows the new steel "T" piece for the contact assembly. This was cut from 0.5mm mild steel sheet using a piercing saw and finely shaped with a needle file. Don't be too fussy in the final finish as the originals were roughly punched out by machine.*

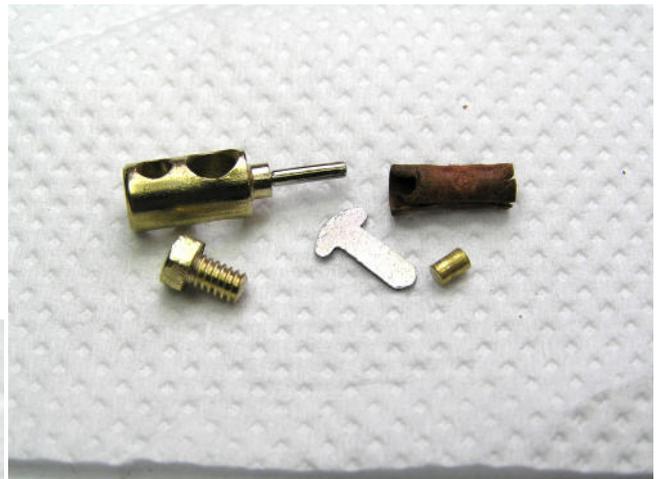
*The damper arm shell has been cleaned and re-pinned with 0.5mm piano wire. I stuffed the shell with some of the old cord that was wrapped around the coil shell and added a few drops of oil. The parts that were missing from the assembly were remade and are shown on the next page.*

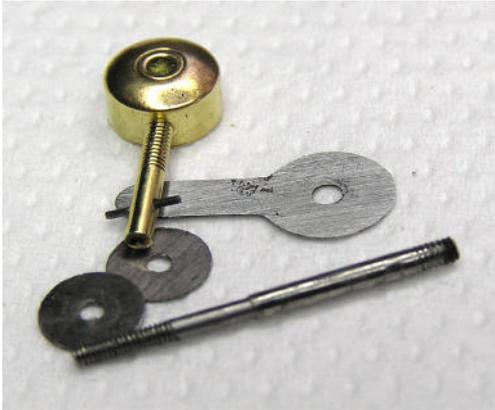
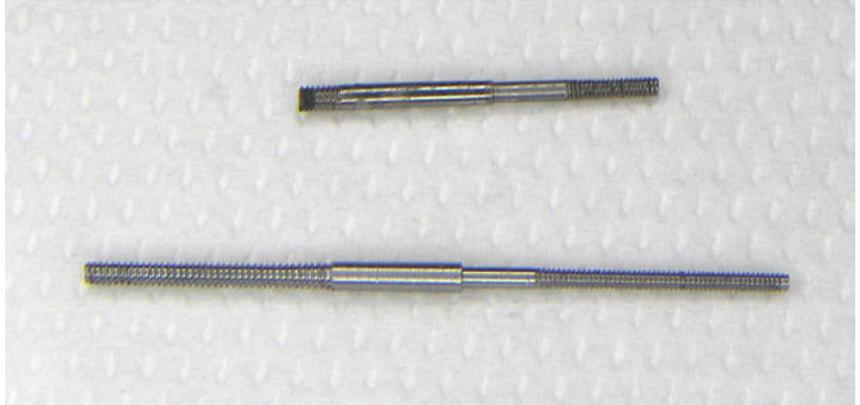
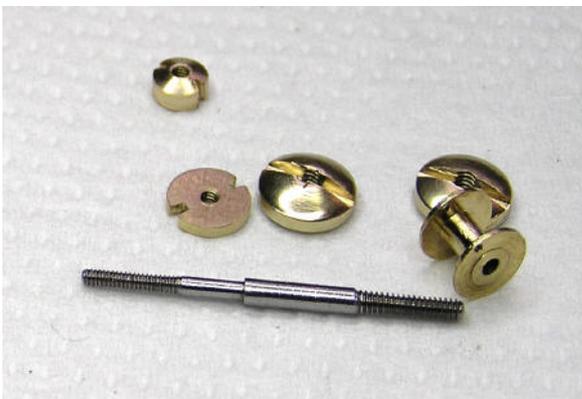
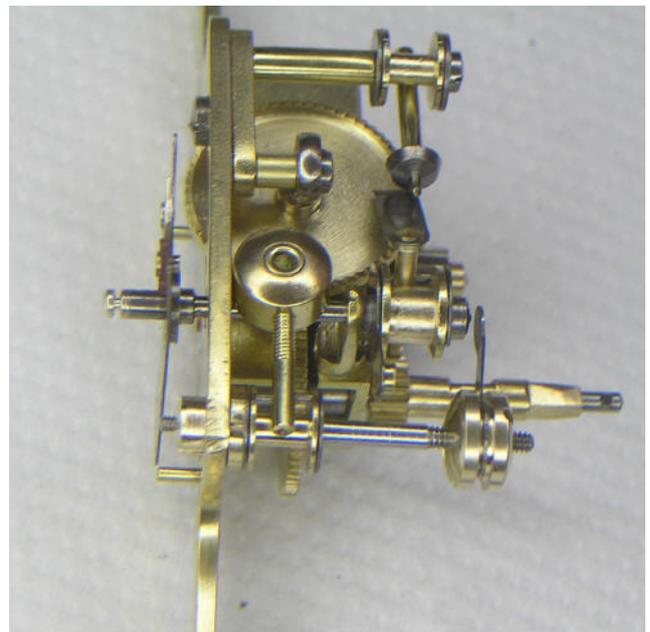
The photo top left shows all the parts I had saved from a part movement that was found in a box of parts from an auction many years ago. The arbour had been snapped on the right hand side and had to be remade. The steel washers, although pitted, were still usable when cleaned up. The new arbour was turned up on the lathe and can be seen in the photo above with the old one for comparison. I left the threads long until I had fitted the other parts and offered them into position on the clock. The maximum diameter of the arbour in the middle was 1.70mm. The smaller diameter is 1.30mm. The other parts that were needed were turned up from brass on the lathe and threaded. The complete set of new parts for this arbour are show in the photo below left. The complete assembly is

shown in place on the clock in the photo to the right. Note how the damper is positioned over the fork arbour . The fork arbour is prevented from moving to far forward by the stop at the right hand side of the new assembly.

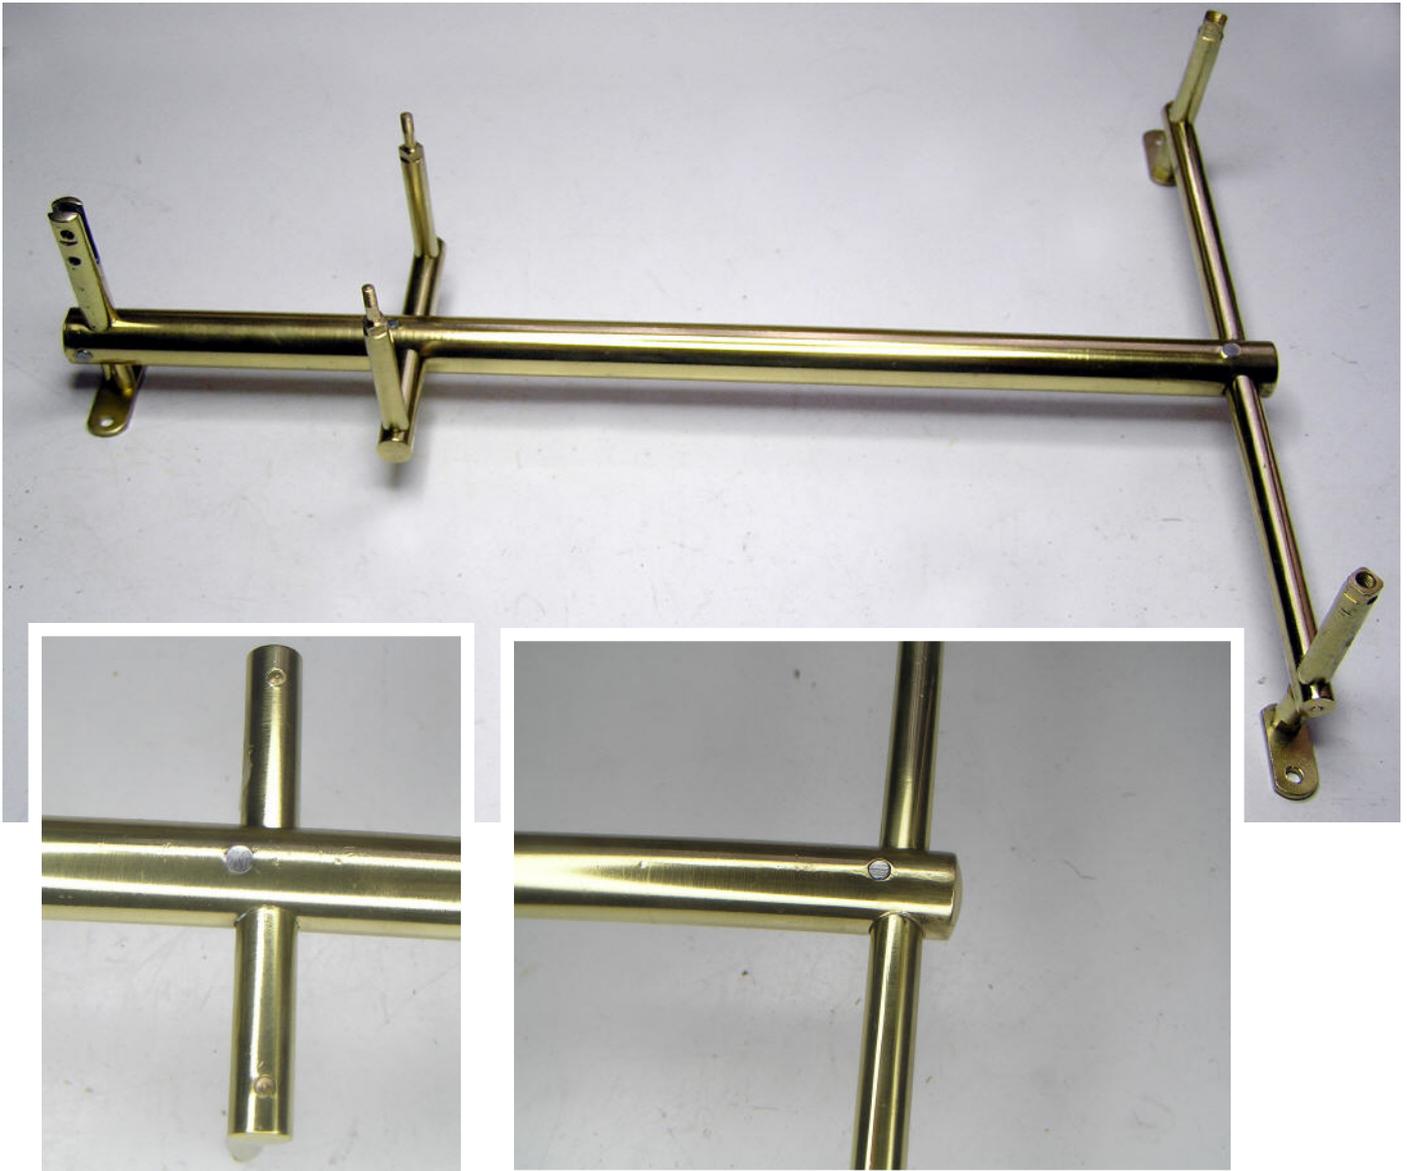
*The frame after riveting and polishing. The frame was checked for square and the joints tested for firmness. The whole was then lacquered.*

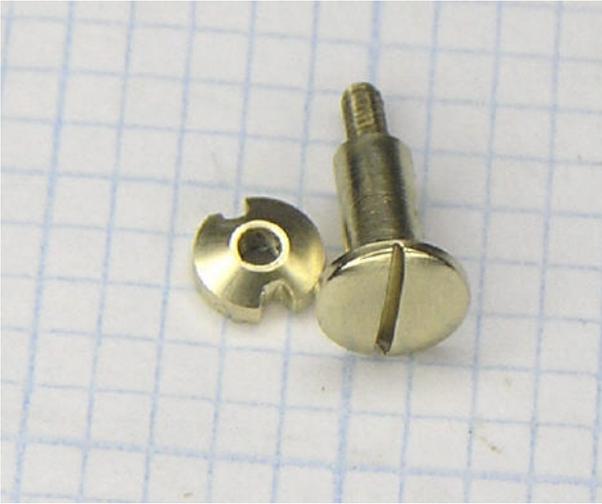
The lower suspension nut and screw were missing and again a new set turned up on the lathe.

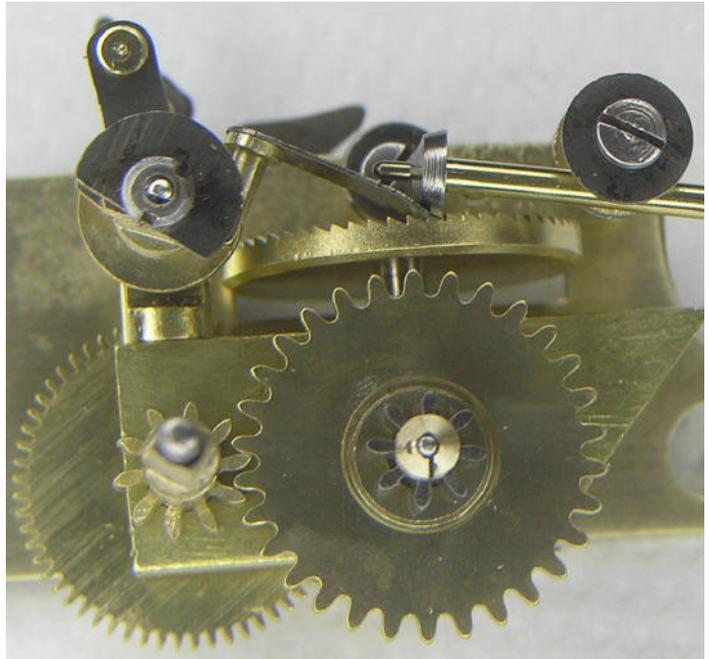
The motion work intermediate wheel arbour was missing the wheel retainer which is just a slit brass ring that can then be squeezed as a tight fit on the arbour.

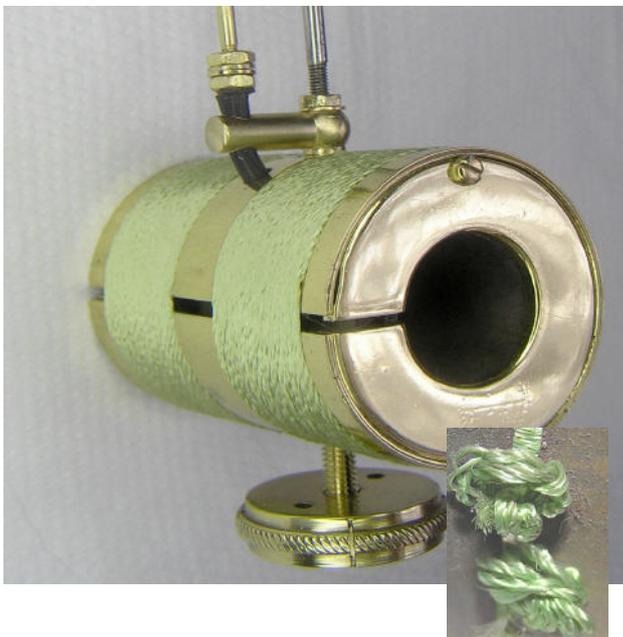
The bottom of the pendulum can be seen in this photo on the left. The original cord ends as found inside the coil cover still retain their original colour and have been matched quite closely with new cord.

Note the difference in the wiring and insulation to that when the clock was received in the earlier photos.

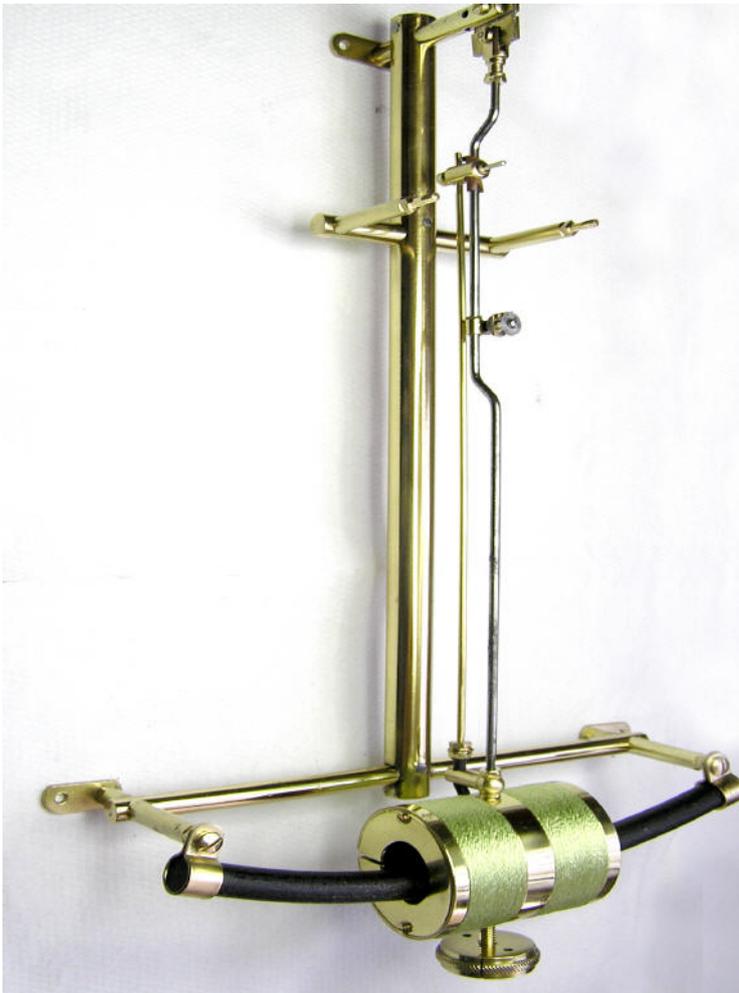
*The photo at left shows the frame and pendulum assembly now put back together ready for the movement itself. The lower Isochron bracket has also been replaced and shown in position. The bar magnet has had a coat of Grate Black to give it a bit of lustre. I don't normally paint these as any scratches would soon show up.*

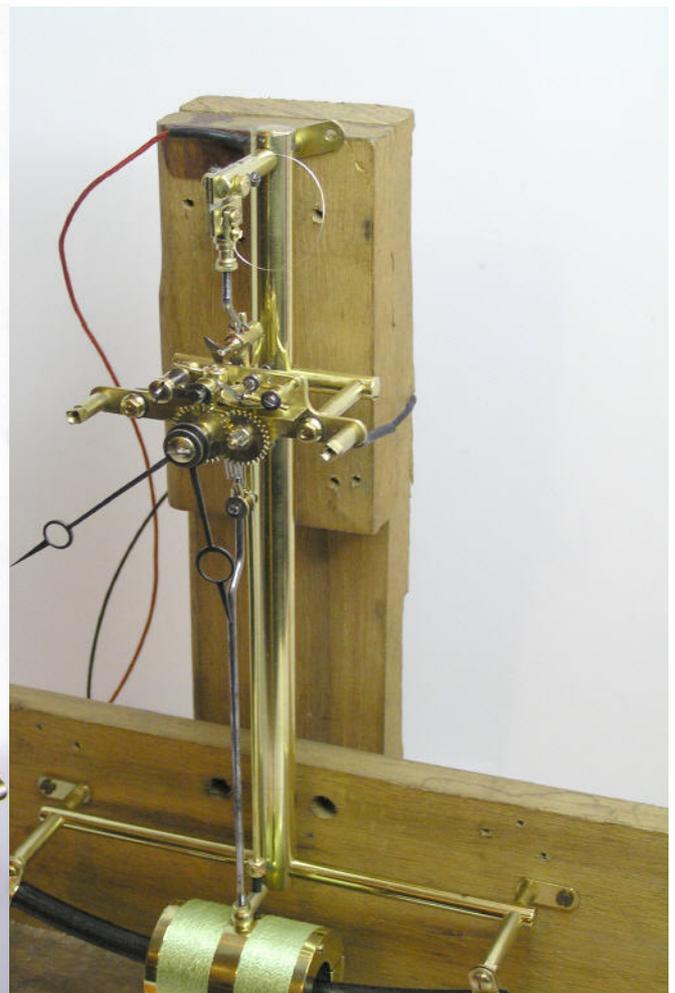
*This next photo shows the frame, pendulum and movement on a made up test stand awaiting the final item - The Dial.*

*The clock is tested over a weeks period to make sure the timing can be fully influenced, both fast and slow, by using the rating nut only.*

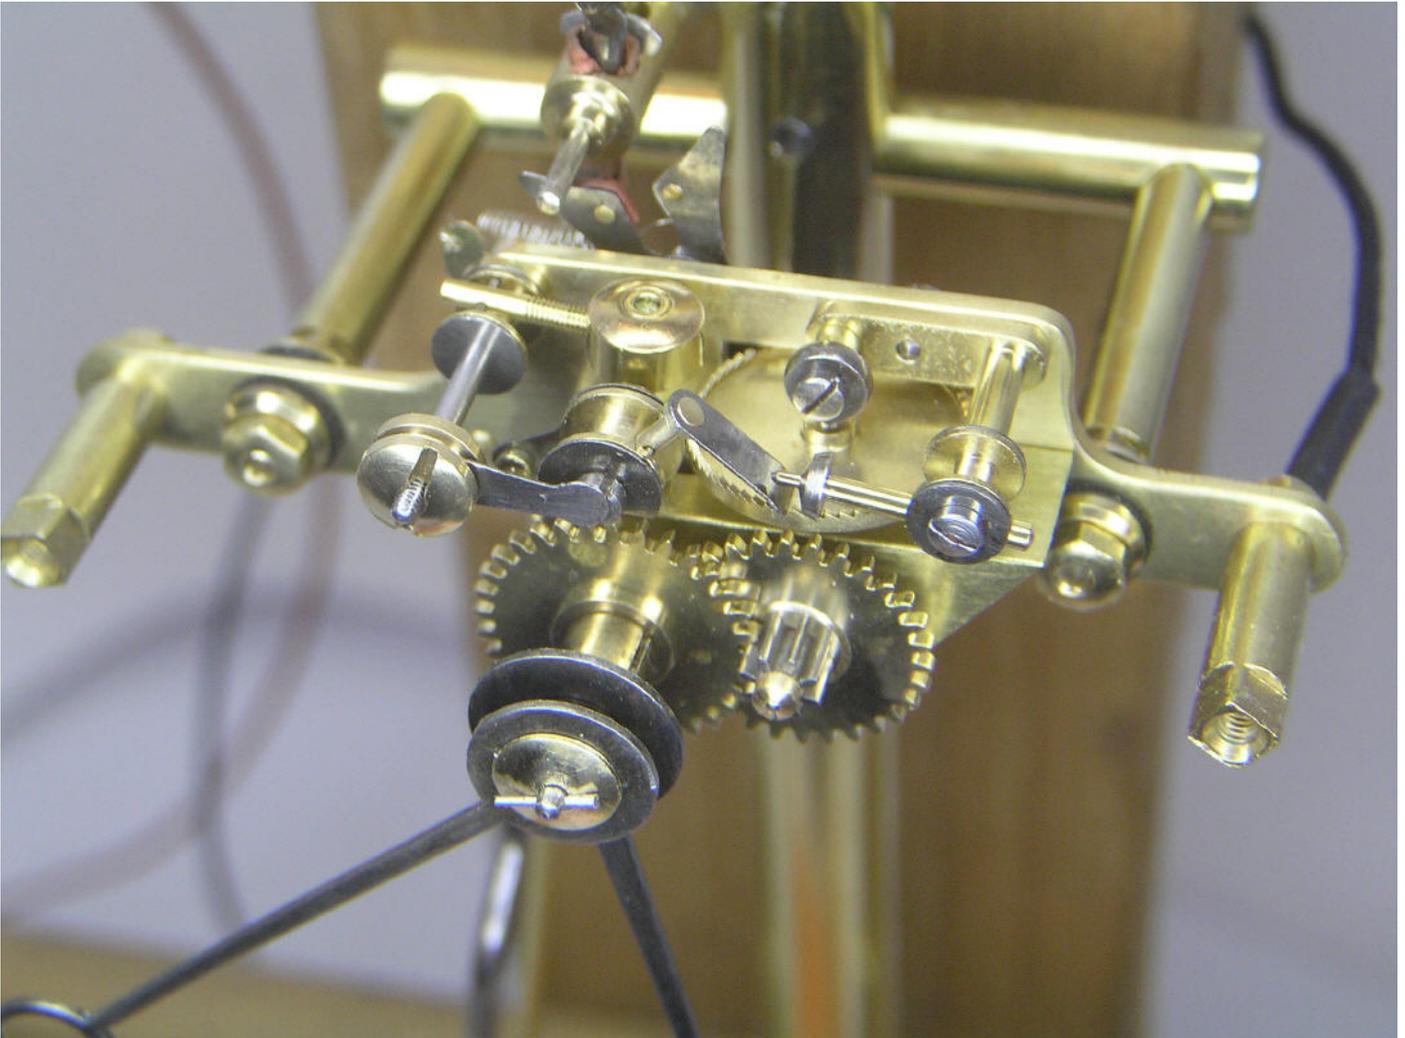
*The movement fully restored with the hands in place being tested for a full week. Note the differences in this photo and the ones taken of the clock as delivered. The new and refurbished parts have blended in very well. You would have to be a real expert to notice. Even then I don't think you could. You can just see the new fibre on the contact fork as the pendulum is swing to the extreme left.*

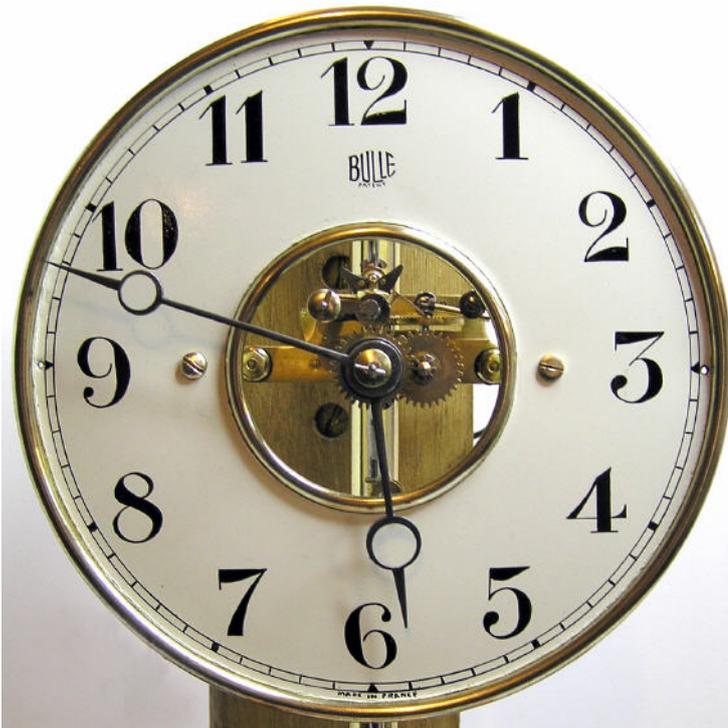
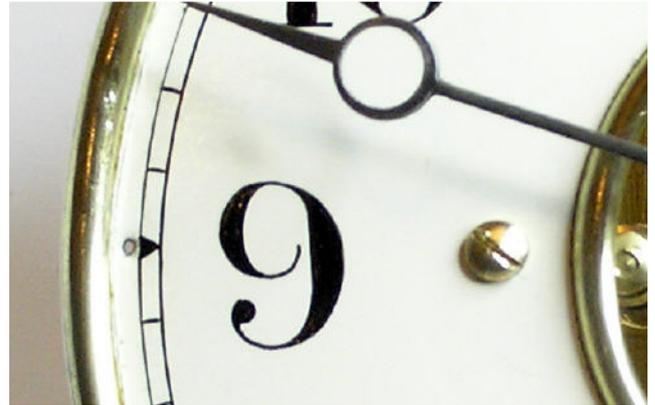
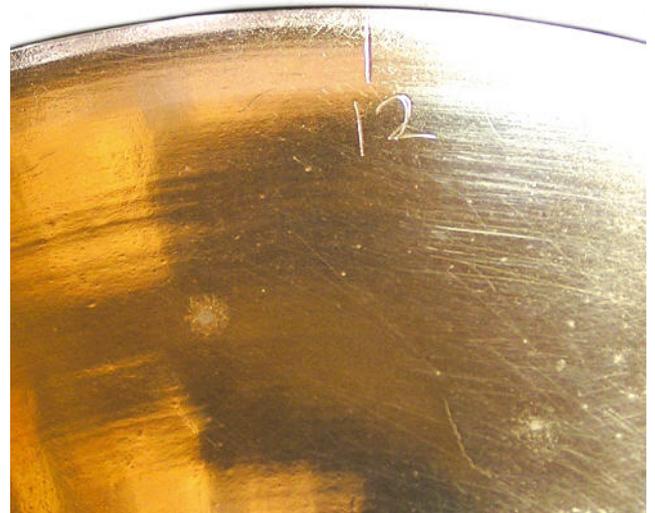
The dial now in place. Further proof that the dial is re-painted is shown in the photo at right. The figures "12" are scratched in the brass where the dial painter needed to know top from bottom. The photo at right above shows a small hole which together with another one at the three o'clock position suggests that this dial may be a replacement.

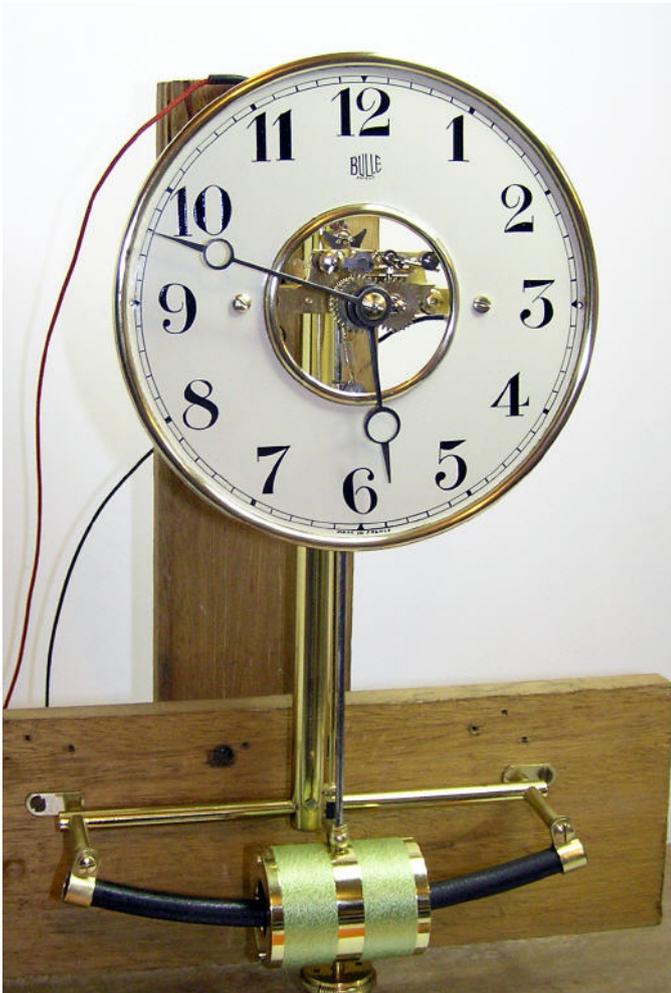
The finished clock ready to be re-united with the case.
