Bulle Clock Serial Number 7446

*Restoration of Bulle Clock
Serial Number 7446.*

Early Battery Clock Parts & Restoration

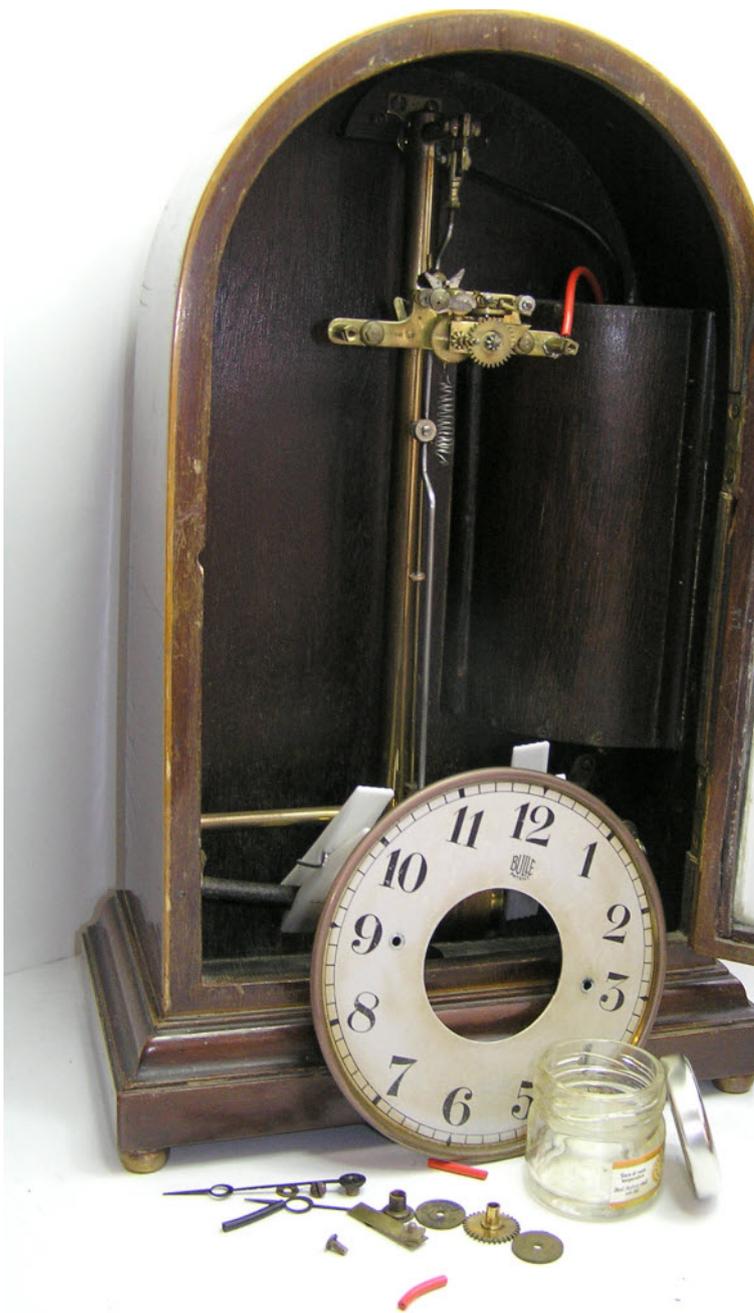
The photo left shows the clock as delivered. Some of the parts have already been disassembled and were in the jar shown. The dial looks OK but has some engrained dirt; probably nicotine stains.

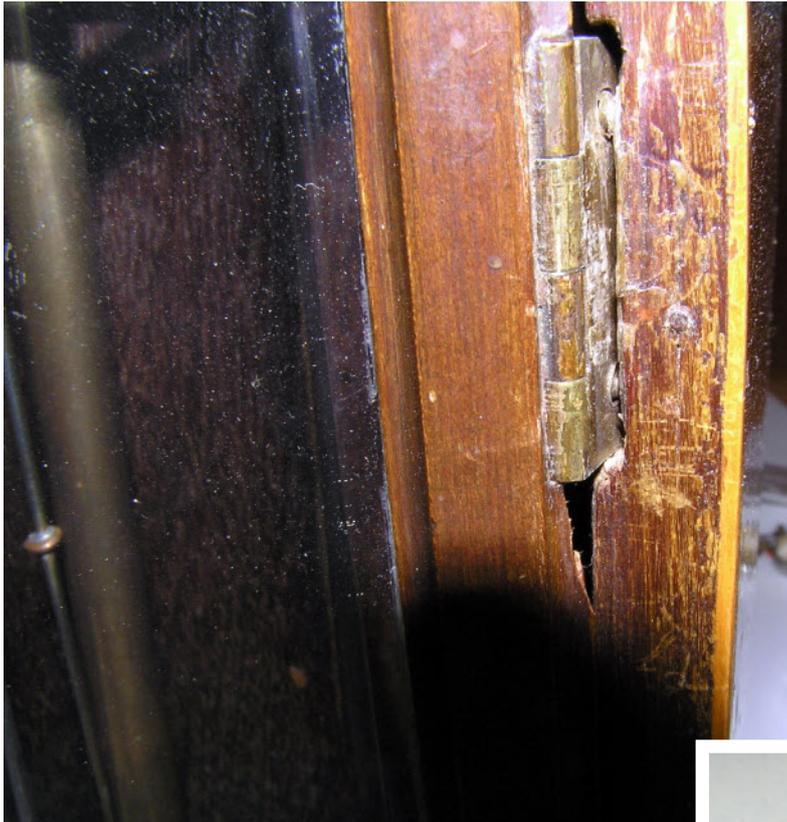
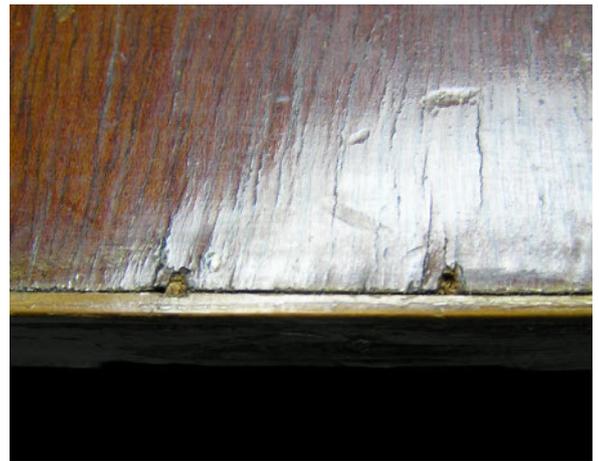
The door hinges are pulling the wood apart. To rectify the situation someone has tried using longer screws with the result that they have push completely through the case at just the right point to separate the stringing on the outside edge.

The movement now is now back in the case which has had some of the damage repaired. The splits were filled and glued as well as the over-large screw holes filled and re-drilled to size.

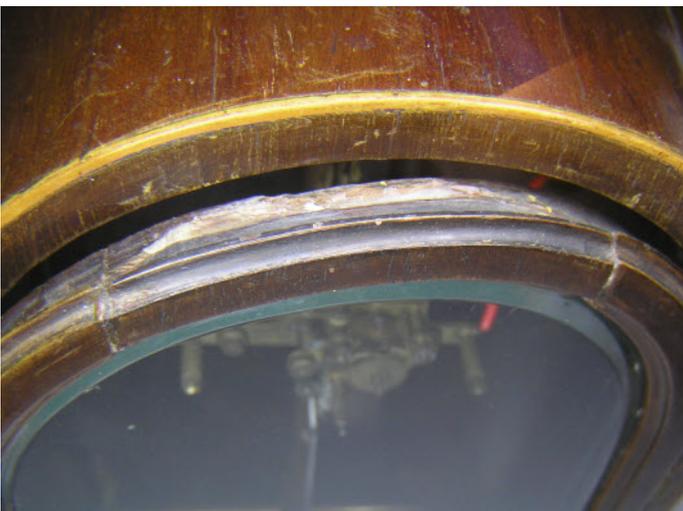
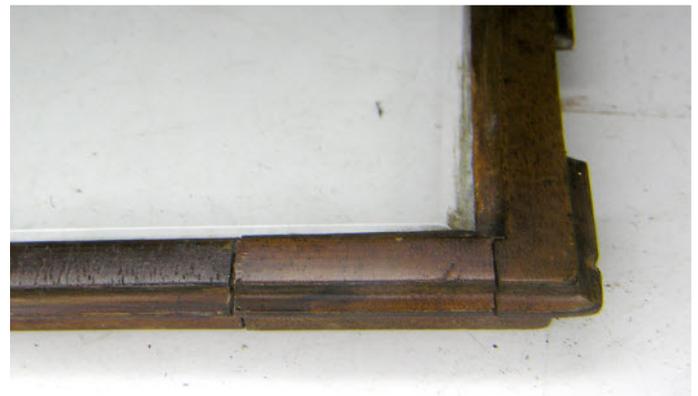
The door has faired no better with broken parts roughly stuck back together with modern glues. So there is a lot of work in just trying to get the case in good order after we have repaired the movement.

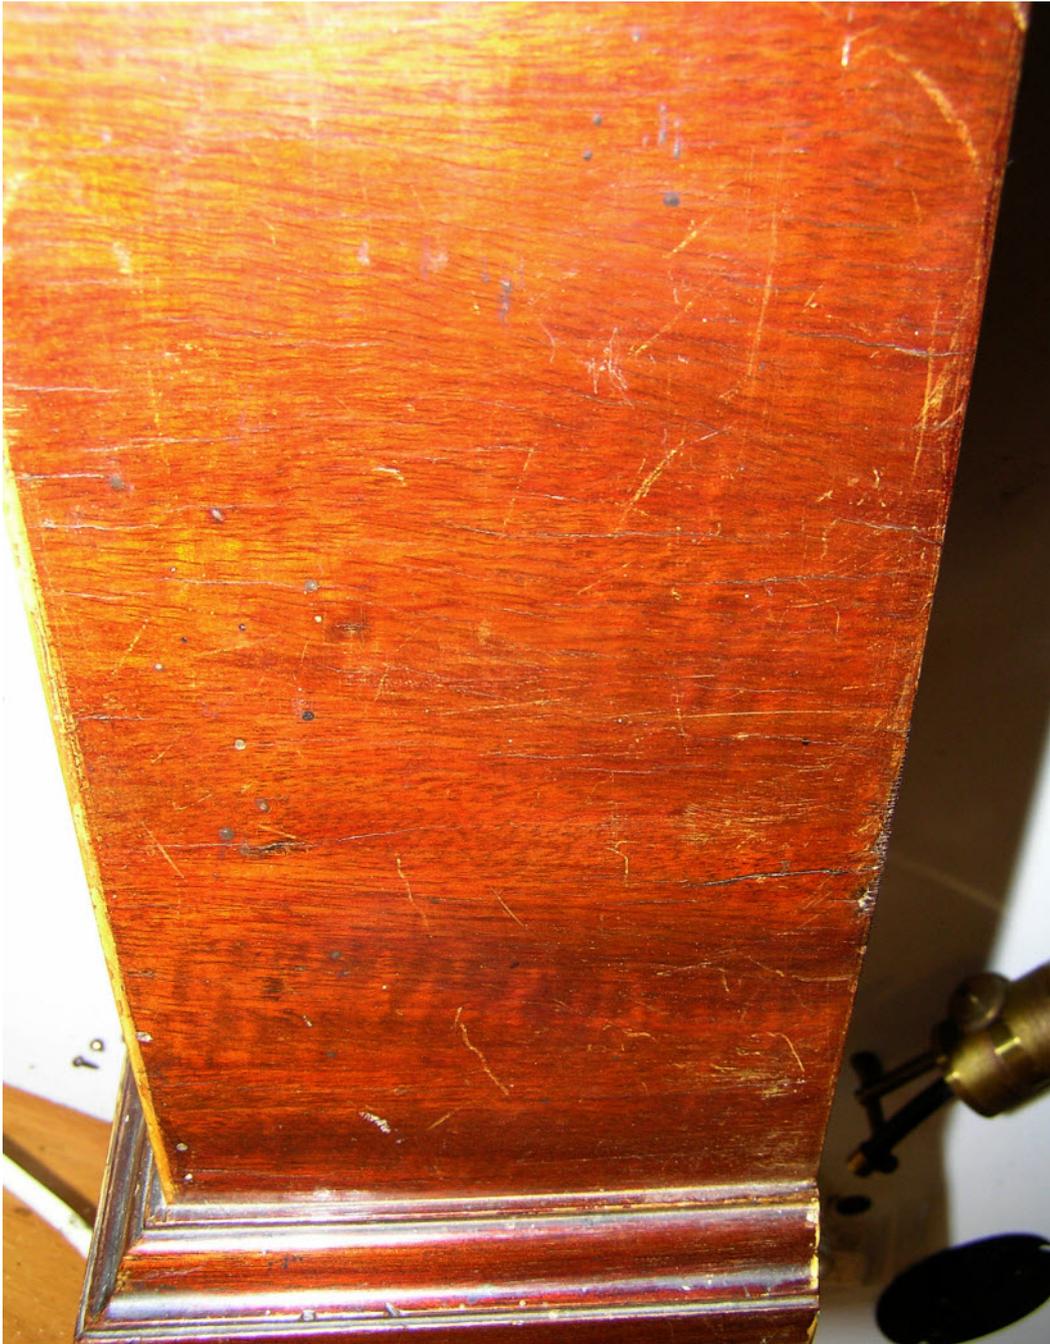
The general condition of the case showing lots of dinks and scratch marks.

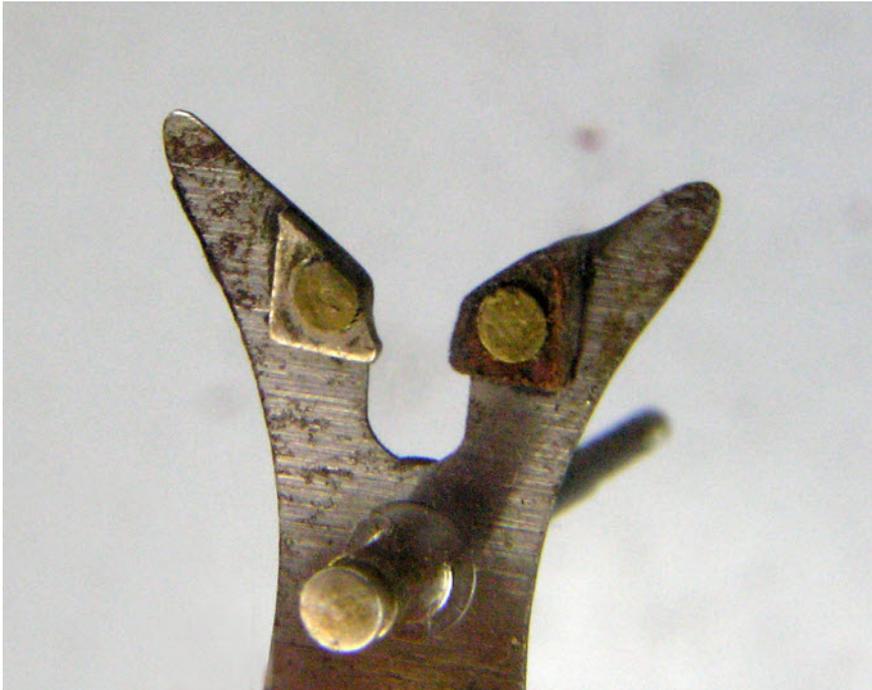
Not only are both the silver and fibre contacts worn and need replacing, but the silver side is so worn that the rivet that holds it in place has also been affected. When I removed the silver I found that the wear was so bad that the hardened steel fork had been worn down to the hole. So I will have to remove and replace the fork as well.

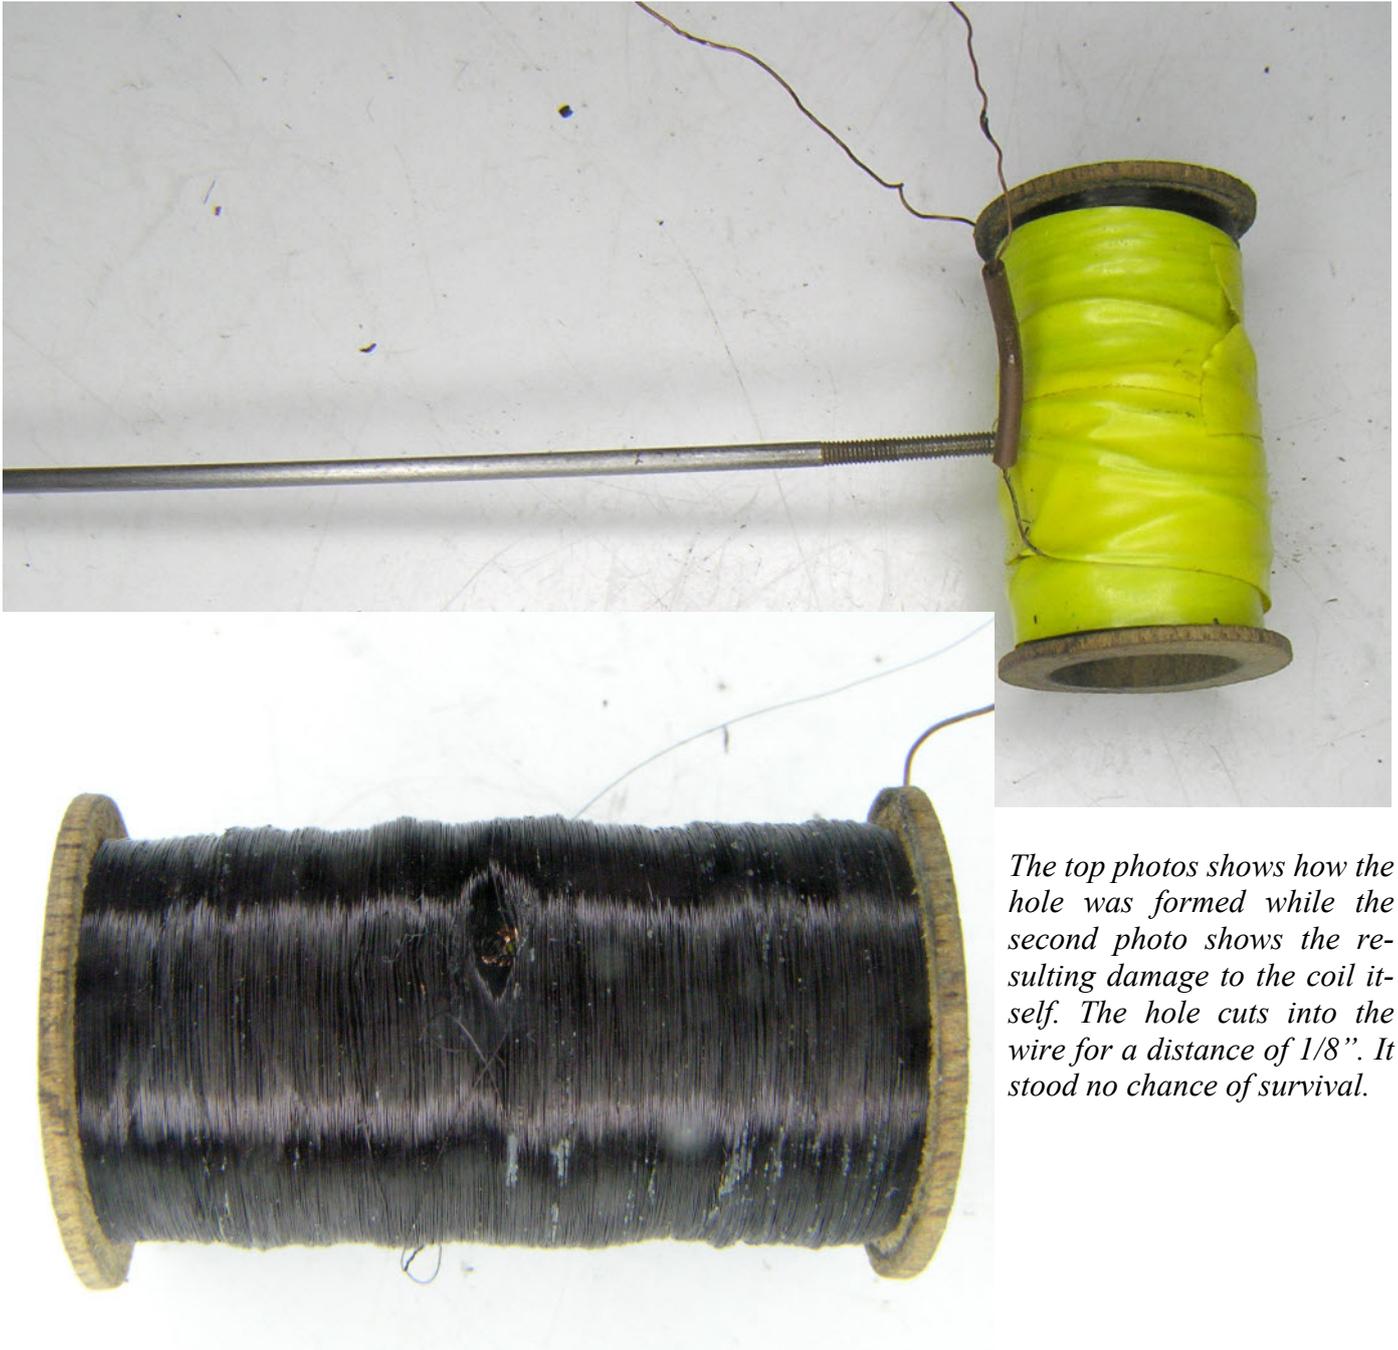
The top photos shows how the hole was formed while the second photo shows the resulting damage to the coil itself. The hole cuts into the wire for a distance of 1/8". It stood no chance of survival.

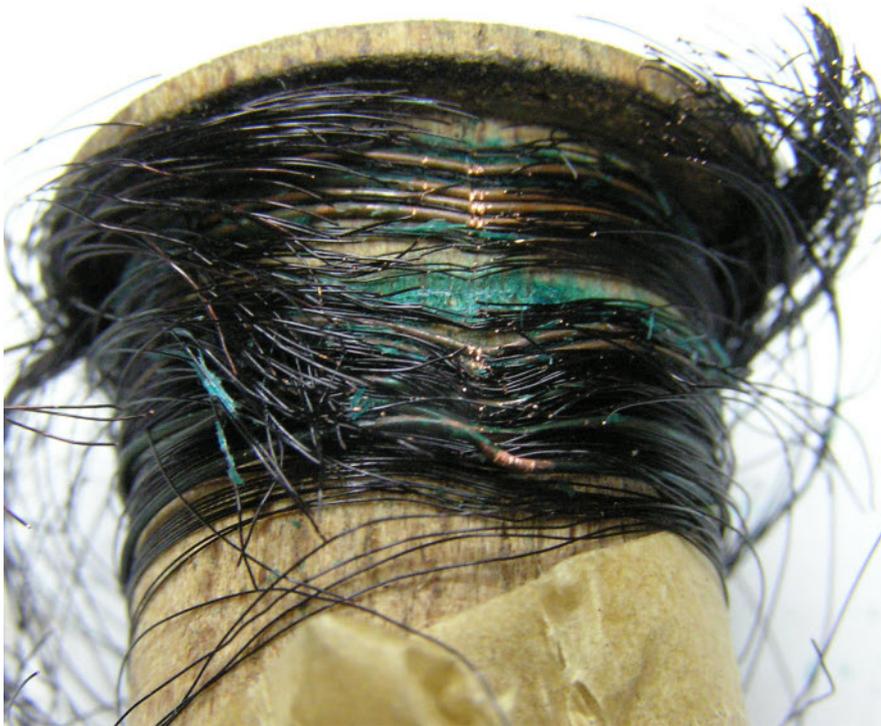
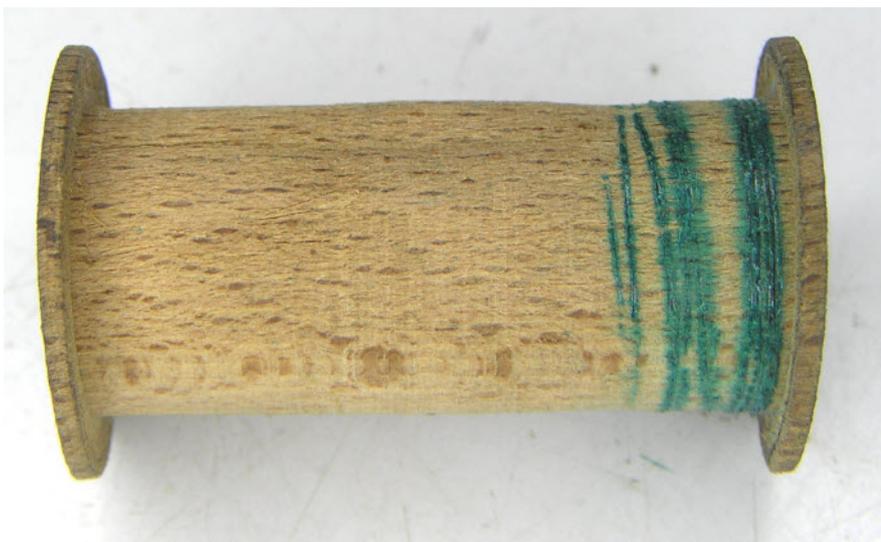
Whilst cutting out the old wire I started to notice the green tint seen in the top photo. This proved to be corrosion of the heavier swg copper lead wire that was soldered to the coil at the start of the coiling process. Wire exits the coil and runs up the pendulum rod. This lead wire of copper was not enamelled as the 42 gauge fine coil wire and consequently has started to corrode. This would have damaged the coil wire at some time probably affecting the soldered joint which was wrapped in paper as can be seen at the bottom of the photo. The bobbin can be seen laid bare below where the green stain is obvious. So the coil would have failed at some point anyway and may have indeed been the reason why it was later taken apart and "Repaired" with the yellow pvc tape. The bobbin itself is in good condition although by necessity they tend to be very thin and quite fragile.

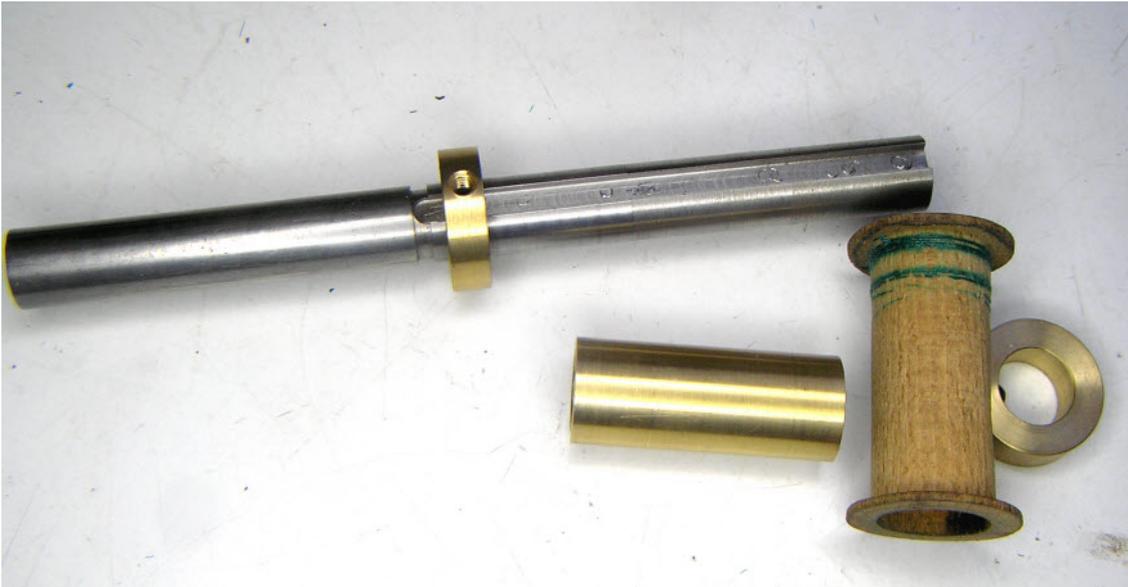
The start of the winding process. I have made an arbour to take the bobbins. The arbour is a one size affair that has been turned to accept a range of brass collets that can be turned up quickly to any size required to fit different bobbin dimensions. The collet can then be allowed to spin freely on the arbour to unwind a coil or pinned tight between the collars so that the bobbin can be rewound in the spindle of the lathe. A pair of these arbours can then be used in the lathe, one to take the bobbin and one to take the new reel of enamelled wire to be unwound.

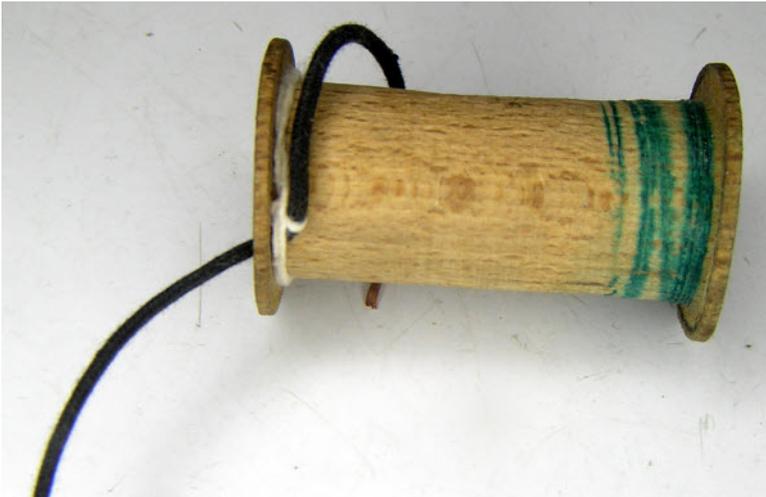
The winding is started by passing the first lead wire through the hold provided in the bobbin and securing tightly with string so that it will not pull through. This would be disastrous once the coil is fully wound as there would be no chance of reconnecting the end which would be under 6500 turns of wire. The second photo shows the 42 gauge wire soldered to the lead. Clean back the covering about an inch back from the joint and check with a meter (arrowed). Thus ensuring that you have made a good soldered for the same reason above. The bobbin on its arbour is then chucked in the lathe. Use a collet chuck so that there is no danger of your hands being caught by the jaws of a three or four jaw chuck. Notice that I have already wound a few turns on the bobbin already so as to capture the the paper I have placed around the soldered joint to insulate it. The feed bobbin is on its own arbour about 10 inches to the rear of the lathe. It must be free to revolve without sticking or jumping.

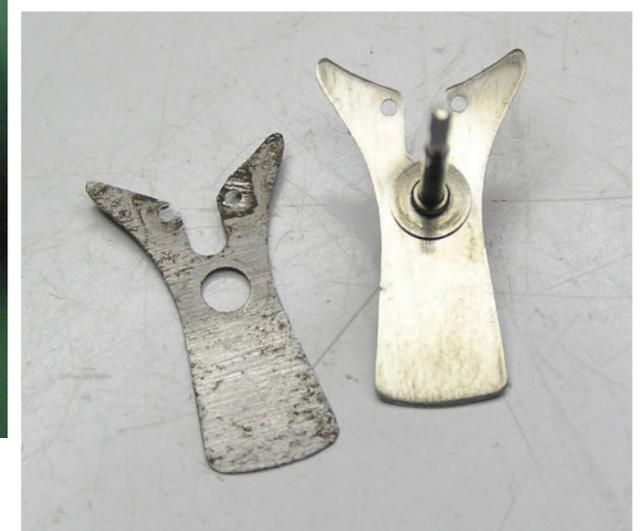
These last two photos show the fork arbour after removing the old and damaged fork. The seating for the new fork has just been turned down to 2.8mm to fit the new Horologix blank.

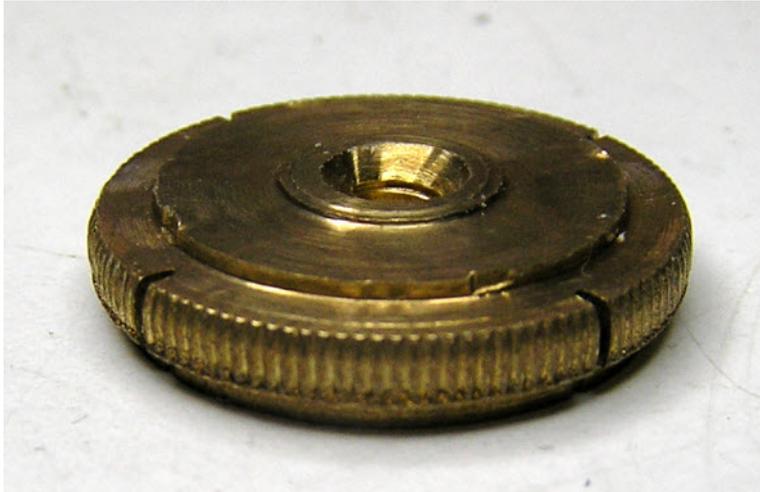
The rating nut from this clock has been turned down at some point. Probably to reduce the weight because a previous owner could not adjust it high enough to increase the rate of the clock. So rather than investigate what the actual problem was they have resorted to lightening the nut. This will have to be replaced as the clock will be in perfect working order when restored and will need the full weight of the nut to properly affect the rate.

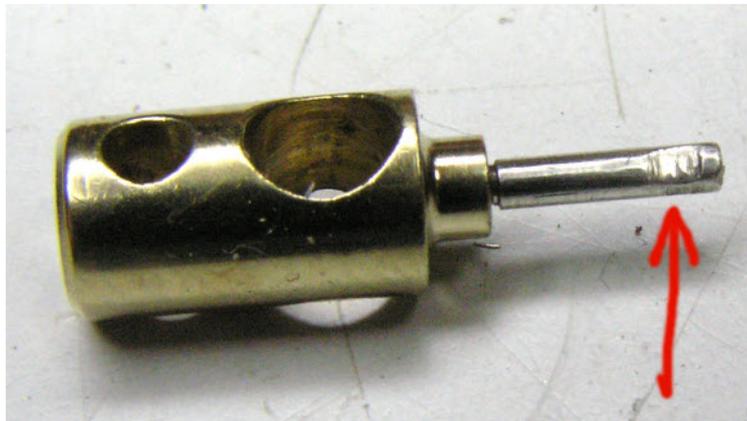
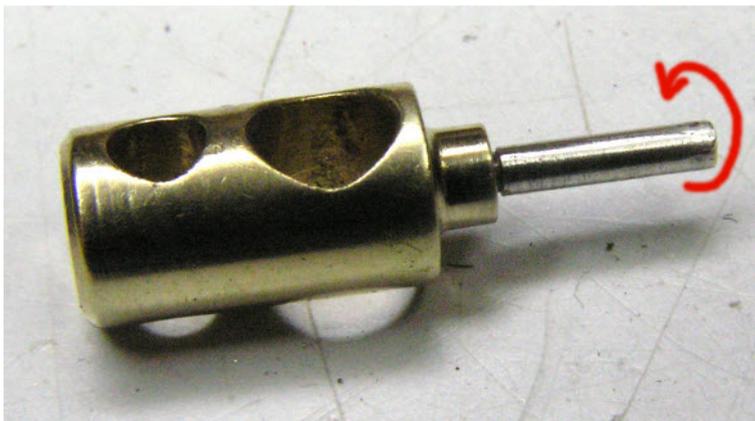
These two photos show the wear in the contact pin. Fortunately the whole contact assembly can be used either way up so it is a simple matter to reverse the fitting and present a new face to the contact fork. The pin should be positioned so that any wear is facing upwards.

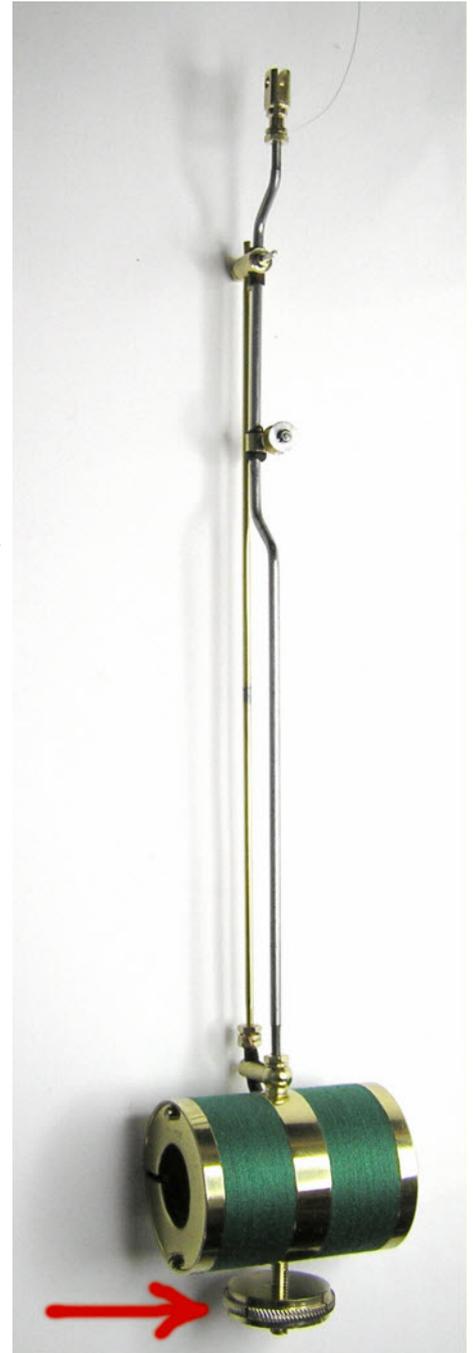
The pendulum rod after reassembly with the new rating nut in place.

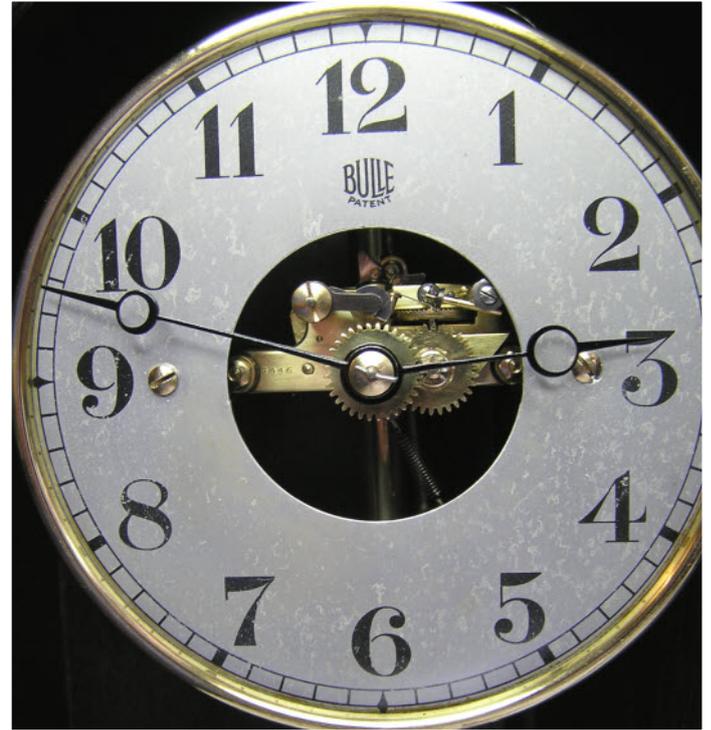
The dial is in relatively good condition and has been washed in warm soapy water to remove a lot of the nicotine stains. There is some mottling on the dial which does not detract from the overall appearance though.

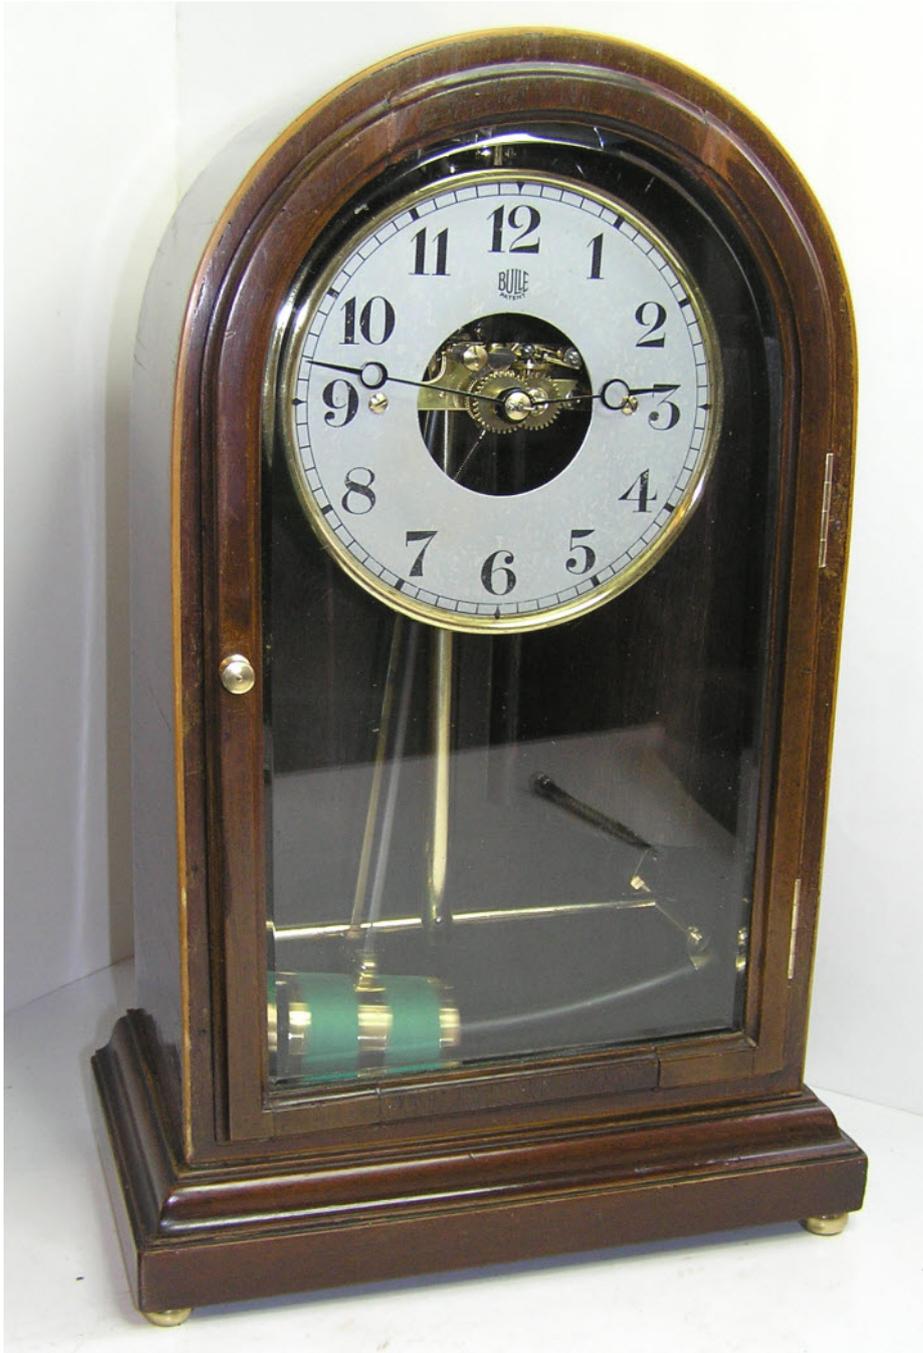
The completed clock.
