## **Bulle Clock No Serial Number Wall Clock**

# *Restoration of a wall mounted Bulle Clock with No Serial Number*

Early Battery Clock Parts & Restoration

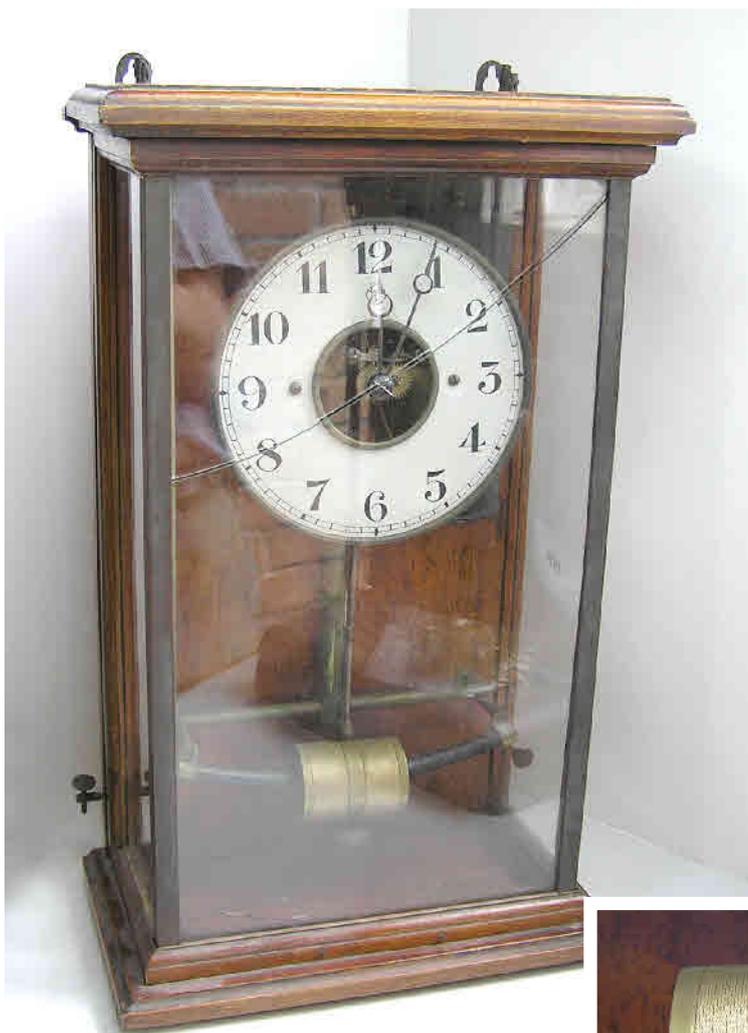
*The clock is a very early example of the Bulle clock. It has no serial number and exhibits some design features seen on only one or two Bulles; all of which have no serial numbers. It can only be assumed that this clock is a "Pre-serial number" model and must therefore date from the earliest time of production. It may even be a "Pre-Production" model that was sold to the market place before the mass "Factory Production" models were introduced. Perhaps it was a Salesman's sample or even a Store Display Model.*

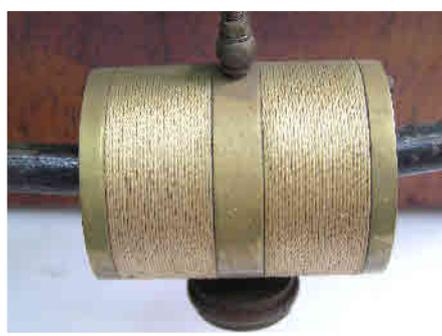
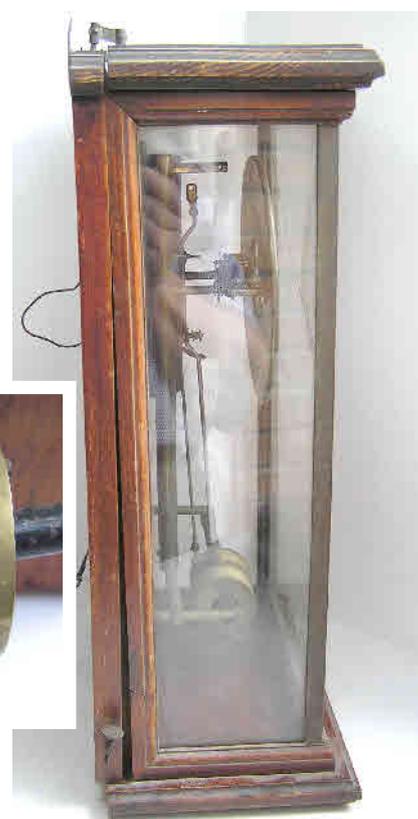
*This clock is so rare that I will try and keep all the original parts unless it is absolutely necessary to repair or replace them. The cord around the pendulum bob being a case in point. It looks in fairly good nick and should stand being wrapped in masking tape as well as a bit of scrubbing..*

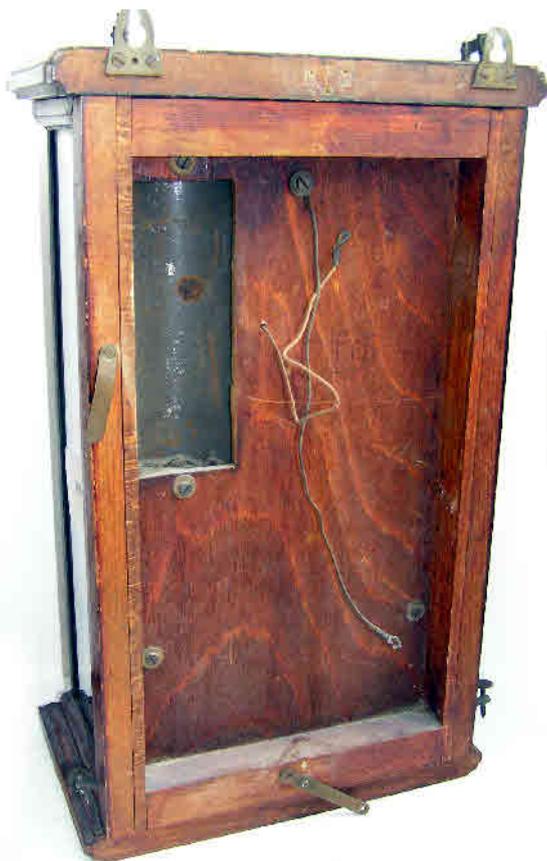
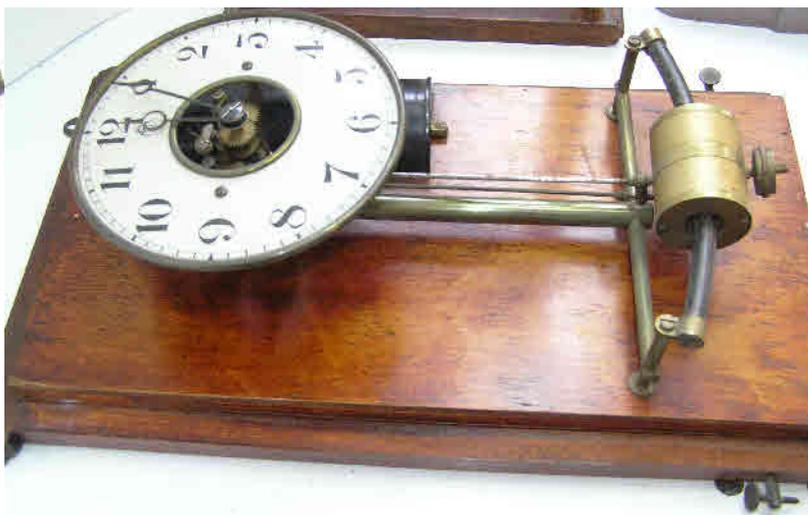
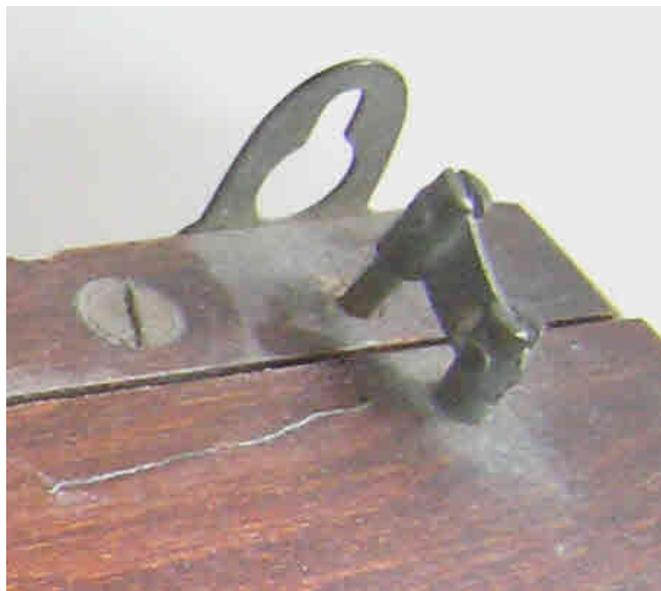
*Views of the case. Note that the clock is fixed on a wall mounted backboard while the majority of the casework and glass is hinged to swing up and front to reveal the movement for adjustment etc. The clock can in fact be table mounted when the lower wall stabiliser folded out of the way. What can't be seen from these photos is the amount of "Buckle" in the backboard. This bows in the middle so that the front cover cannot entirely sit flat against it. Other than that the case is in good condition and other than a polish will be left alone.*

*These small up and over hinges allow the front of the case to lift out and up to reveal the backboard mounted movement. They are a little bent but with care I should be able to clean and straighten them back to their original shape.*

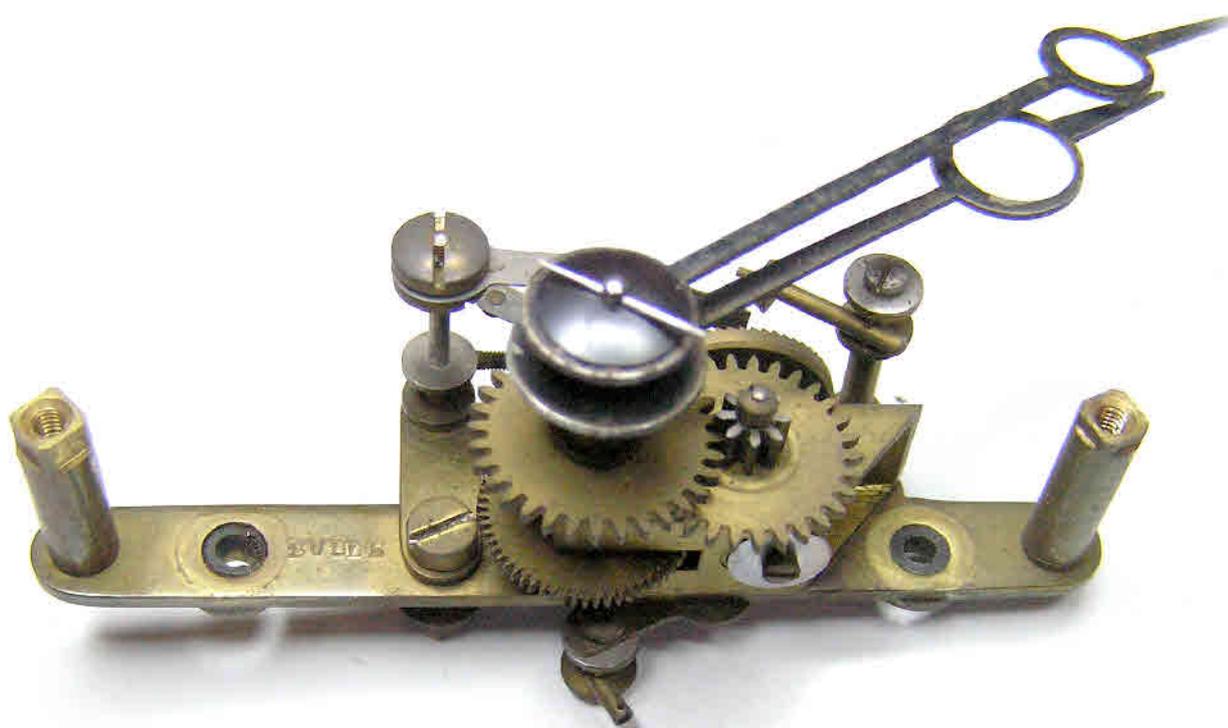
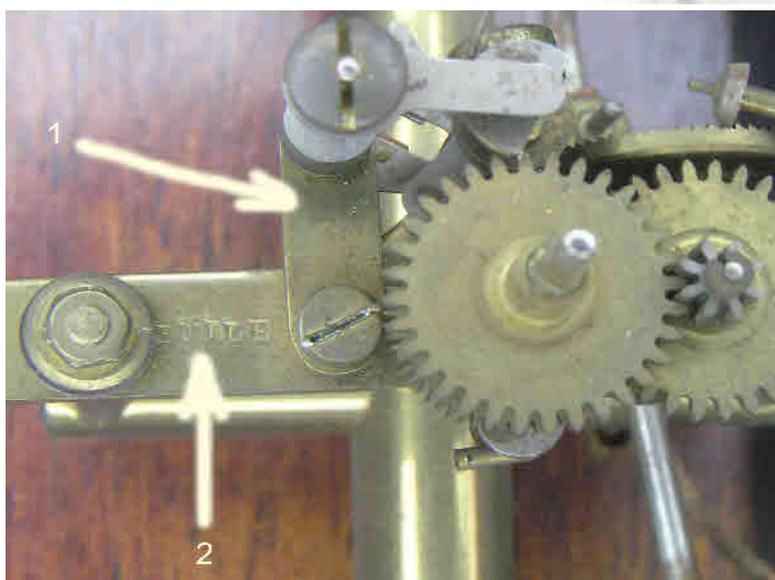
*The photo above shows the full movement which almost deceives the eye into seeing a standard 1925 or 1926 movement. But note the way the damper arm is mounted (1). The arm support is in fact a separate bracket screwed to the main plate. In the standard movement the main plate is extended to accommodate the arm. Note also the fact that this clock has no serial number and only the Bulle name is stamped onto the main plate (2).*

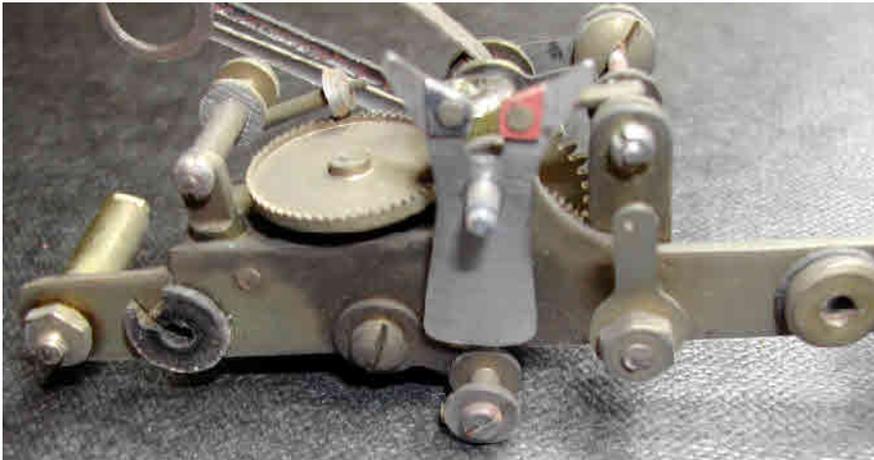
The reverse of the movement. From this view it is easy to see the size and shape of the main movement plate. Note the damper bracket as mentioned previously.

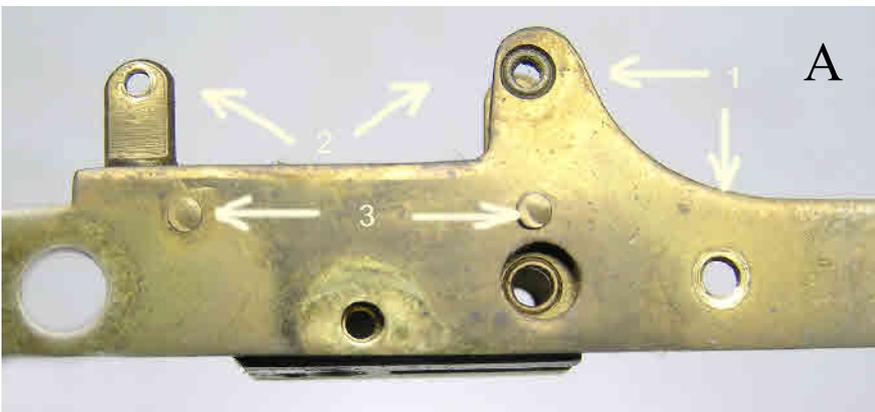
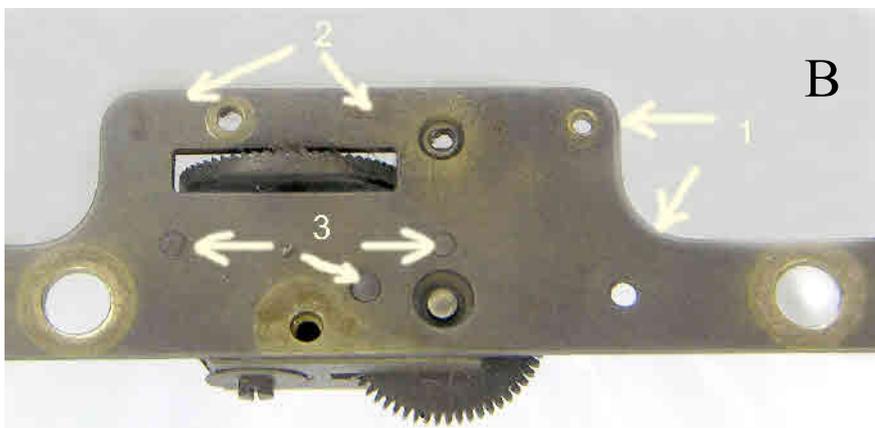
The second two photos show the marked differences between this pre serial number clock (A) and the slightly later production model (B) which was produced in the first year of production in about 1921. It is completely different. Most of the design changes have come about because of the extra parts needed to be accommodated.

On the clock "A" the plate (1) is only extended upwards to support the fork arbour and there is nowhere to support the bracket. Also the count wheel is completely in the open and has no stop to restrict it's end play up or down (2).

The plate on the later model (B) extends completely over this area with a slot to accommodate the wheel. It would also carry a "Stop" for end play.

One last thing to point out here is that the square count wheel assembly is riveted on instead of location pins and screws (3) as in the later clock (B).

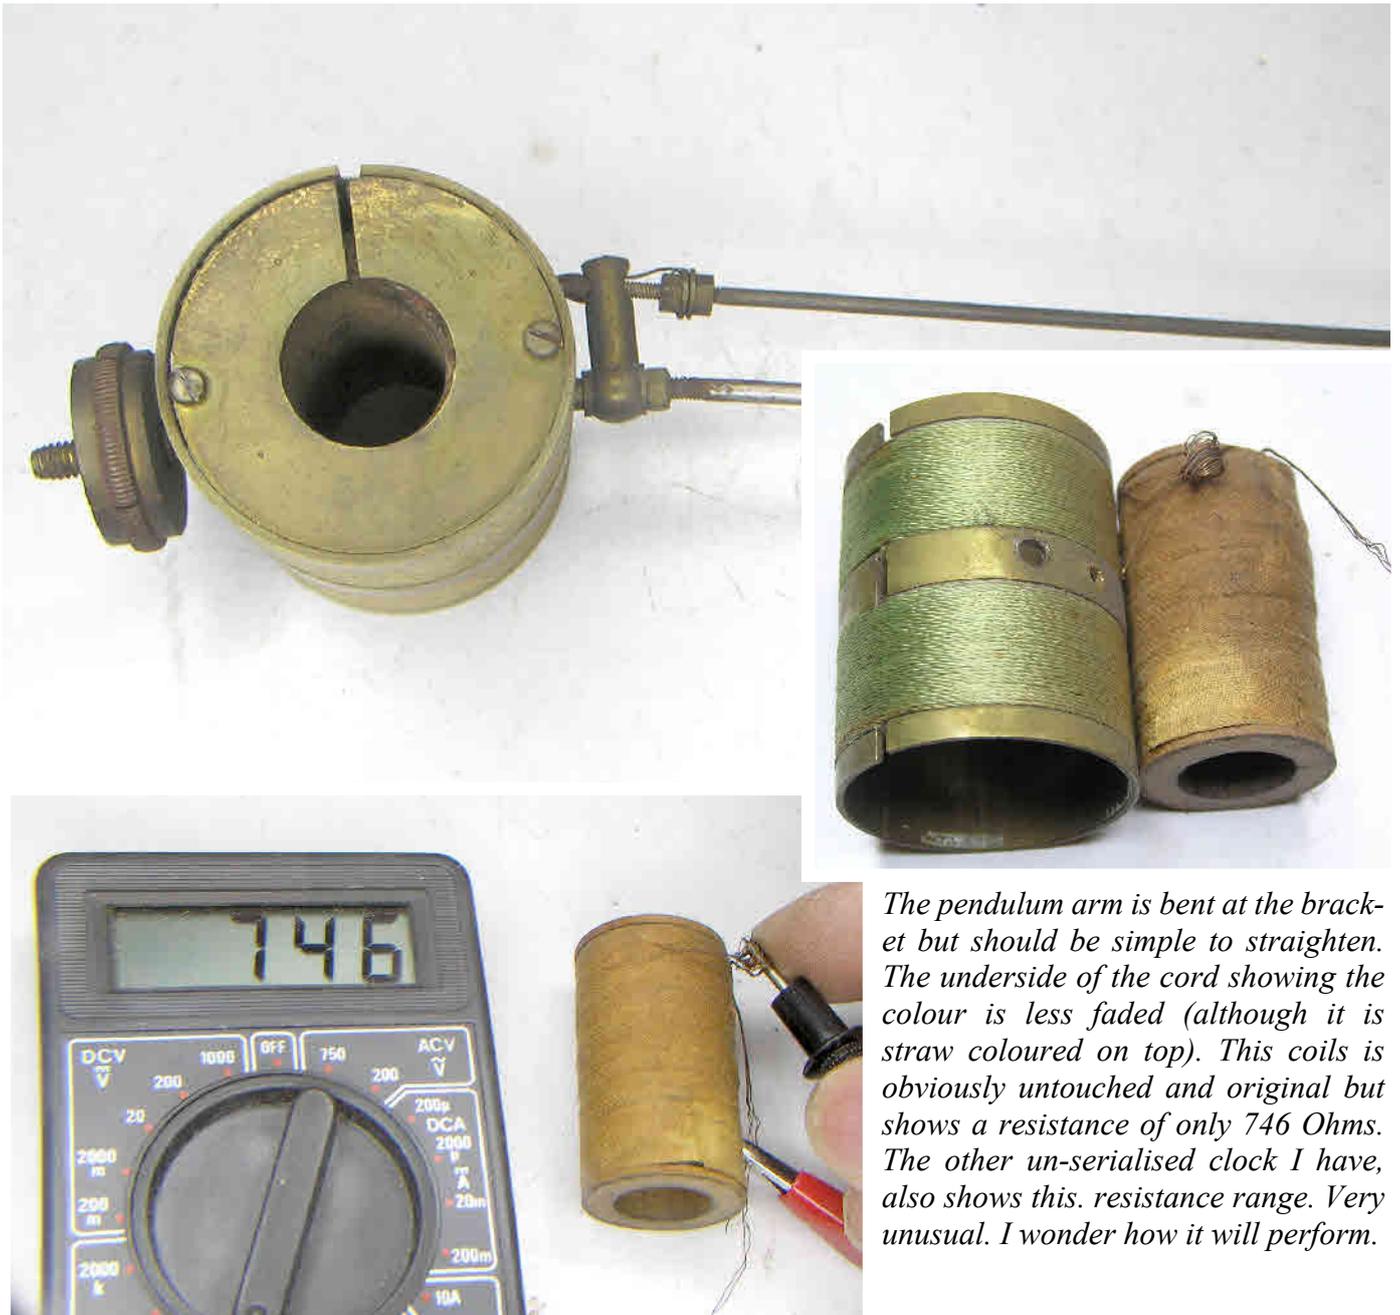
*The pendulum arm is bent at the bracket but should be simple to straighten. The underside of the cord showing the colour is less faded (although it is straw coloured on top). This coils is obviously untouched and original but shows a resistance of only 746 Ohms. The other un-serialised clock I have, also shows this. resistance range. Very unusual. I wonder how it will perform.*

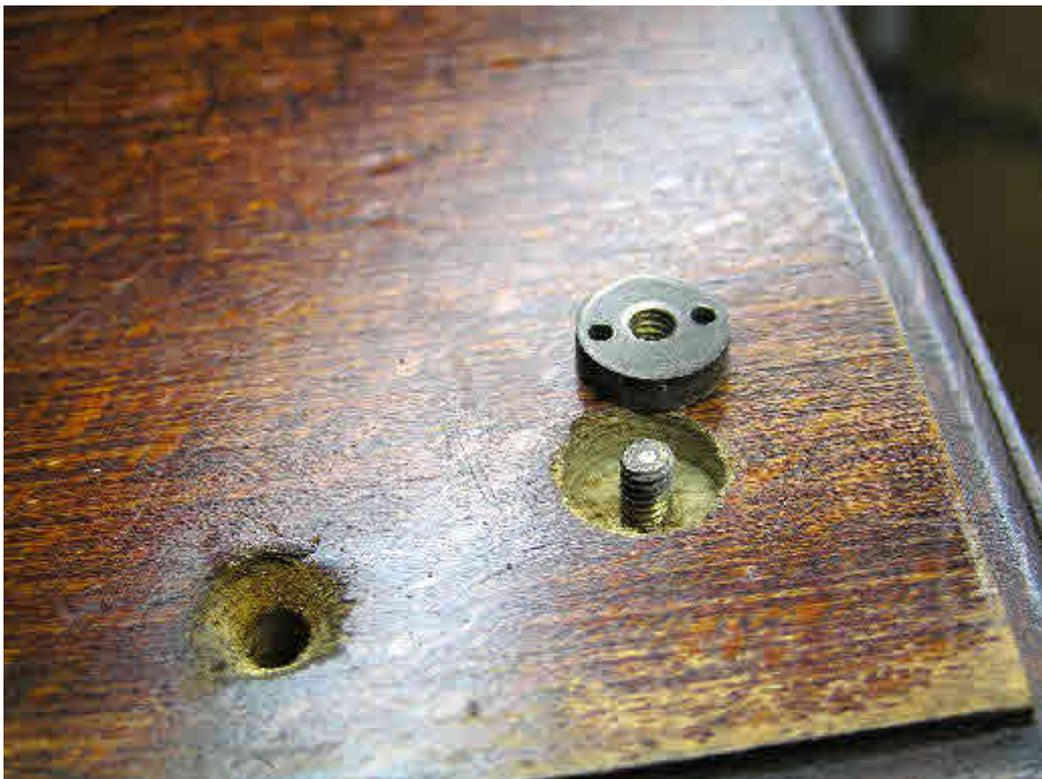
*The front of the case is held together by brass tie rods that are pushed all the way through the case to protrude in counter bored holes. These threaded ends are then captured by threaded washers with two 1.5mm driving holes. The glass is held in place by slotted wood beads with brass angle to cover the plate ends.*

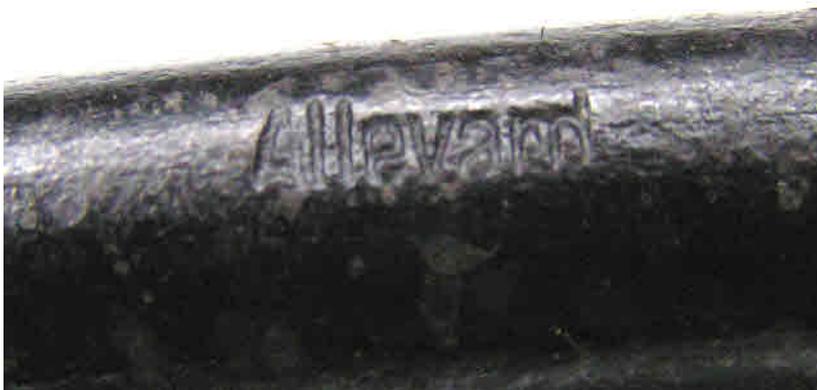
*This original bar magnet is in good condition and gives a reading of 160mm on my home made magnetometer. This is just a little lower than I would normally accept so I re-magnetised it to read 190mm. It is stamped with what could be the manufacturer's name - "Allevam", "Allevard" or even "Allevam". But the most probable explanation is that it is the name of the town where iron and steel were produced at the end of the 19th and beginning of the 20th century - Allevard in South East France*

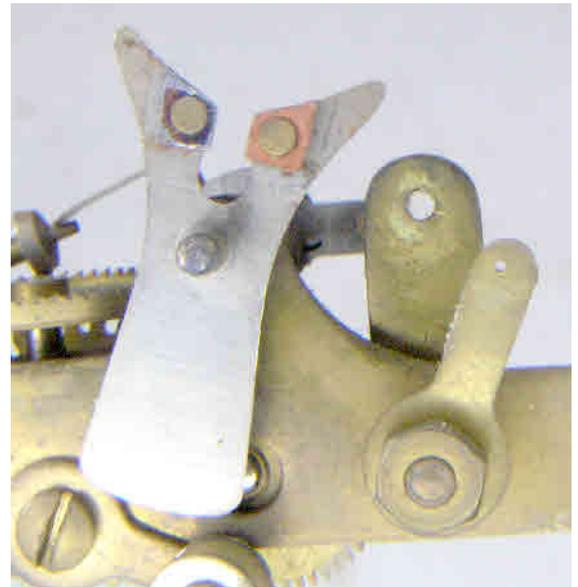
*This photo shows the square tube used in the early clocks to hold the wheel work. On later clocks this became two or even three plates held together with pillars and screws. You can also just see the head of one of the rivets that hold it to the main plate.*

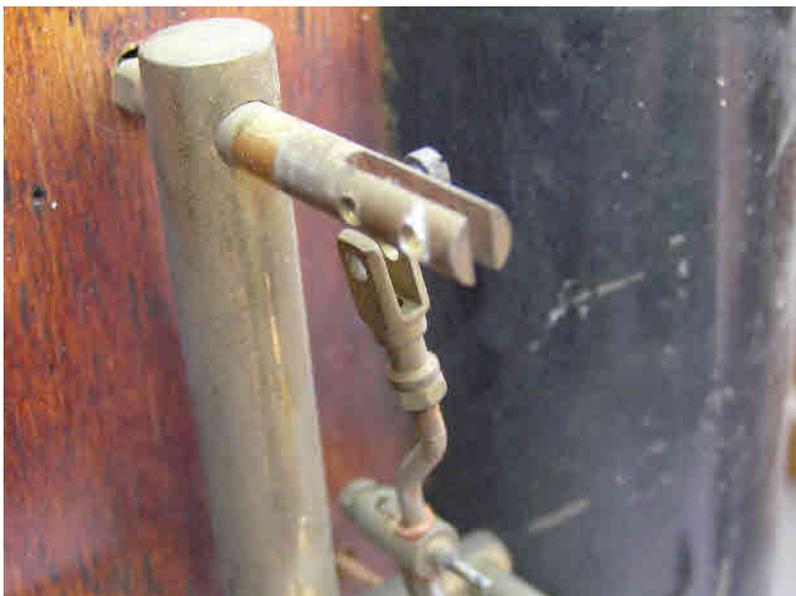
*The contacts were worn right down to the steel and need replacing.*

*The suspension itself is missing as well as the all the nuts and screws of the assembly. These will need to be manufactured.*

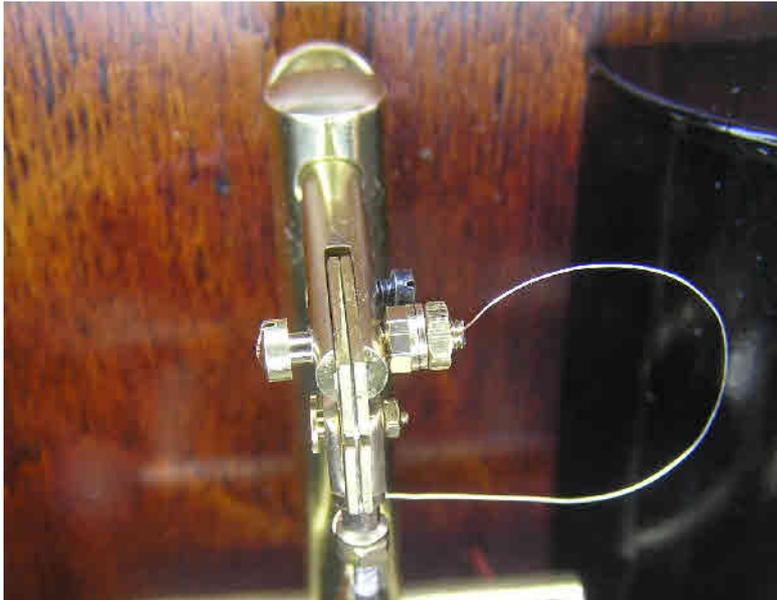
*The suspension assembly with it's new nuts and bolts. These earlier pendulums did not have the small screw and washers with which the contact wire was secured to the top of the pendulum. Instead the wire was captured by the nut that locked the lower suspension bracket to the top of the steel pendulum rod.  
The only thing missing is the second blued steel screw on the left hand side of the frame.*

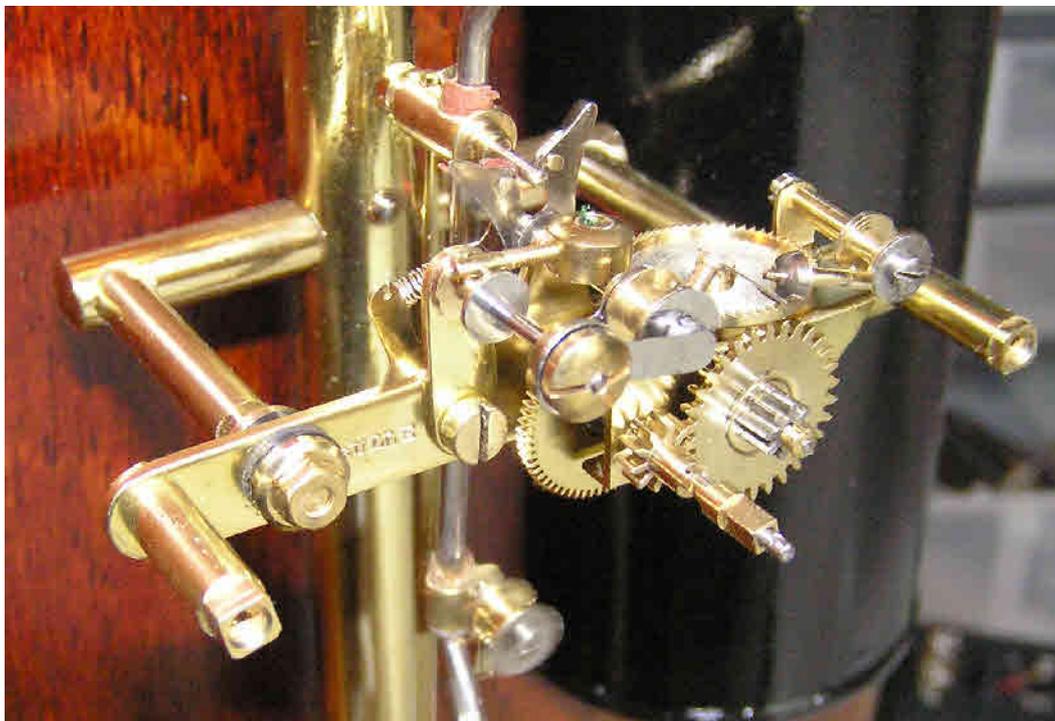
The movement reassembled with the new fork contacts and silver contact

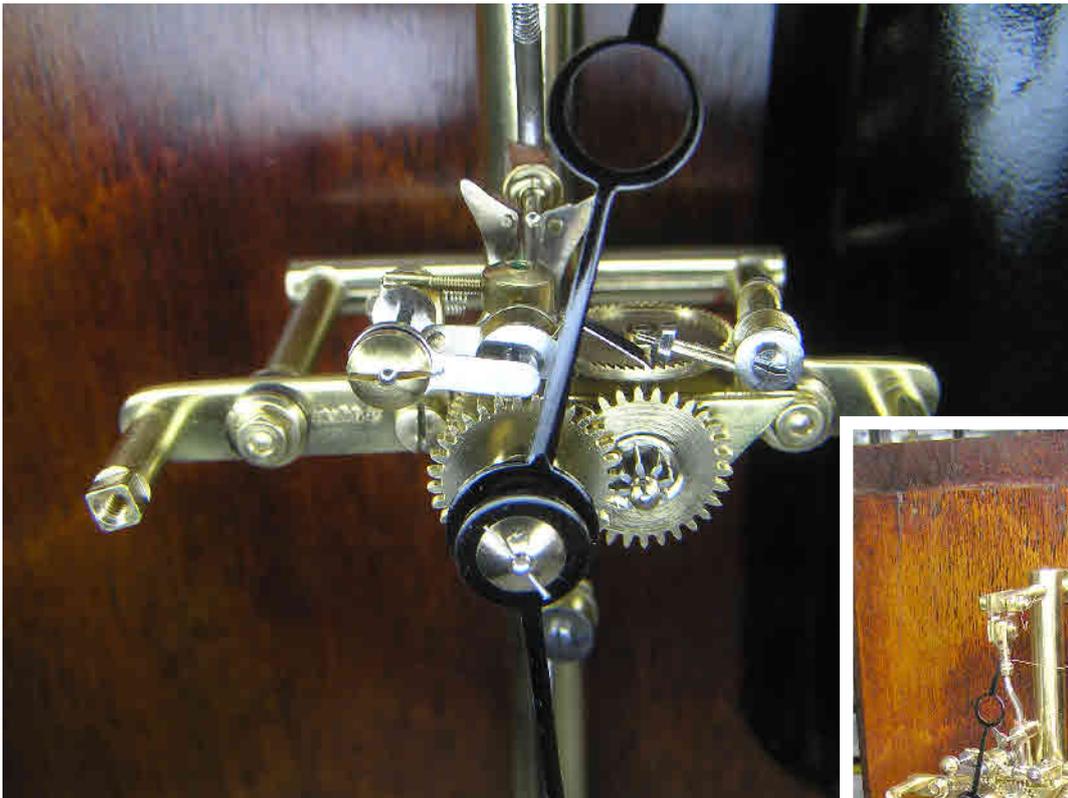
*Another view of the movement. Note the depthing of the contact pin in the fork. The hands have also been cleaned and painted. The earlier clocks tended to have painted hands rather than blued.*

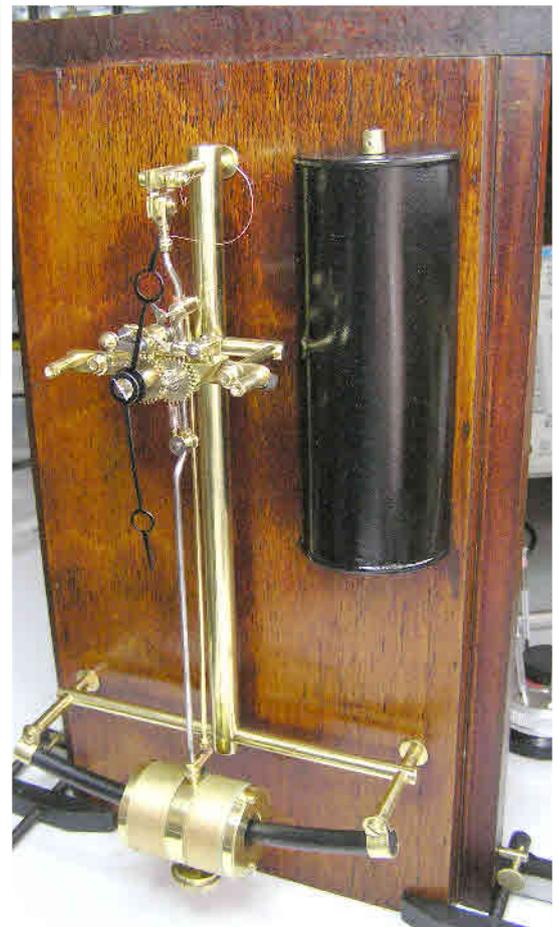
*The pendulum, movement and frame re-assembled to the back-board. The battery box is also back in position after cleaning and spraying. It had a few areas that needed special attention due to battery acid burns. But these had not burned all the way through and were easily treated with a standard motor vehicle rust cure before undercoating. The magnet has also been treated with Grate Black.*

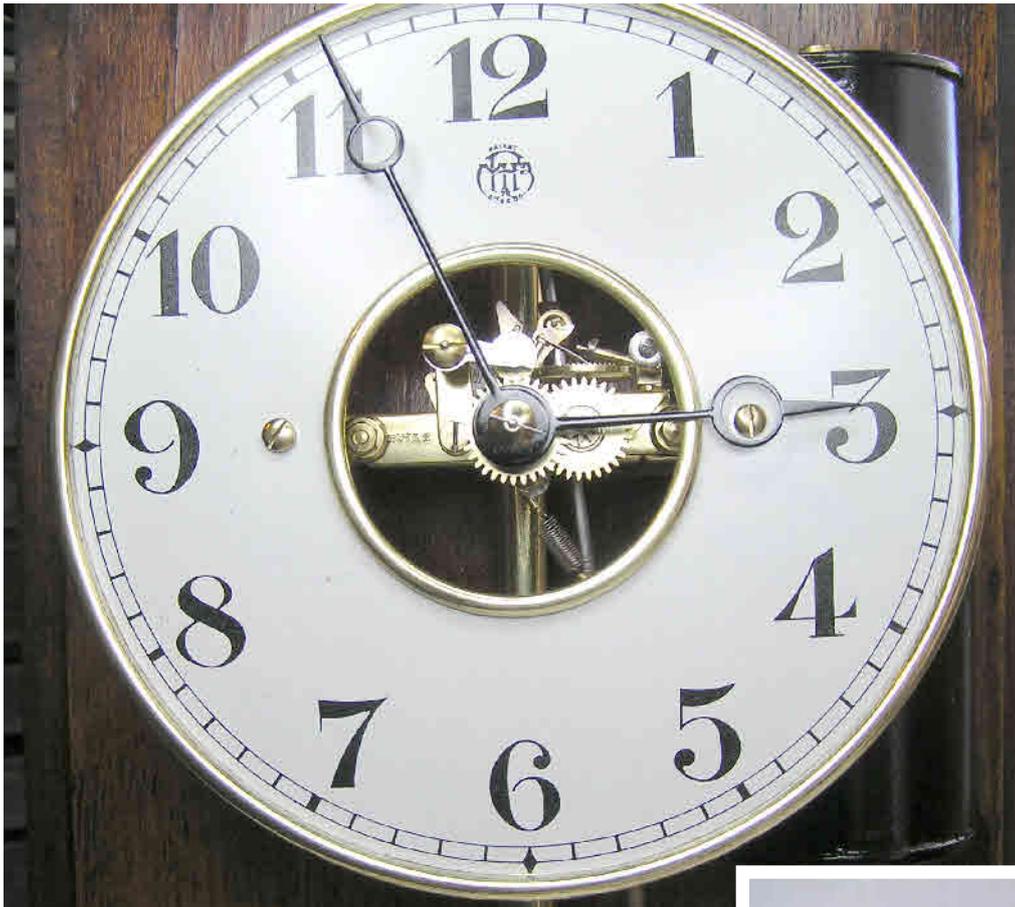
The dial was in a very good condition with just the brass surround needing a good clean. It do not lacquer the brass as it will be difficult to remove for cleaning in the future. Without damaging the dial painting. I prefer to give it a coat of bees wax. The one thing you cannot adjust on this early clock is the slack in the hands. This is normally governed by the stop work which restricts the end movement on the count-wheel. As we saw earlier, this pre serial number clock dos not have these parts.

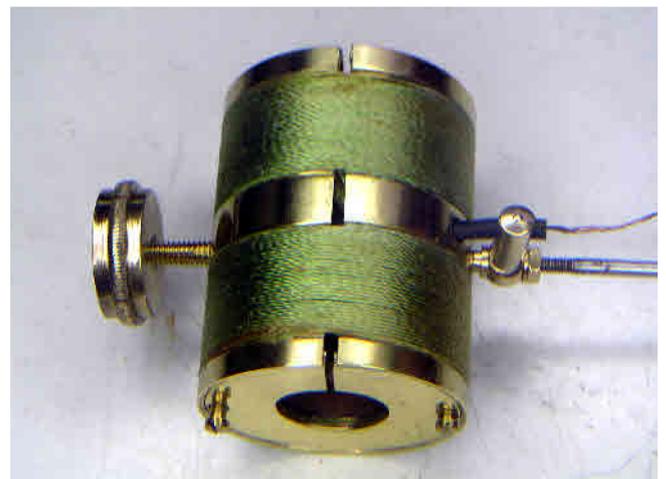
The pendulum bob was cleaned with the cord in situ. This photo shows the cord at the rear of the bob where much of the colour has been retained. The coil has just been replaced and the cover is being screwed on. The wire is ready for trimming and fitting.

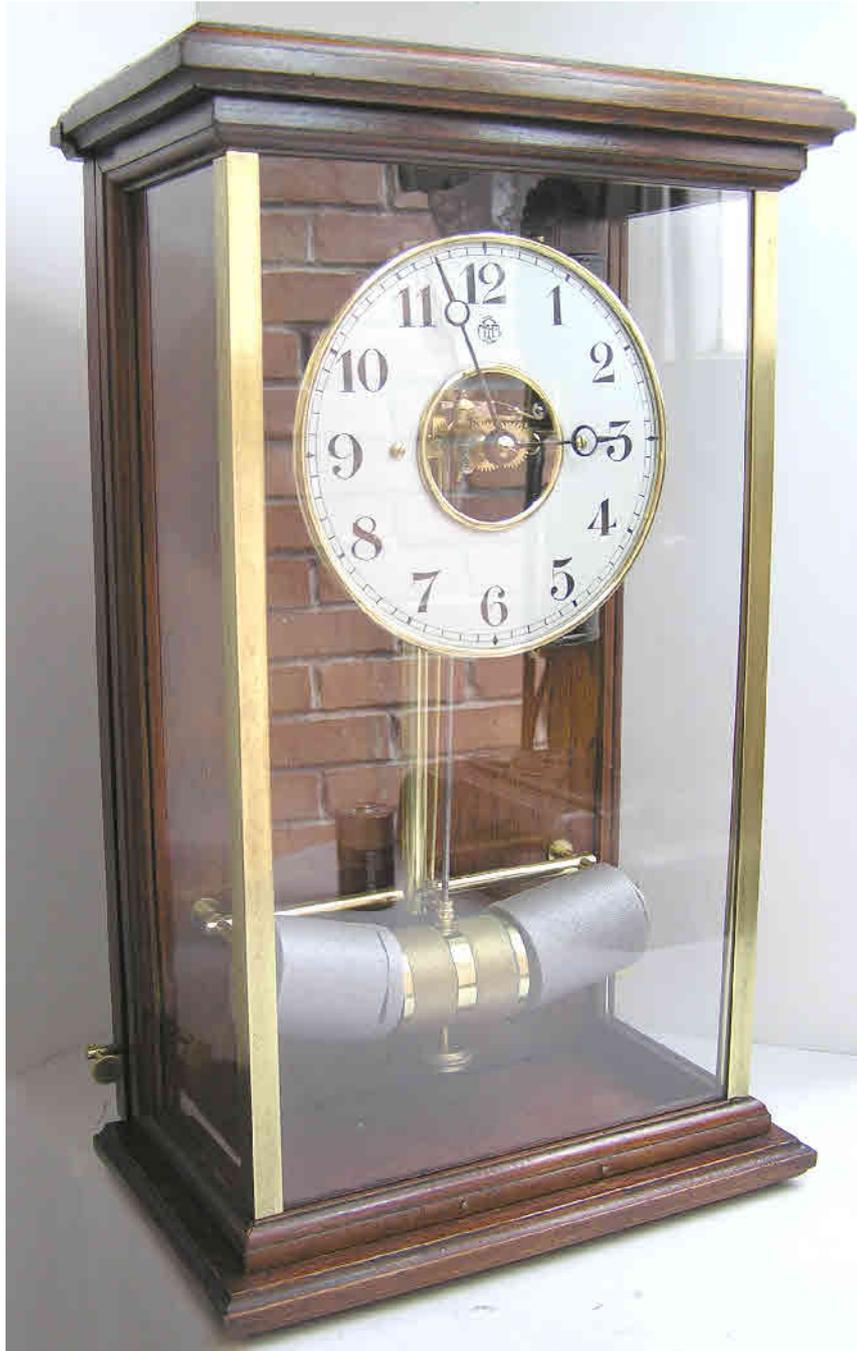
*The finished clock.*

*I have used this photo to illustrate the use that foam pip lagging can be put to in transport. It has been used around the magnet to stop the bob from sliding back and forth. A small piece of foam has also been inserted inside the bob between the magnet and bob shell to prevent forward and backward movement.*
