Bulle Clock Serial Number 12019

*Restoration of Bulle Clock
Serial Number 12019*

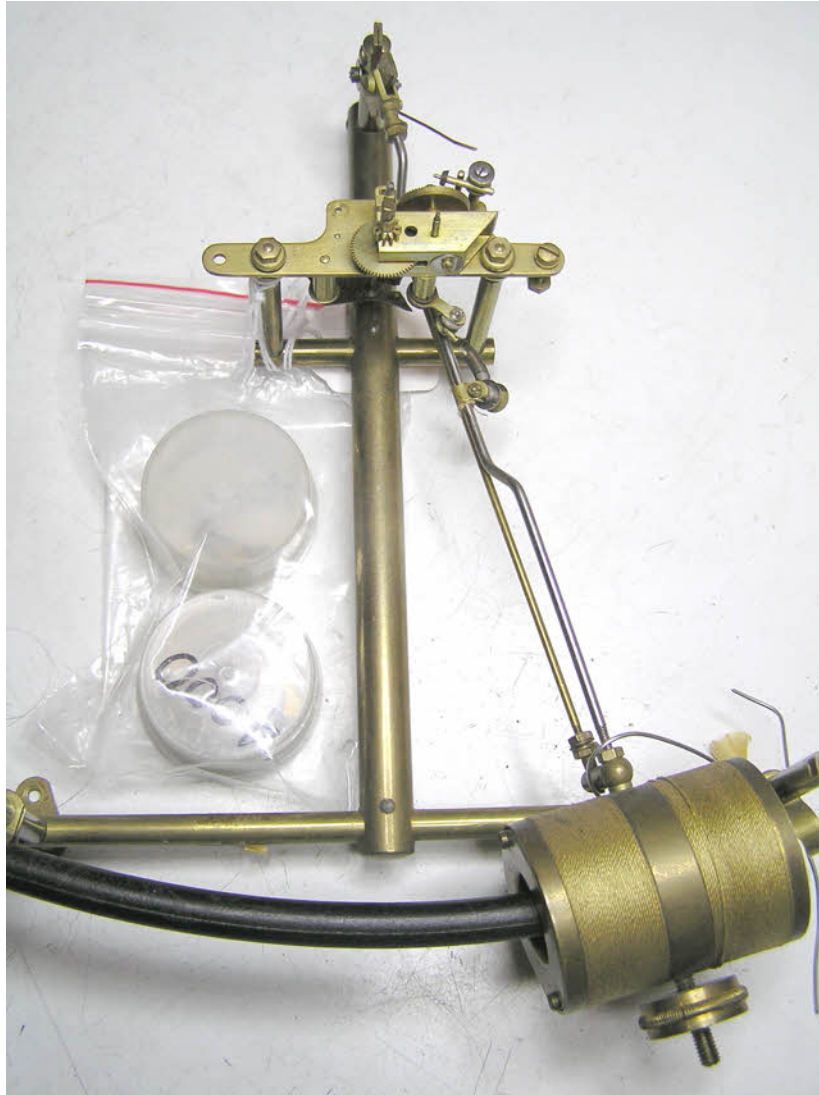
The clock as delivered.

This clock is an early model and exhibits all the characteristics of a full fplate box movement. The dial, hands and case were not delivered with the clock. Unfortunately the movement has been partially disassembled and there are two small plastic containers with some of the components inside. I hope all the missing parts are there.

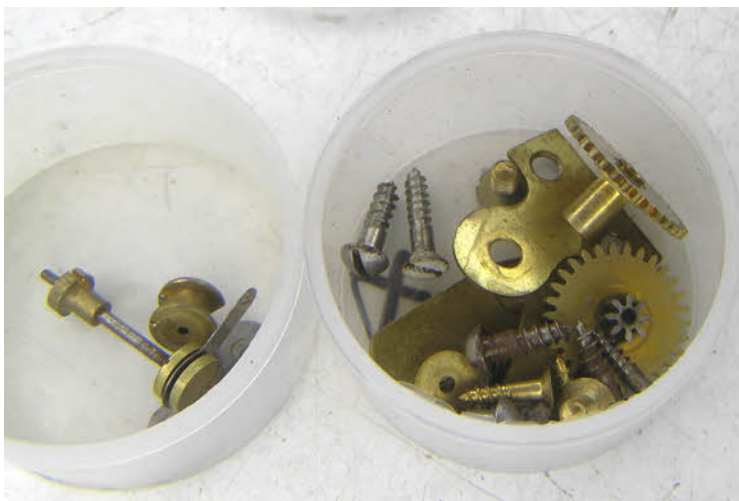
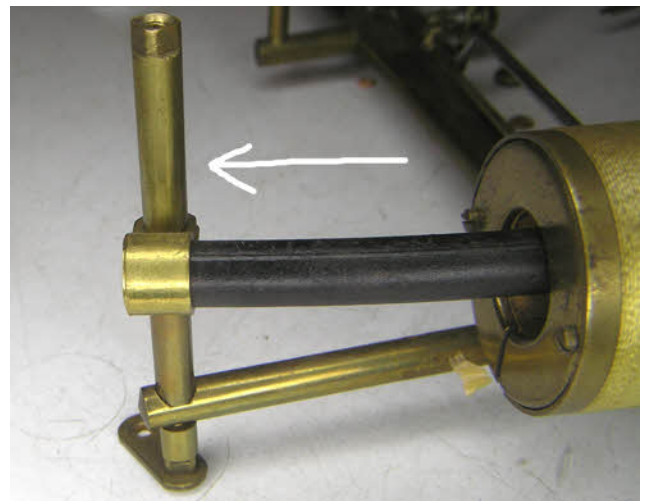
One strange thing to note is the way the magnet is secured to the frame. Note that instead of the familiar pan head screws, this clock has extra pillars. I cannot fathom out where these come from or in which clock they would fit with the movement configured this way. They will be removed and replaced with the normal screws.

Pendulum and magnet back in place with screws replacing the extra pillars..

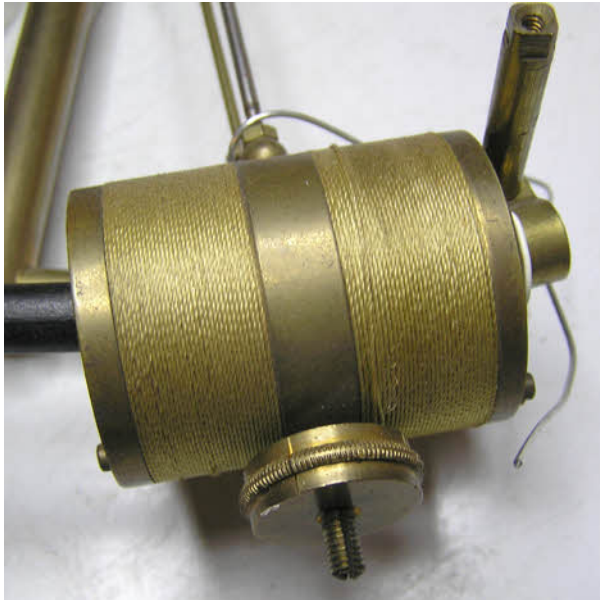
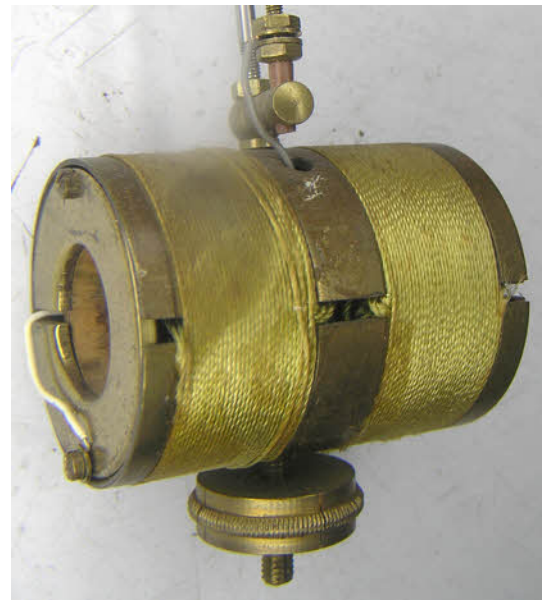
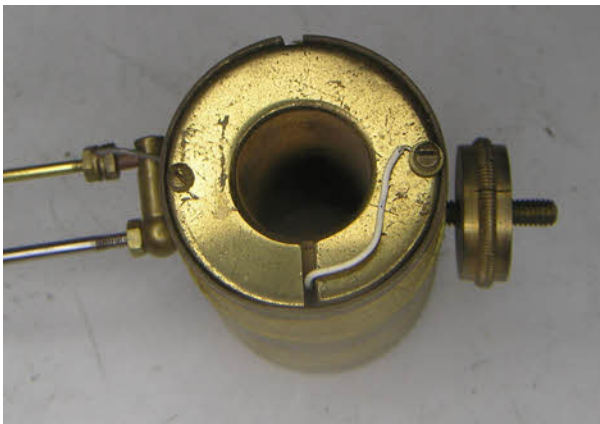
Front and rear of pendulum casing showing the disintegrating cord. The large stain on the back seems to be super glue or similar. It is rock hard and crumbly. Note the wire coming from the coil to the casing?

The photo at lower left shows that the pendulum rod and rating screw are somewhat out of line. It's probably just that the pendulum rod is loose.

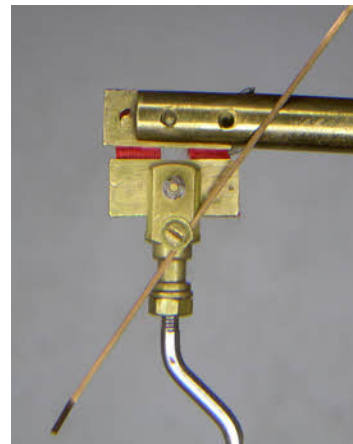
In this photo we see the pendulum suspension which looks to be complete except the two blued steel steadying screws.

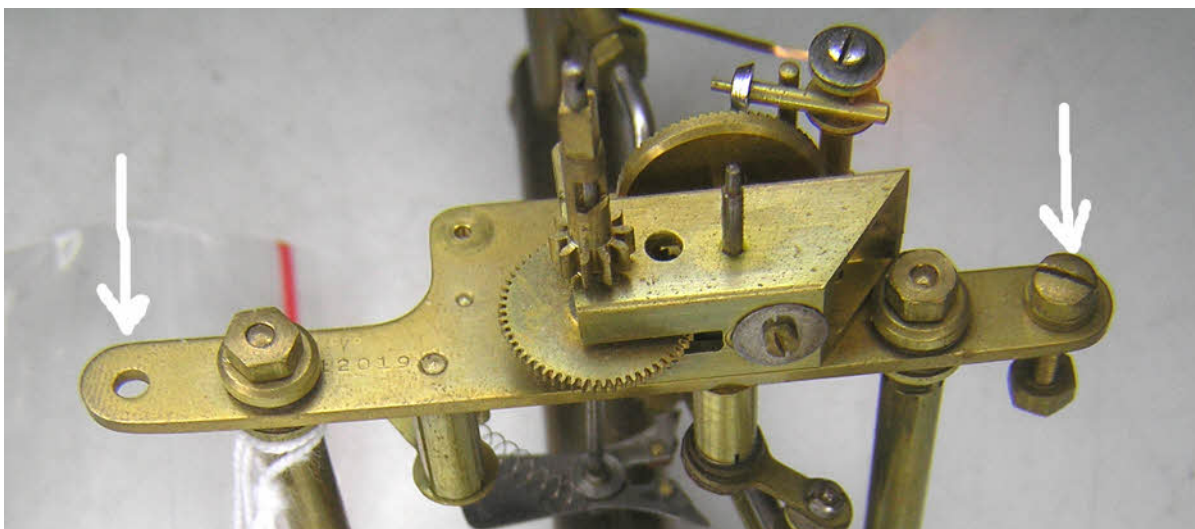
This photo shows that the dial support pillars are missing. These will be replaced.

The movement back in place with the replacement dial support pillars.

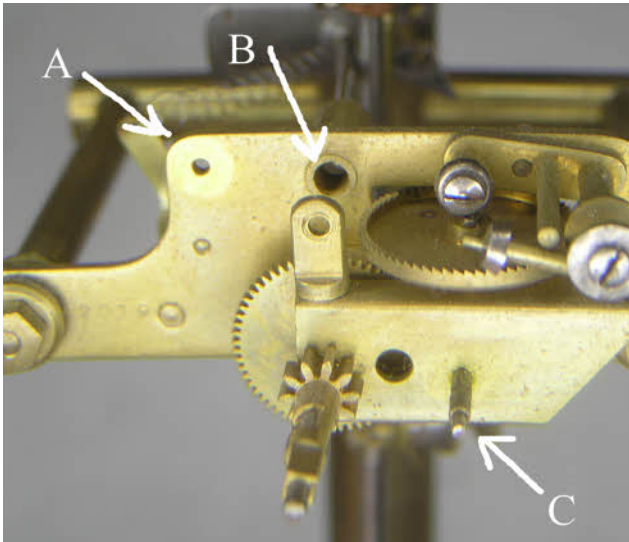
This photo shows the missing arbour (A that carries the steel stop piece for the fork arbour(B).. Both of the items were in the plastic containers. The motion work retaining piece (C) was not found though and a new one will be made.

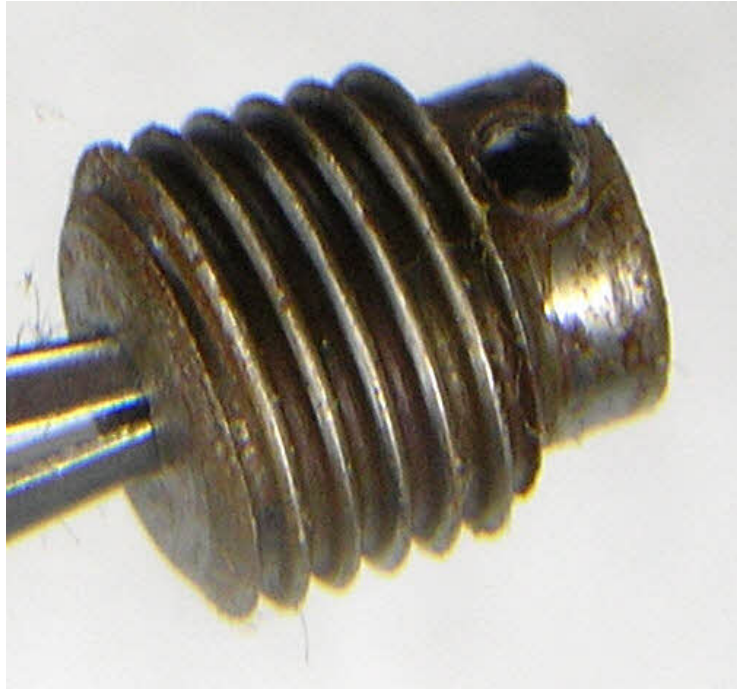
This photo above shows the rusted worm. This will clean up well with the application of a fine rotary wire brush.

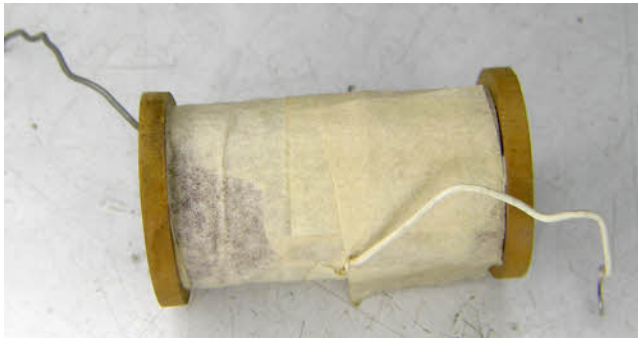
The coil (left) after removal from the pendulum casing. This doesn't look good as the masking tape is modern and if left for too long will prove difficult to remove without damaging the coil wire..

The coil was checked after removing the masking tape and found to be giving a good 1200 Ohm resistance. So all I needed to do was attached new lead out wires and wrap in brown paper before installing back into the newly cord bound Cover.

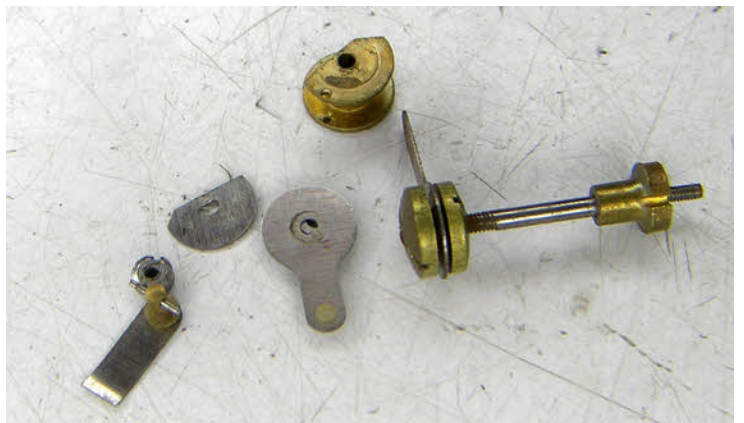
At right is a photo of the stop piece arbour and parts for the fork arbour which were found in one of the plastic containers.. There is a nut missing, a replacement for which is shown below.

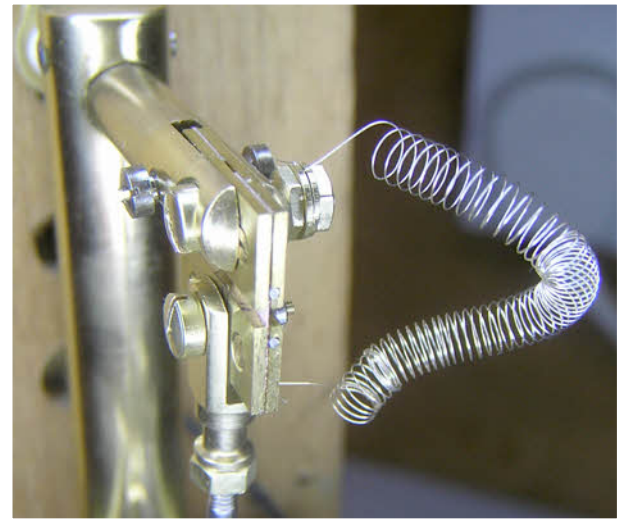
Below is the new suspension and spring contact wire.

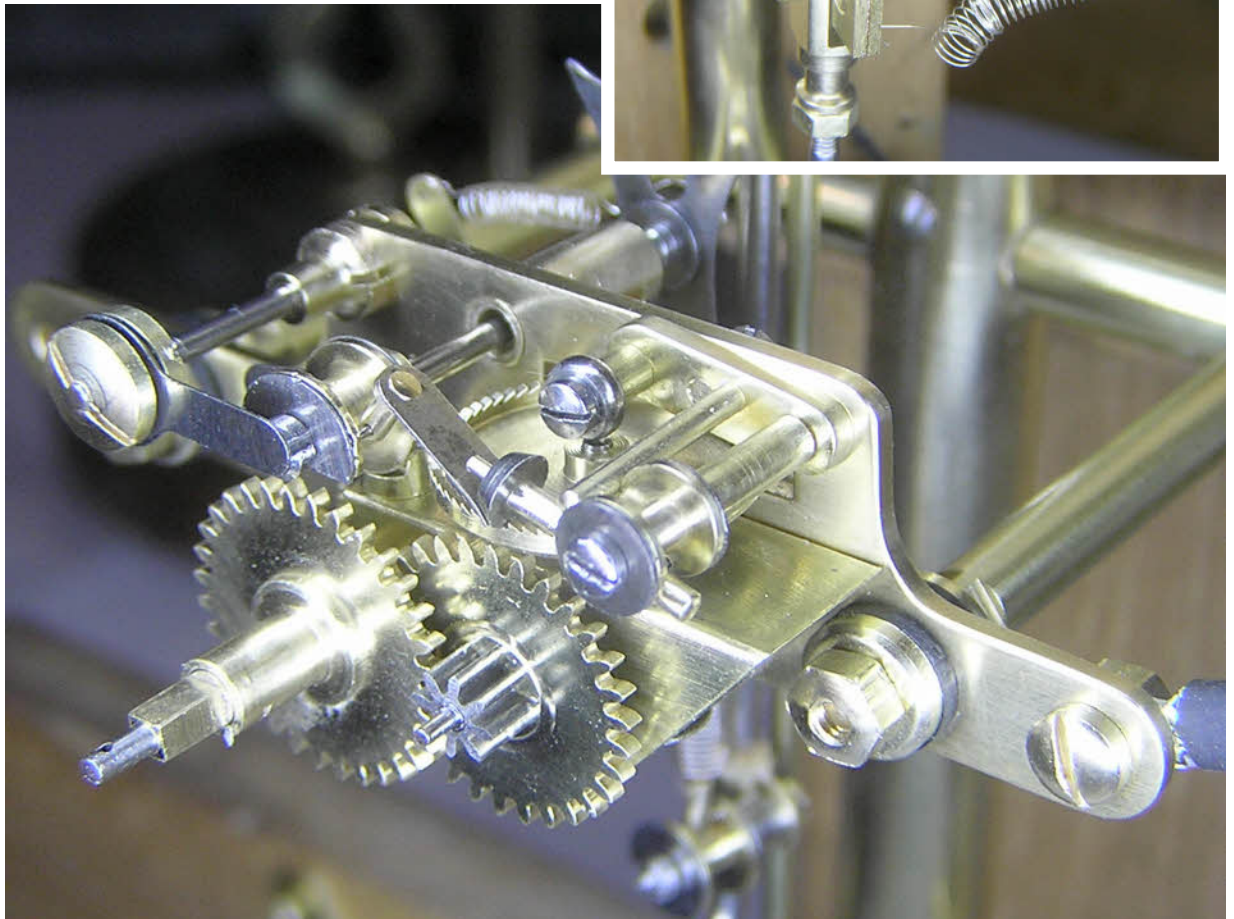
The movement after repairs and cleaning.

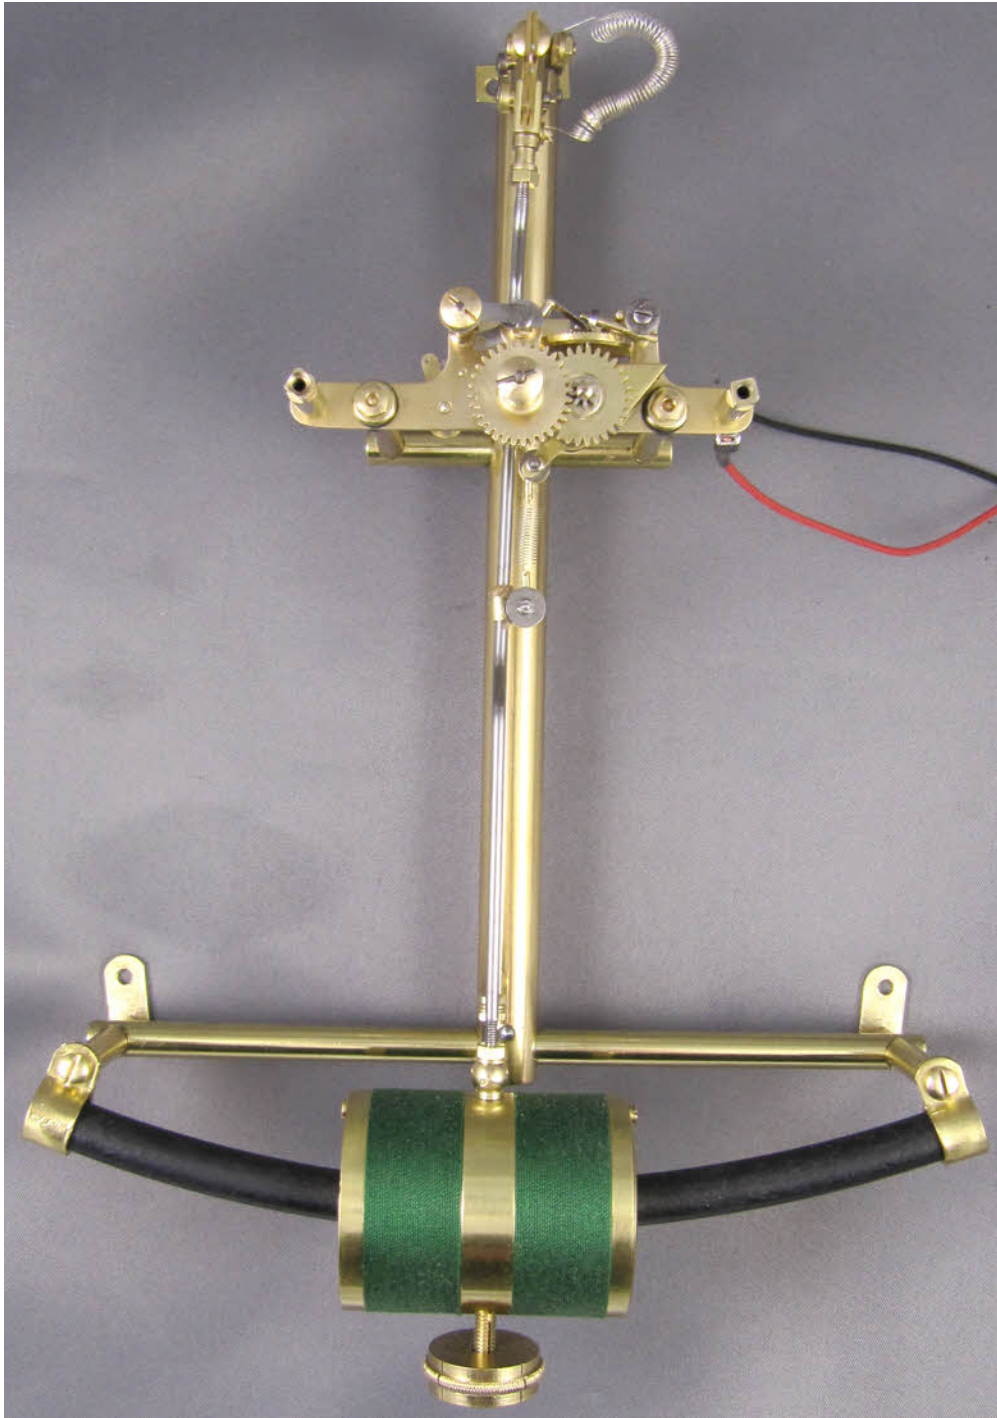
The finished clock

The clock ended up with new or replacement.

- Coil Cover cord..
- Dial Support Arms
- Isochron Spring
- Silver Contact Spring
- Motion Work Retainer
- Fork Arbour Stop Nut
- Silk Suspension
- Contact Pin 'T piece.
- Suspension Contact spring.
