**Bulle Clock Serial Number 178735**

## *Restoration of Bulle Clock Serial Number 178735*

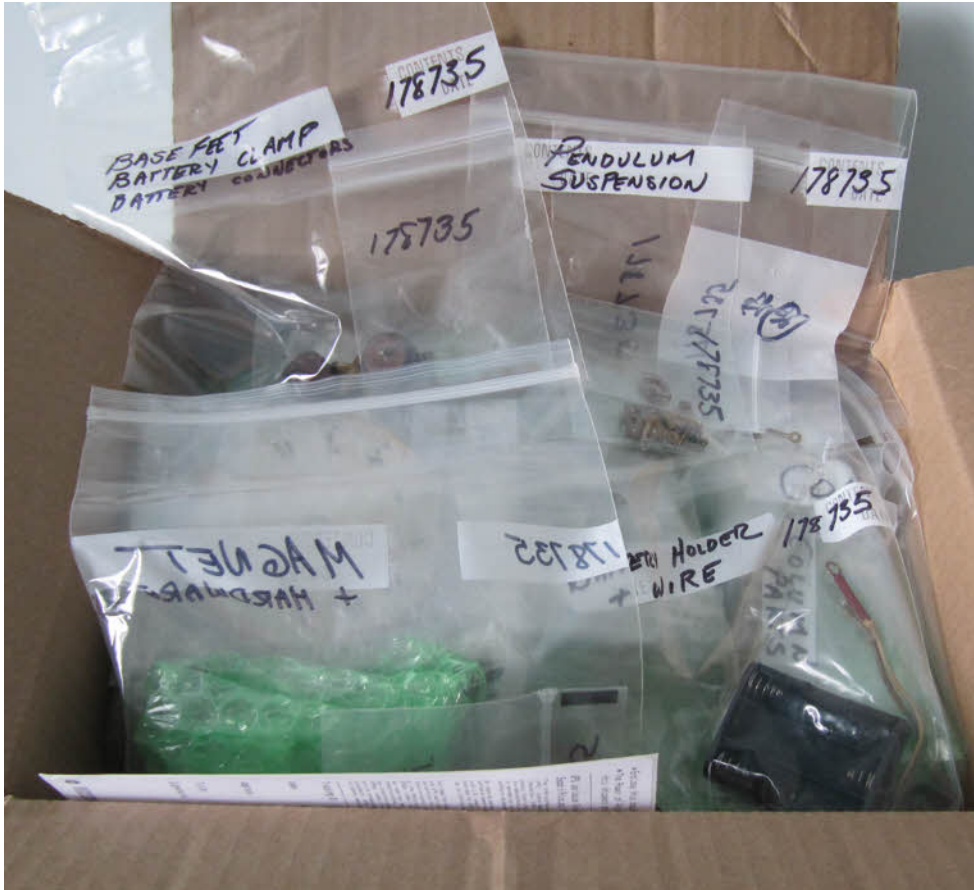
*The clock as delivered.*

*A short movement Clockette on a round wooden base. No dome supplied. The clock was delivered in parts well bagged up and tagged. Some of the sub assemblies were still complete such as the pendulum. After checking I found no parts missing and so it was just a job of cleaning and re-assembling.*

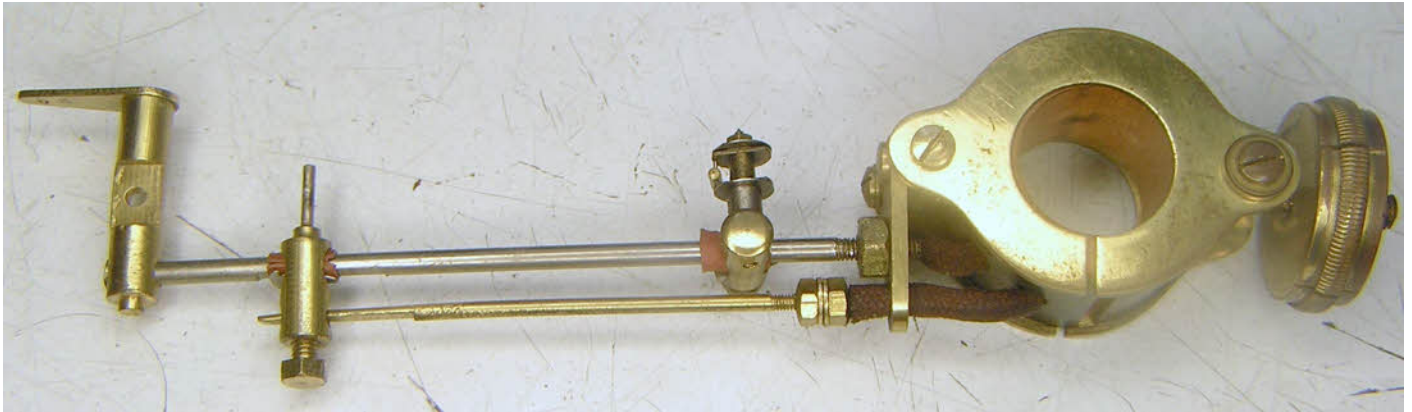
*The pendulum complete as supplied. No parts missing.*

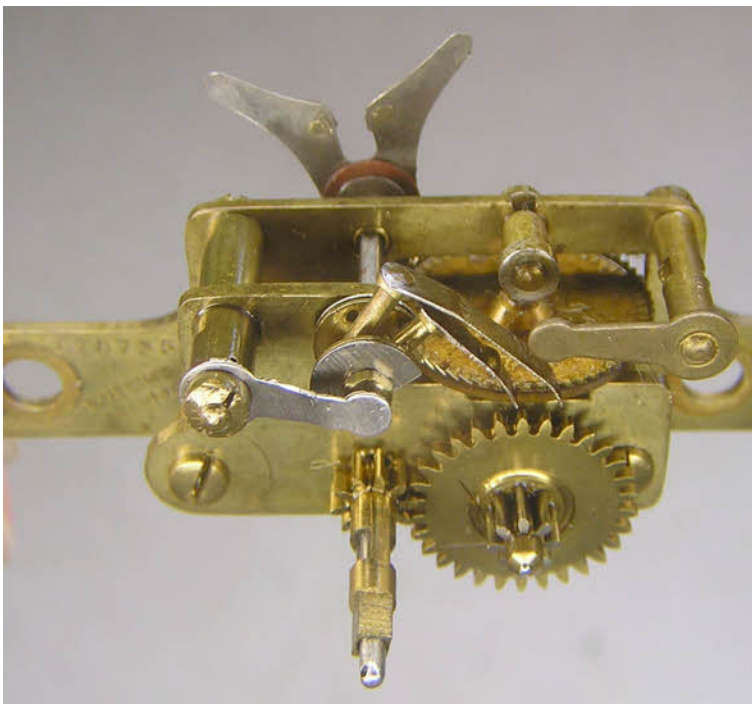
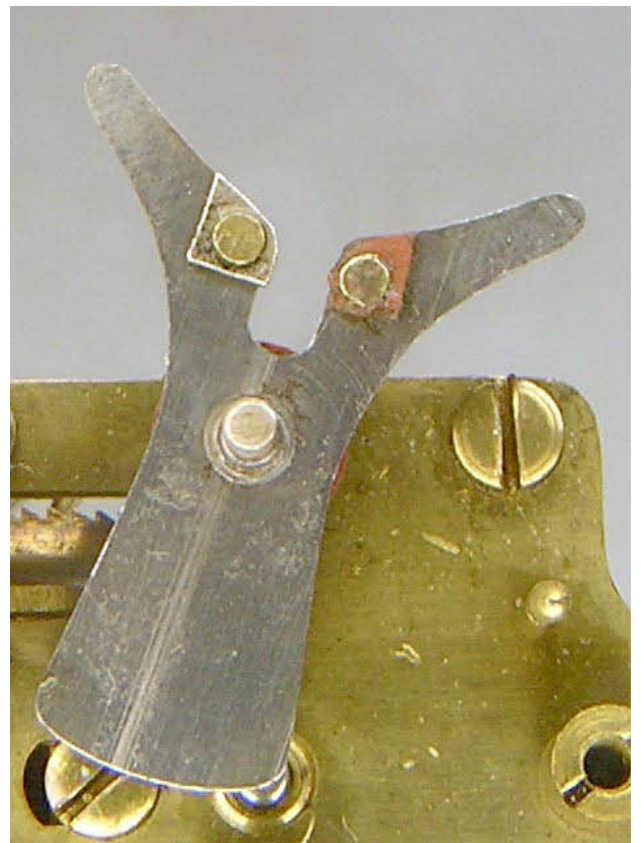
*The movement itself is complete and in good condition. The fork fibre insulator is very worn and needs replacing. The silver contact though is pretty good with hardly any wear on the inside, so it will be kept. All the assemblies can now be stripped and cleaned.*

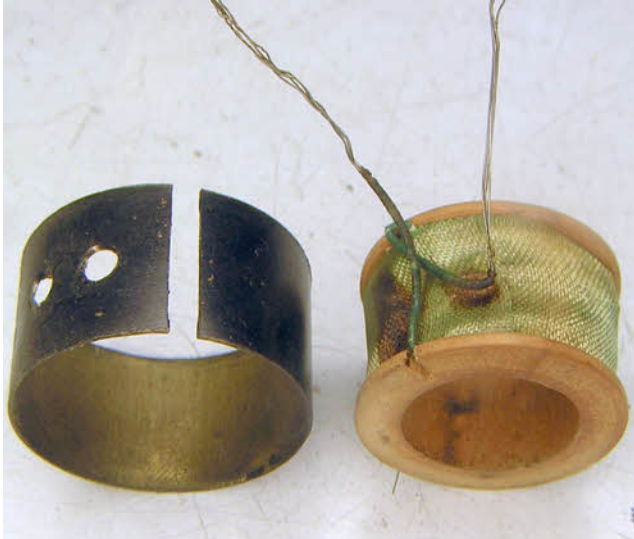
*The coil proved to be fine with a 1200 Ohm resistance. The lead out wires are OK and just need tidying up with new insulation.*

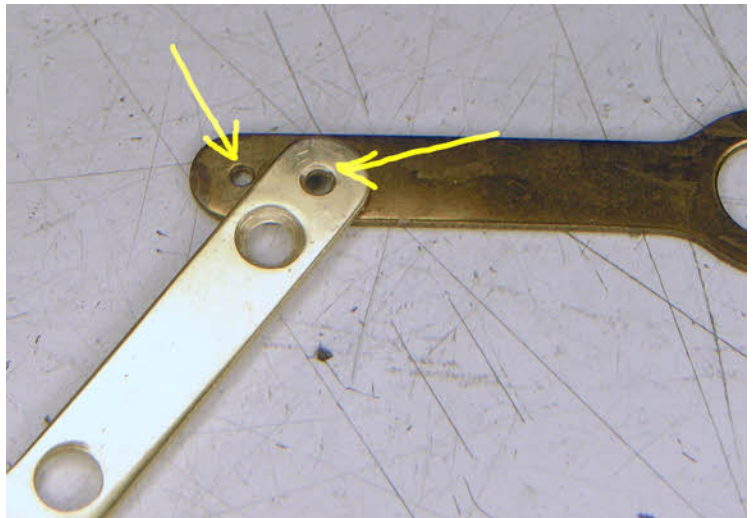
*The only real problem with the clock was the dial support bar which had the screw holes drilled out such that the screws no longer fitted. When I checked the photos supplied by the owner I noticed that the screws had nuts applied to them after passing through the dial and bar. I replaced the bar with an original and the screws then screwed in perfectly. The arrows show the large holes in the bar supplied compared to an original bar behind. I used this bar after cleaning.*

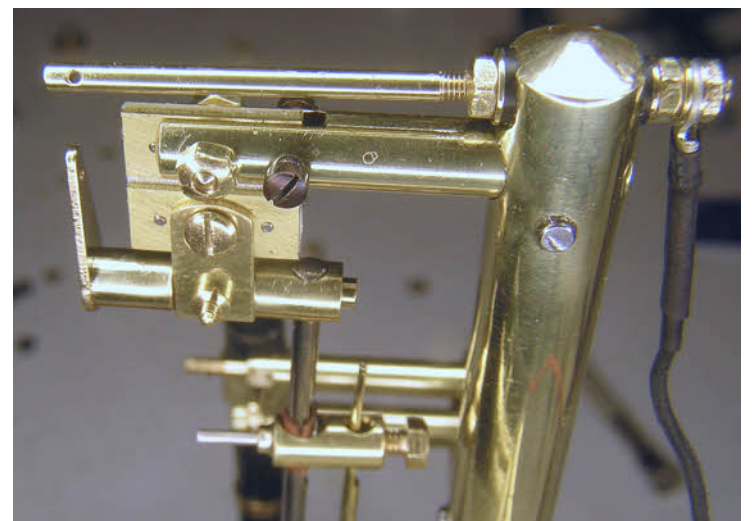
*The last photo shows the pendulum back in place with a new suspension.*

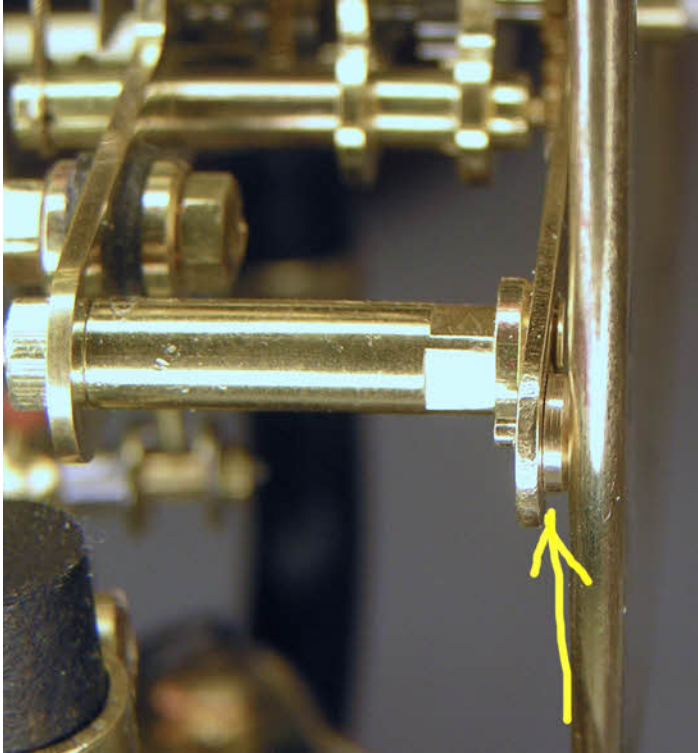
*The new bar in place with original screws*

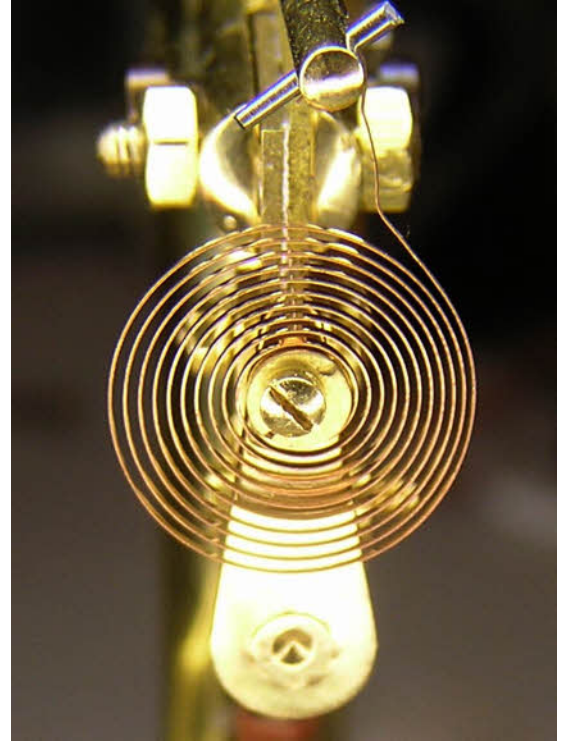
*New hair spring from an alarm clock*

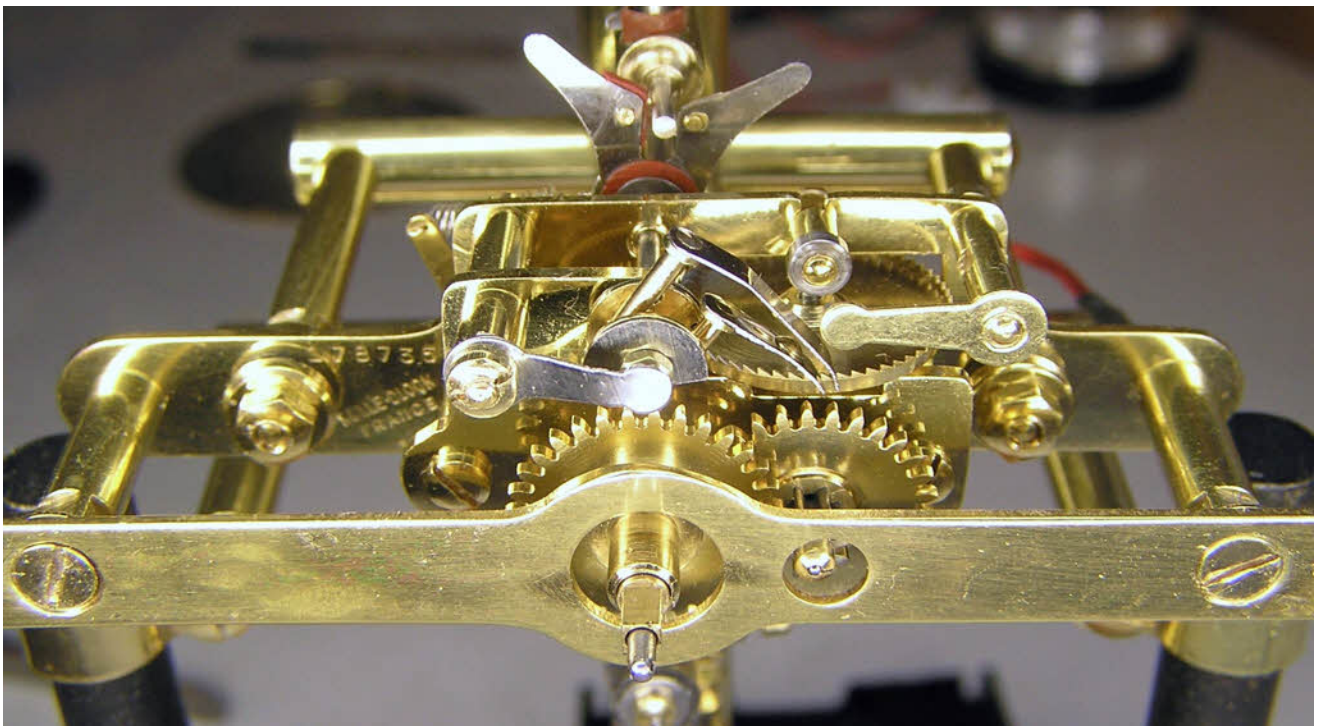
*Movement back in place*

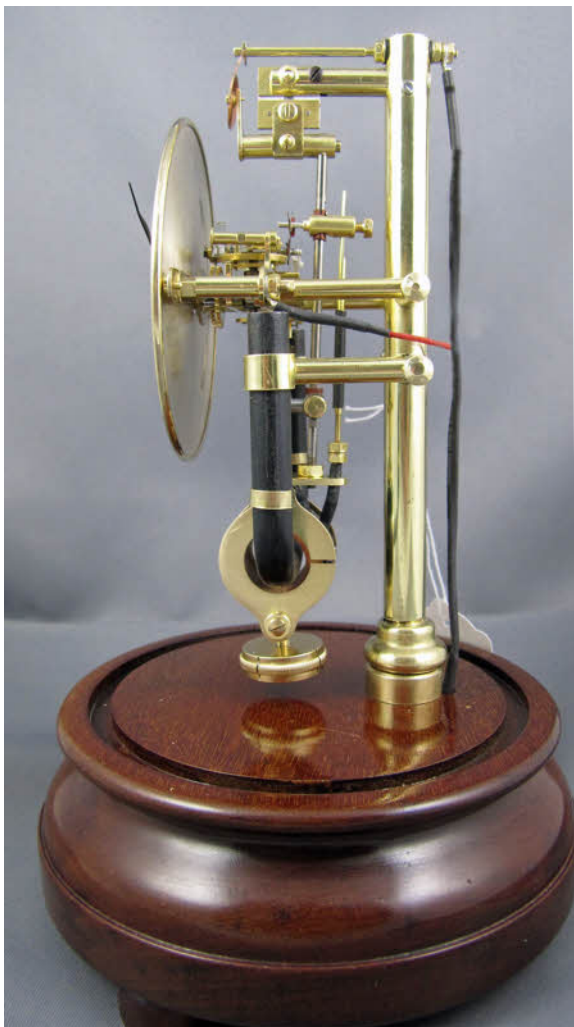
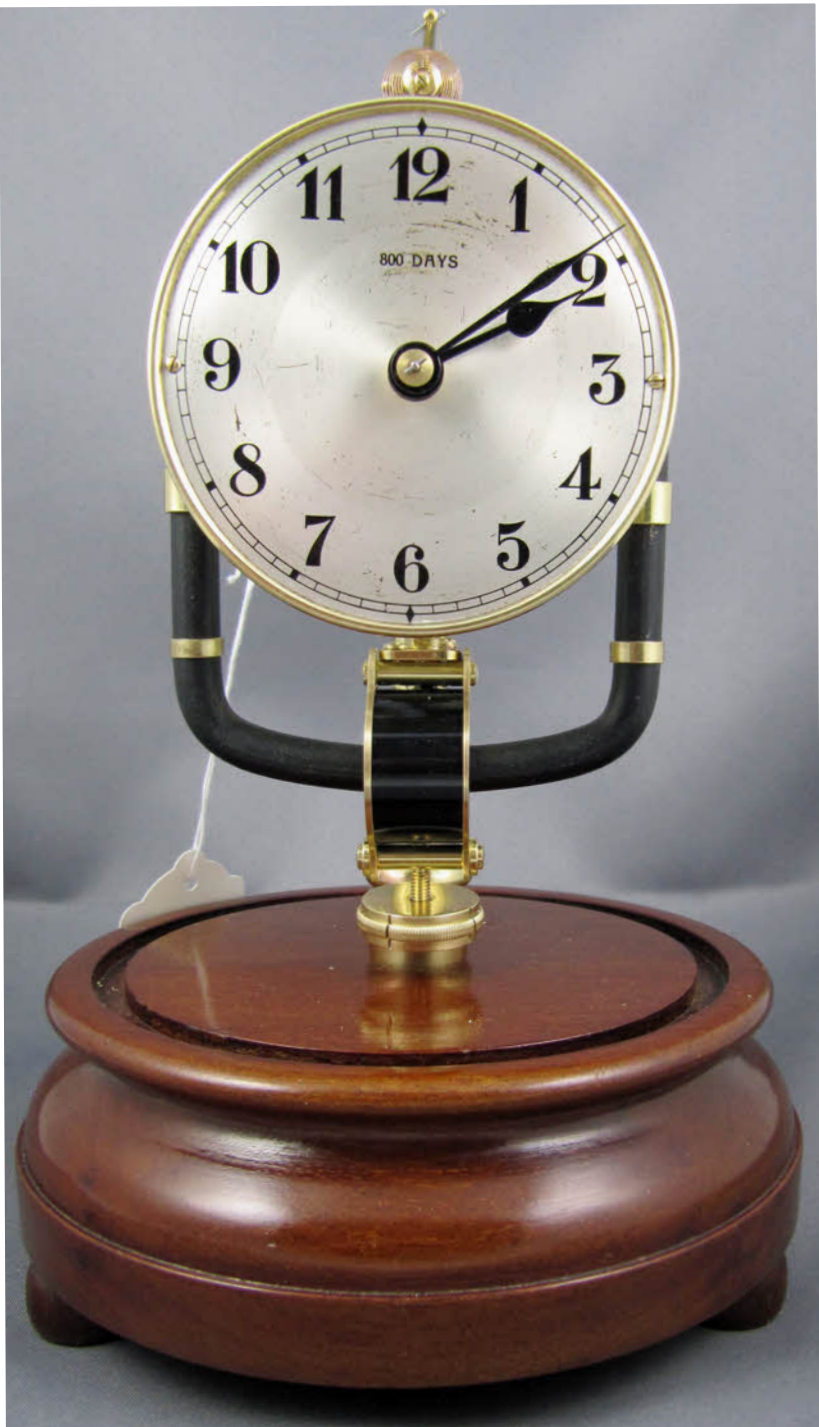
*The Finished Clock*
