Bulle Clock Serial Number 253053

*Restoration of Bulle Clock
Serial Number 253053*

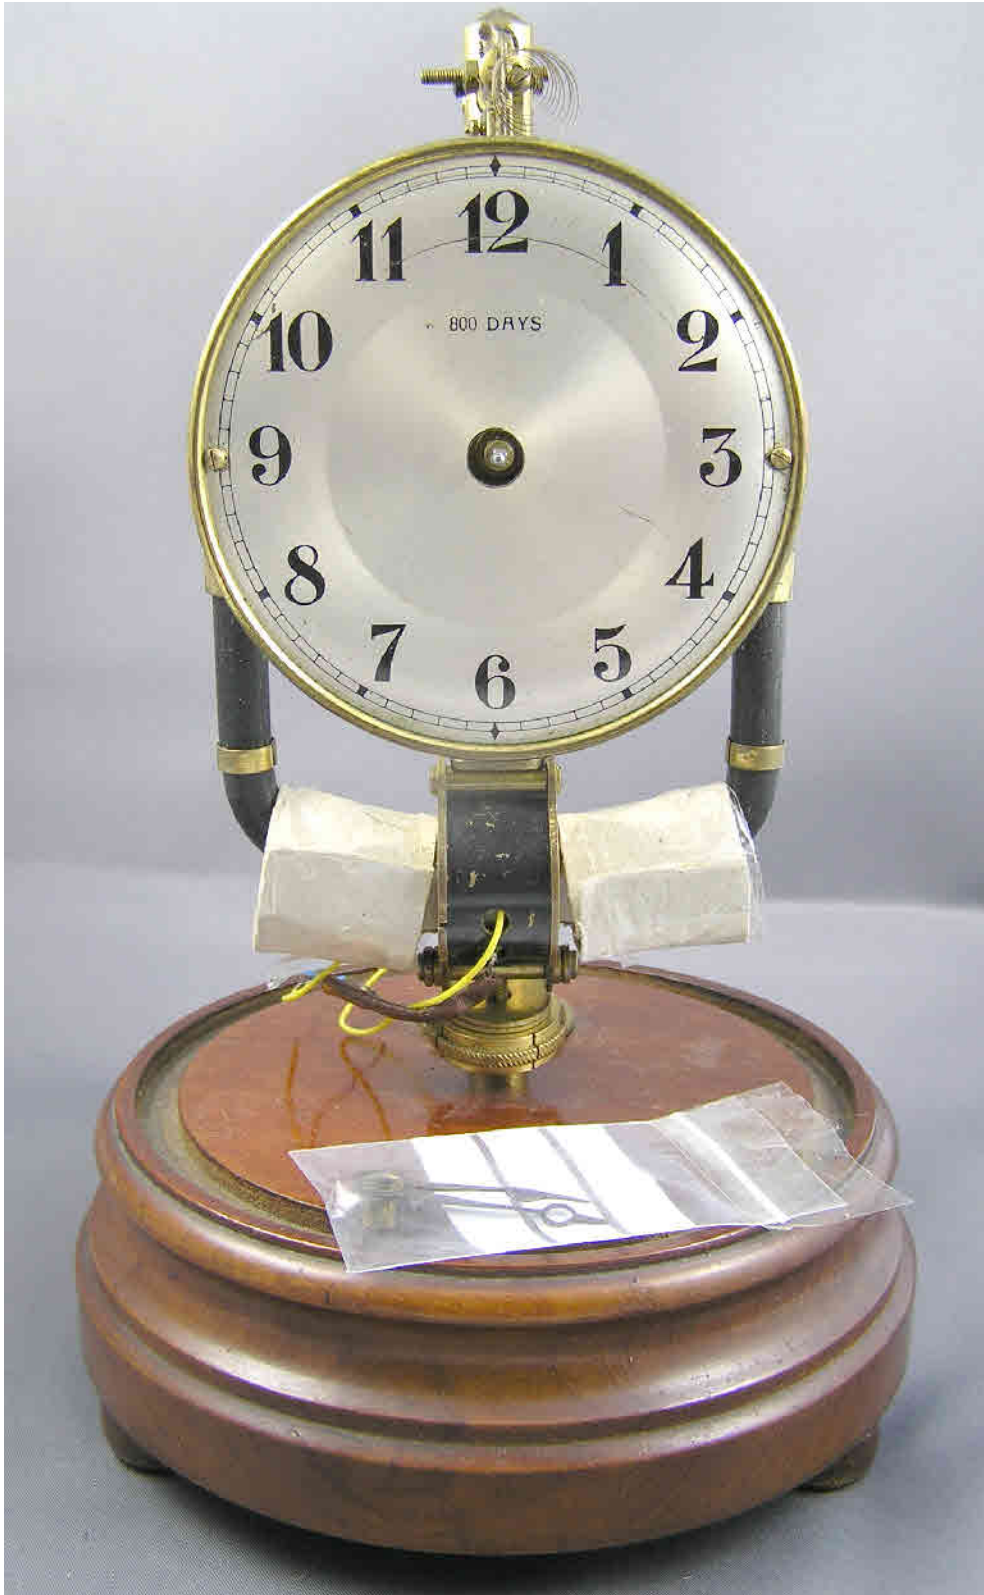
This short movement clockette sits on a round mahogany base which houses the 1.5 volt battery underneath.

The first thing to note is that there is a lot of wire floating free from the coil which itself seems to be mounted back to front? The hands are also missing and supplied in a separate plastic bag. On further inspection, they are of two different sizes and designs and are not original.

There are also two extra weights added to the pendulum just above the rating nut.

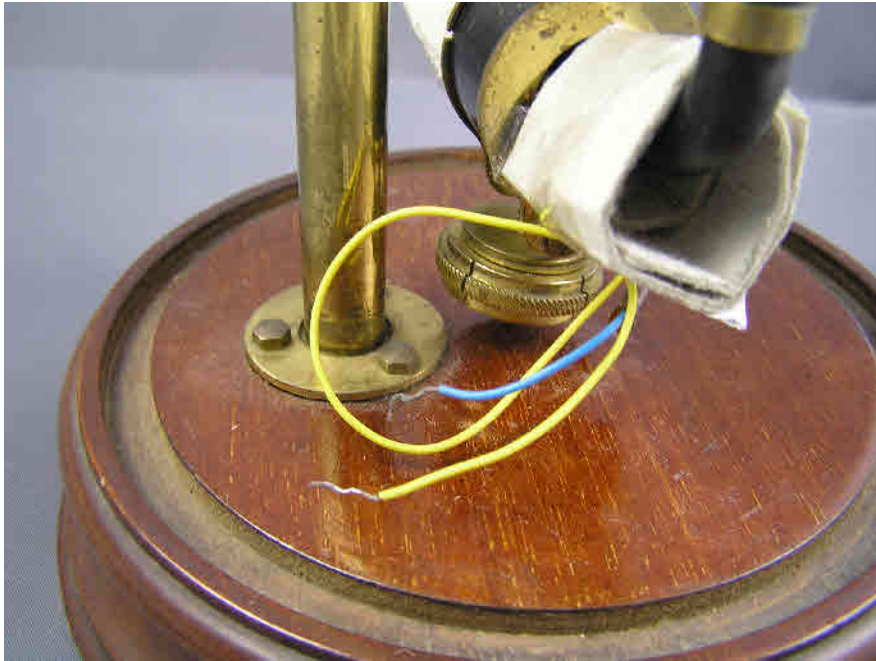
A close up photo of the floating wire and the extra weights

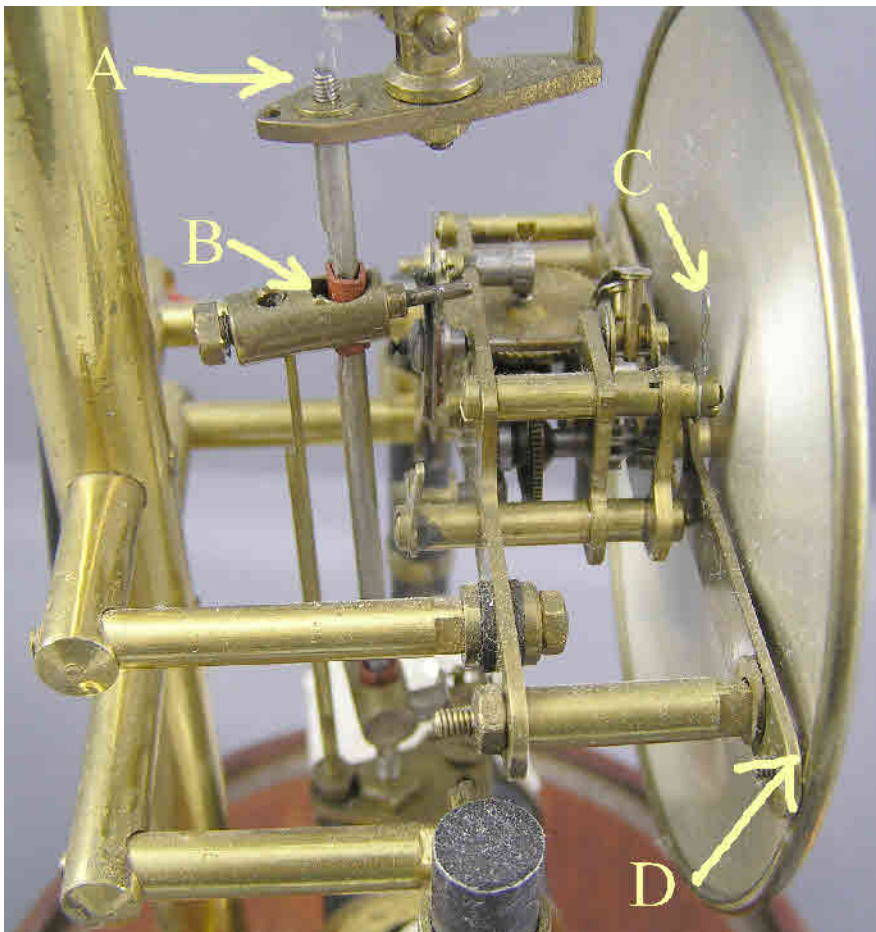
This photo shows a number of issues

A) The retaining nut is missing which secures the pendulum rod to the suspension assembly

B) The "T" piece which prevents the pin piercing the fibre is missing (see below)

C) The pawl arbour stop piece is set vertical and therefore not engaging with the arbour

D) The dial is missing the two pyramid shaped washers that support the dial.

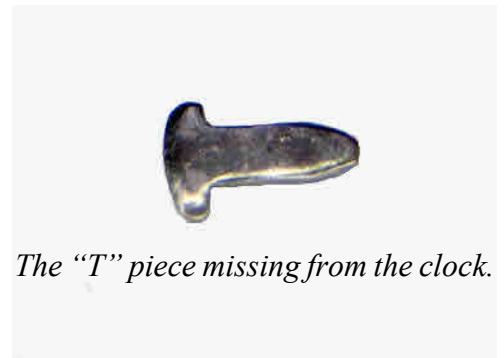
The "T" piece missing from the clock.

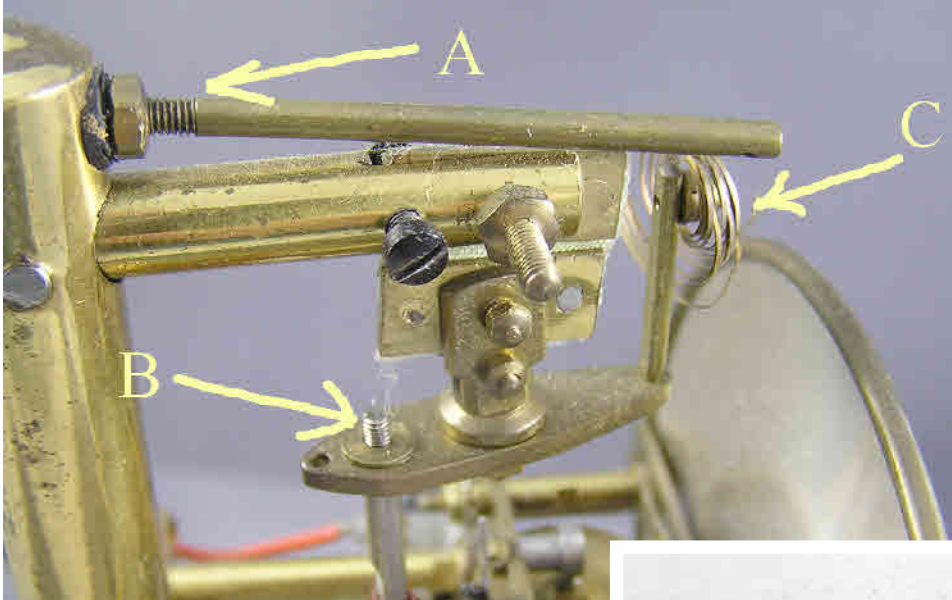
A) The bent arm that carries power to the small balance spring. This is a simple matter to straighten. The arm is shown removed below..

B) The missing pendulum rod retaining nut.

C) The mis-shapen spiral balance hair spring. I may be able to straighten this with a little patience.

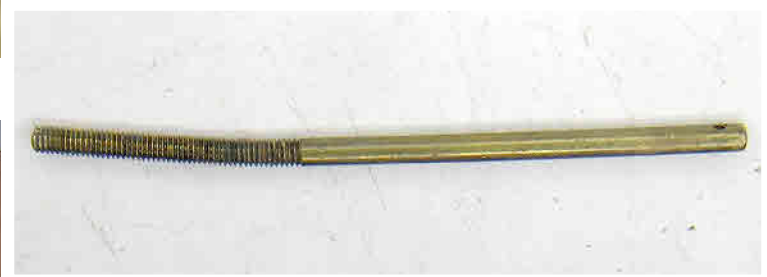
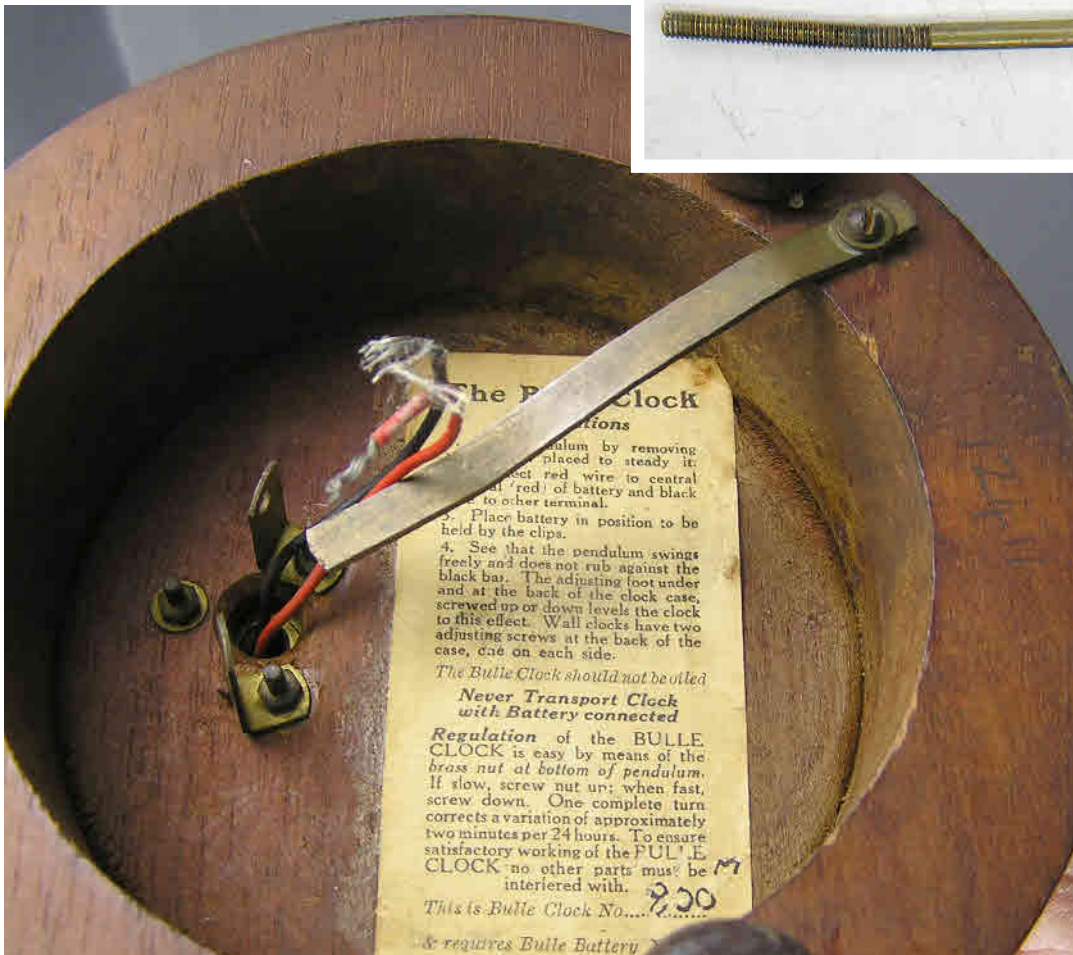
The underside of the base still carries the original label and is generally in good condition with no acid burns. The wiring is modern and will be replaced

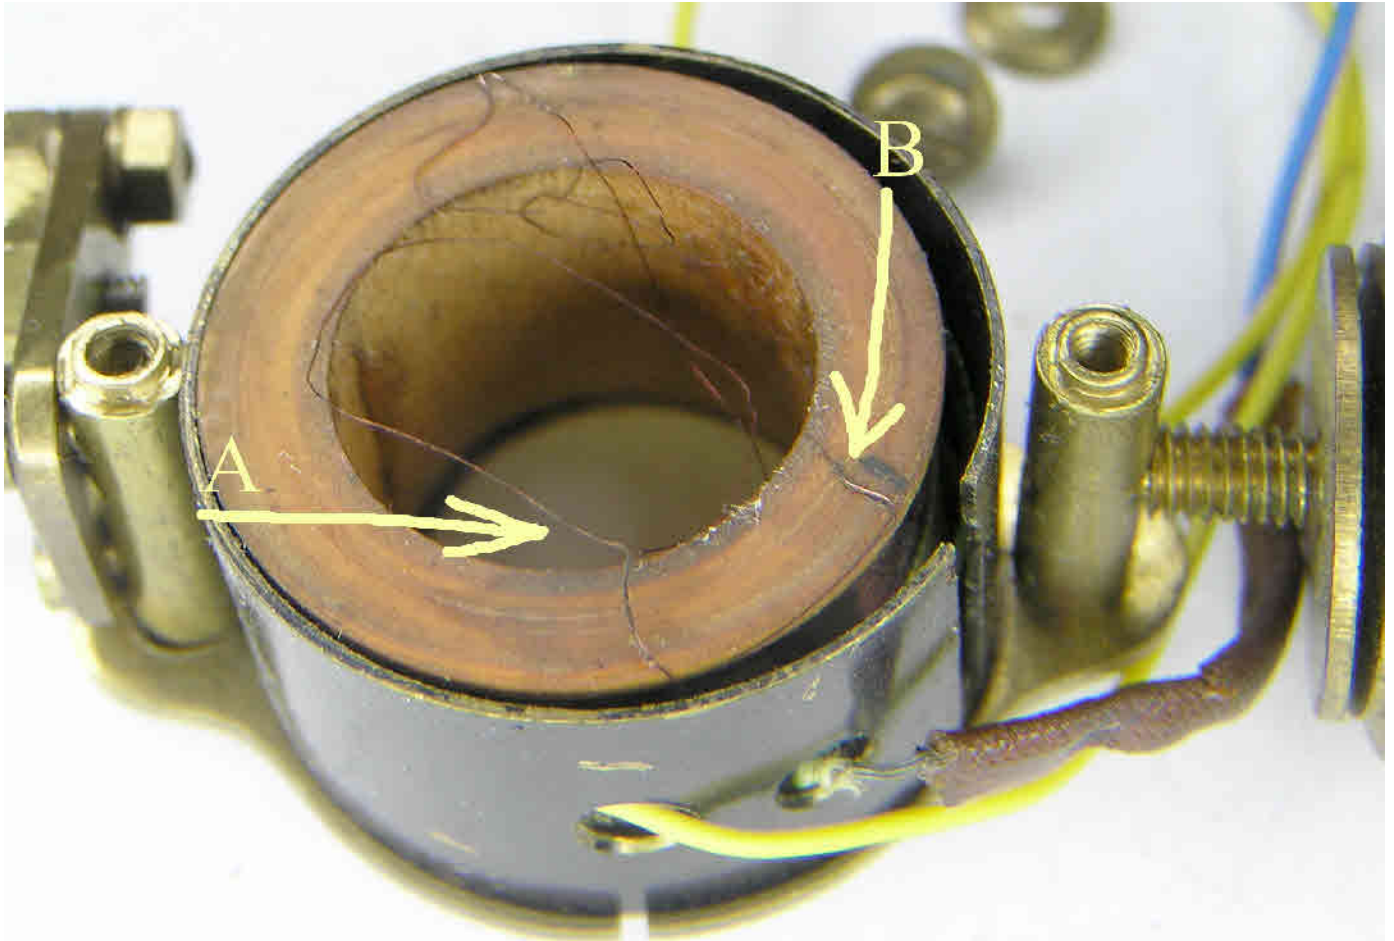
The coil looks to be in a worse condition than I first thought. I have enlarged this photo so that the core winding wire can be seen protruding beyond the casing at "A" and "B". I tried a resistance reading at all the ends I could find but to no avail. I hope this isn't a rewind!

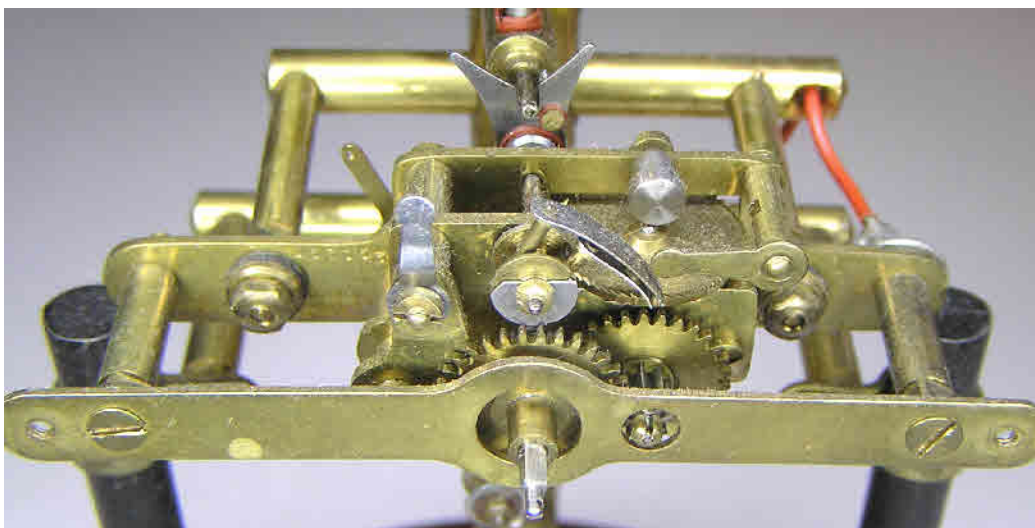
This photo shows the movement which seems to be in good condition with no major parts missing or broken., albeit that the steel half washer on the end of the pawl assembly is upside down.

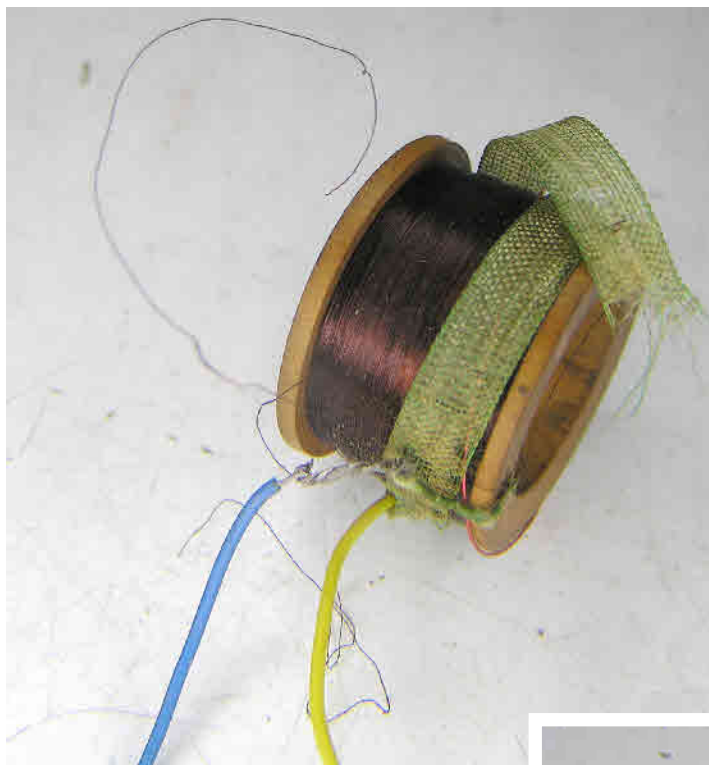
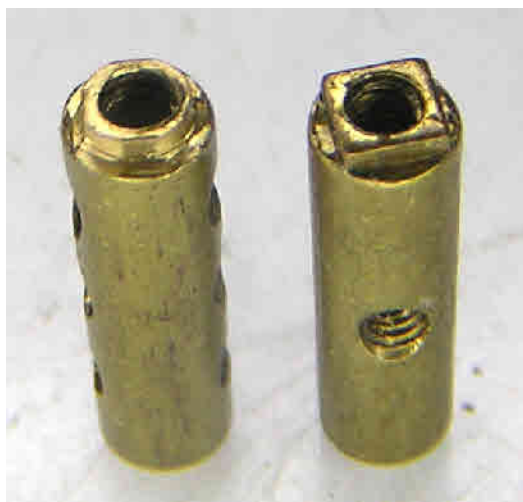
To the left can be seen the coil after removal from the brass casing. I eventually removed the two modern pieces of wire and traced back the winding to find the original ends. I then burned off a half inch of the enamel coating and cleaned the ends. The coil then proved to be good with a 1200 Ohm resistance reading. So all we need do is remake the lead out wires and secure the winding. Below we see the coil caps and spacer bar. These caps have one square and one round hole to accommodate the the similarly formed spacer bars. These squares assist in making sure the pendulum rod and rating nut sit vertically when attached to the coil.. As can be seen the caps have the round holes drilled out to be oversize and the square has been turned away on the upper spacer bar that carries the pendulum rod. Although the enlarged holes will not present too much of a problem, the spacer bar will need to be replaced.

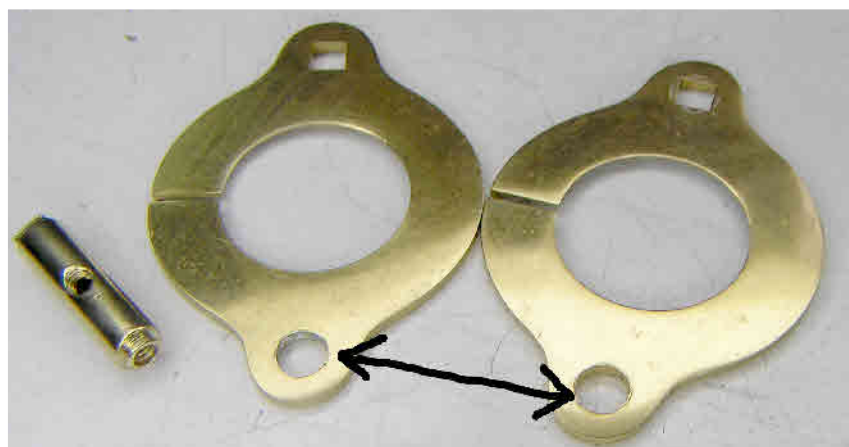
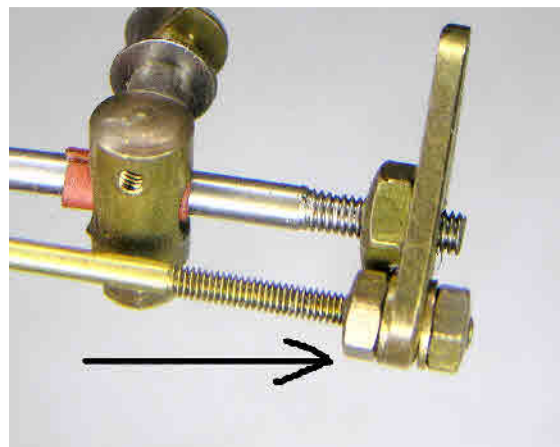
The last photo shows that the rod with the threaded end which normally carries the power from the coil back up the the contact pin assembly has been attached to the pendulum rod which normally carries the power down to the coil, thereby completely shorting out the system. The lead out wire from the coil should be insulated and pass through the plate and attached to the threaded rod by the two nuts.

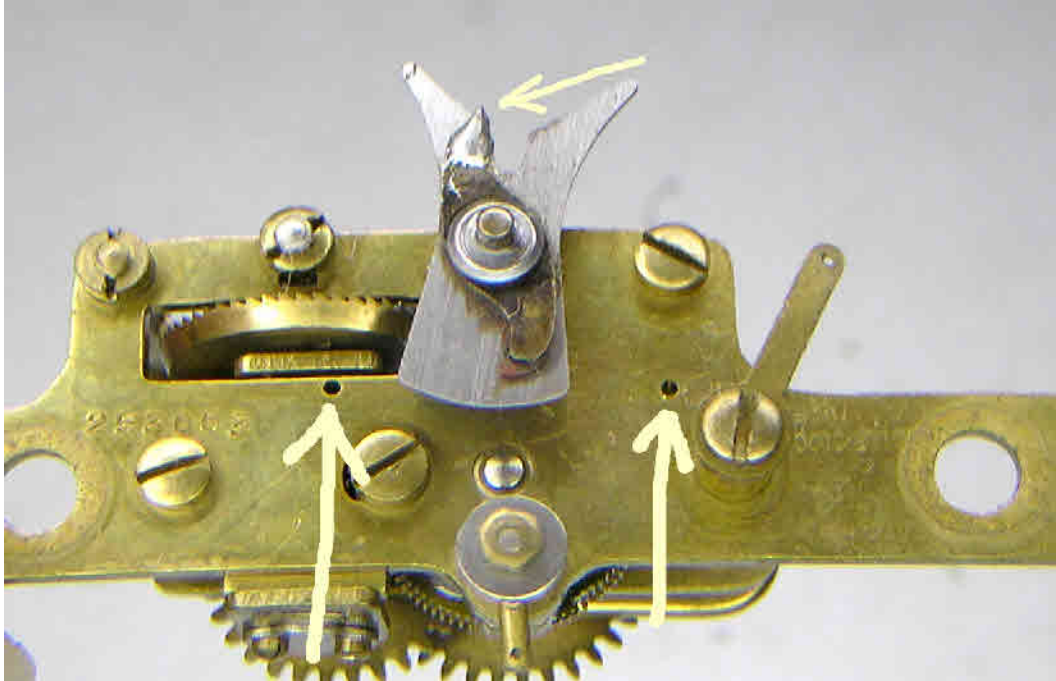
The fork has had the silver contact "fitted" with a lump of solder! We will remove this and investigate further. Note also the two holes in the main plate. These would normally be fitted with two banking pins to stop the pendulum from over-swinging by arresting the tail of the fork. But in this case the fork is of the smaller type and is not long enough to hit the pins. The pins have therefore not been fitted at time of manufacture.
