Bulle Clock Serial Number 3720

*Restoration of Bulle Clock
Serial Number 3720*

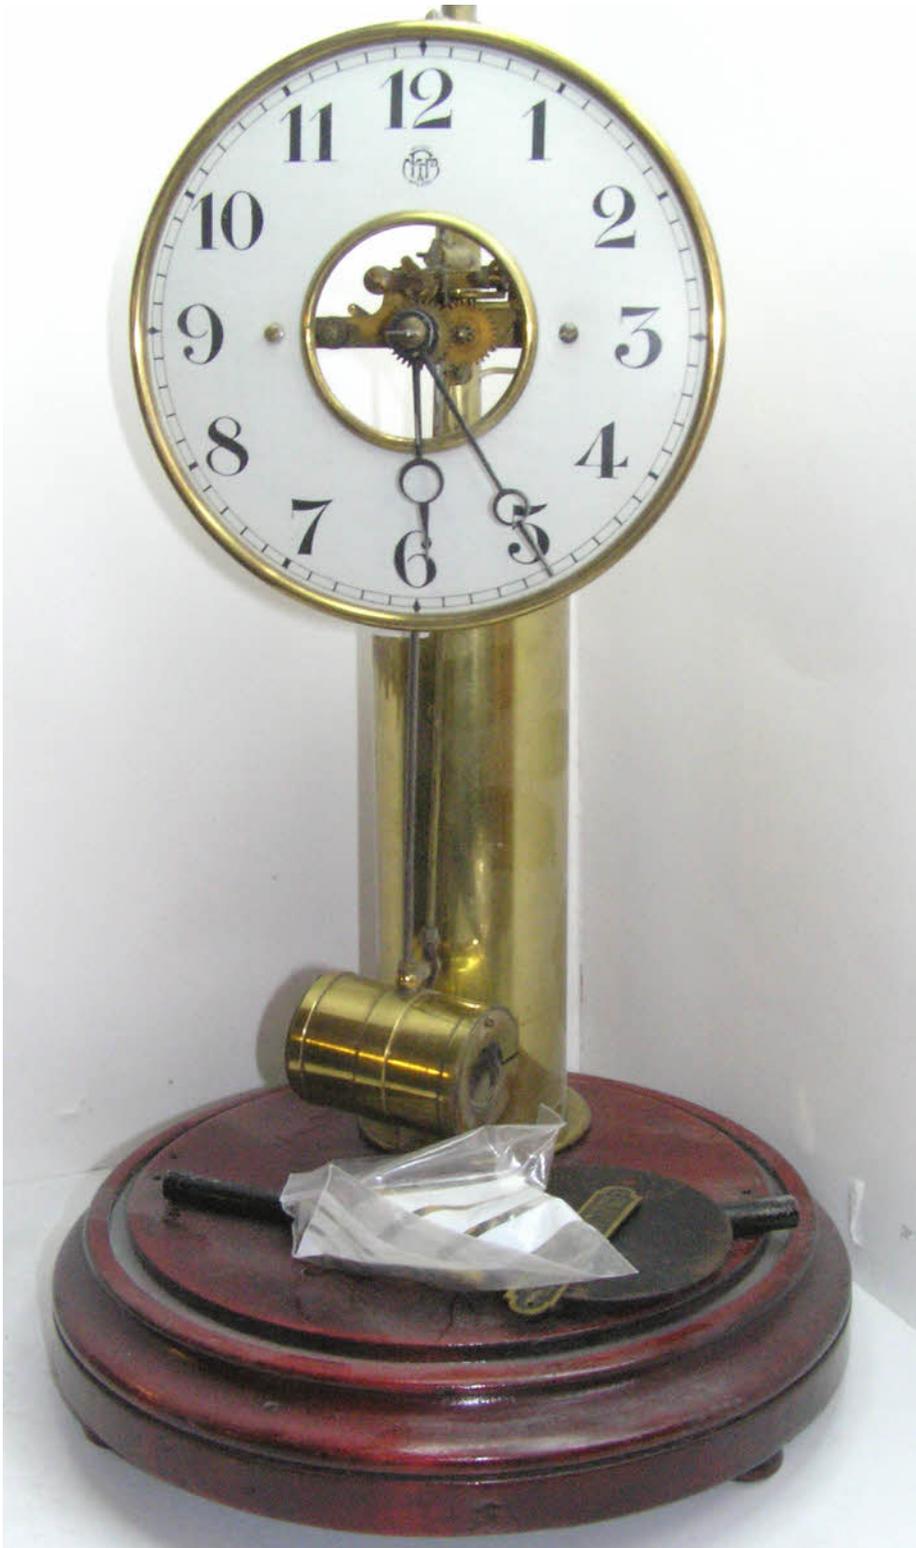
This clock is a tall movement on a round wooden base under a glass dome. It is from my own collection and interesting as an early example with a perfect dial.

The movement is a single plate movement dating to the first year of production 1921. The coil casing is a brass shell which originally was wound with green cord. In this clock the cord is missing, probably pulled off by the previous owner because it had rotted or discoloured.. The time is indicated by elegant moon hands painted black. The majority of these early clocks had painted hands although blued ones are not exactly rare.

All the important features and parts of the clock are original, although the base has had a hole drilled in the top near the front which has been filled in at a later date. I could find no reason why the hole was formed in the first place. The whole base will be cut back slightly and re-polished to it a "used" feel consistent with its age..

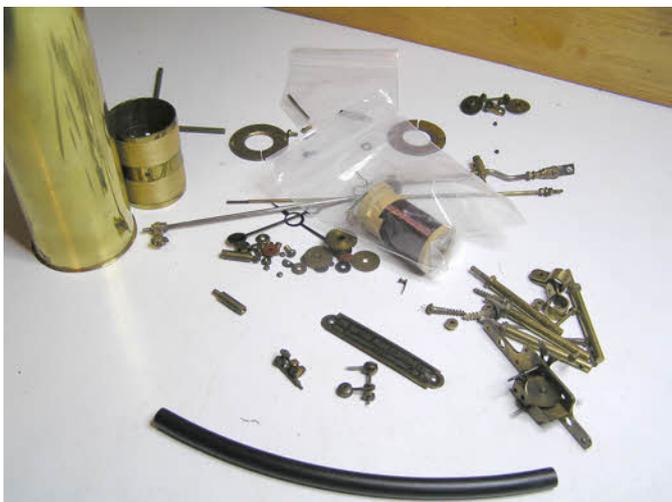
The clock in it's partially disassembled state

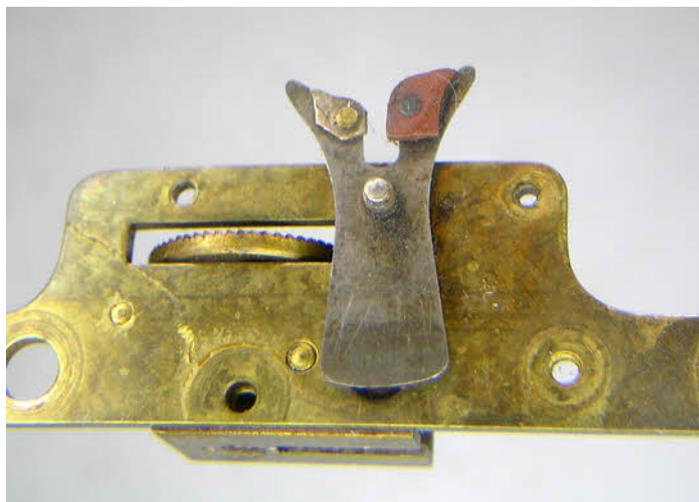
The fork has obviously had some attention in the past with a new piece of fibre added at some point. The silver contact also looks like a replacement. The fork arbour and fork itself look OK.

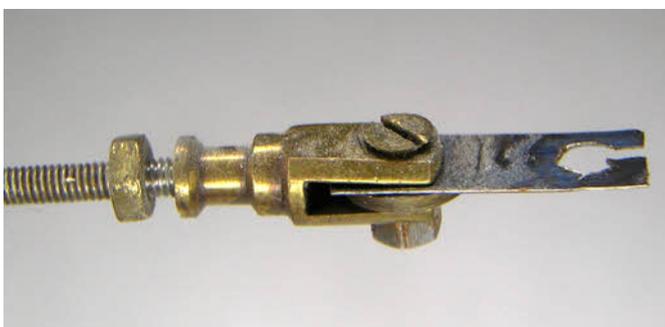
The silk suspension unit is missing and has been replaced with a steel spring. The special screw and nut have obviously gone with the suspension and a standard screw and nut used instead. The missing parts will be turned up on the lathe.

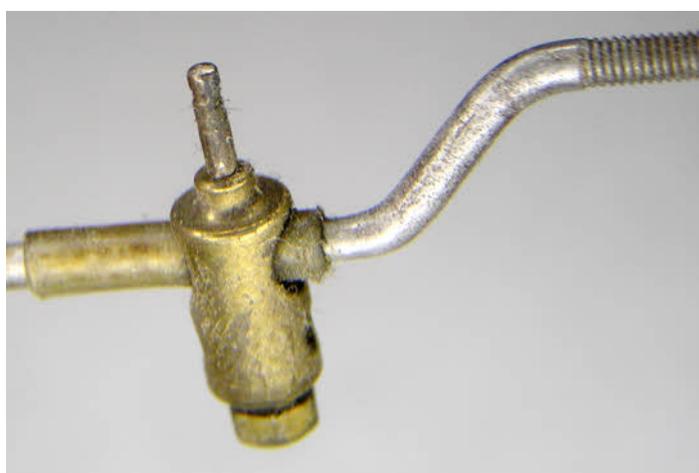
The contact pin assembly is missing the original fibre insulating sleeve. A piece of plastic tube has been used instead. The original fibre will be replaced.

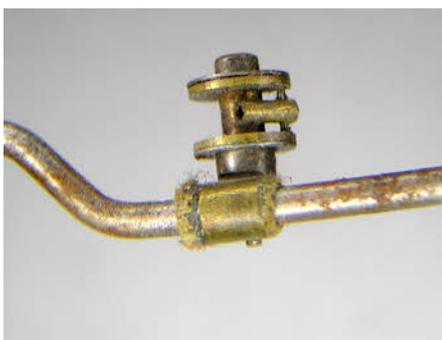
The pendulum Isochron suspension bracket is all original including the cloth insulator. The rust is of no importance and will be polished away.

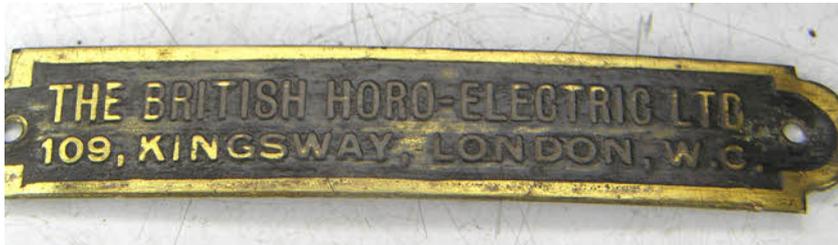
The original English label is showing its age but is still intact and will not be touched other than a dust off. The two pins securing it to the base are also original and will not be touched.

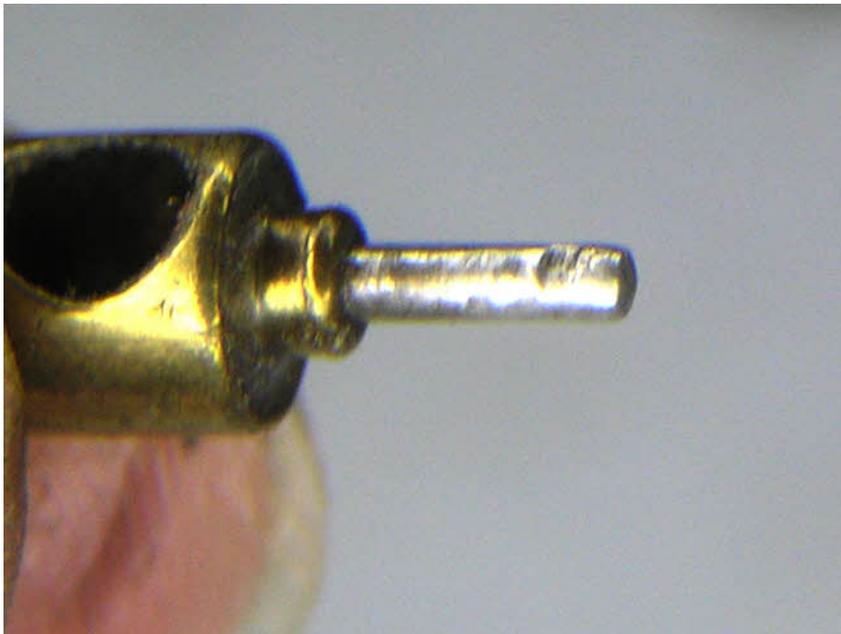
This photo shows the silver contact pin has some slight wear but this will easily be polished out and will be good for another 30 years

The contact pin was polished to remove most of the wear and all that remains is a small blemish. But this doesn't matter as the whole assembly was re-attached to the pendulum upside down and a new face presented to the fork.

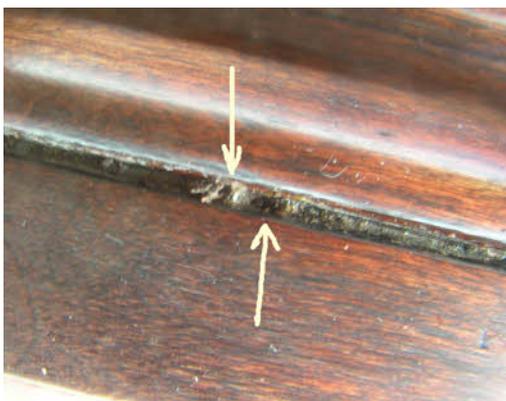
This photo at left shows the holes left by the original 1mm brass band that wrapped around the base with the ends hammered in the back to retain it. Not all clocks had the band and careful inspection is needed to verify the use of a replacement

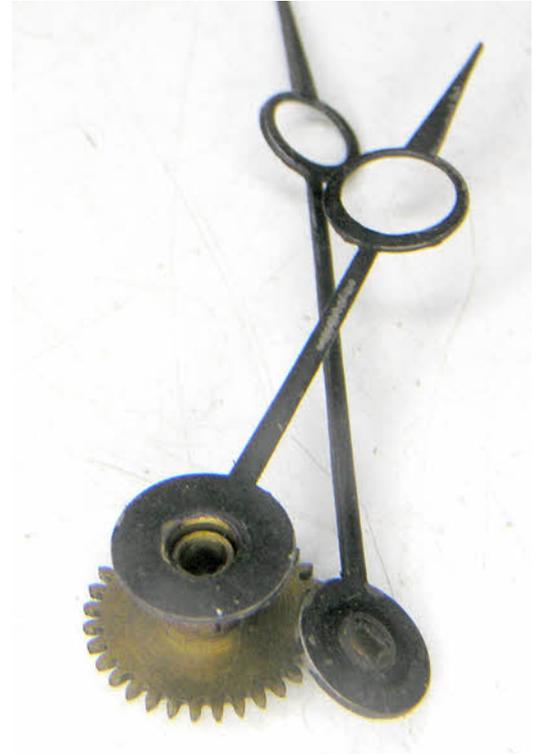
The photo above shows the original moon hands with the remnants of black paint still showing. These will be cleaned and re sprayed.

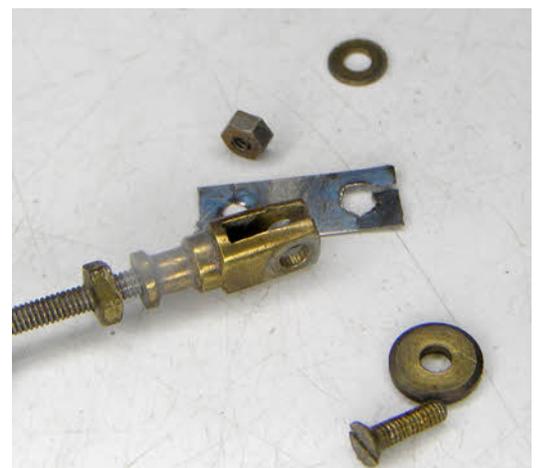
This photo shows the suspension parts in more detail.

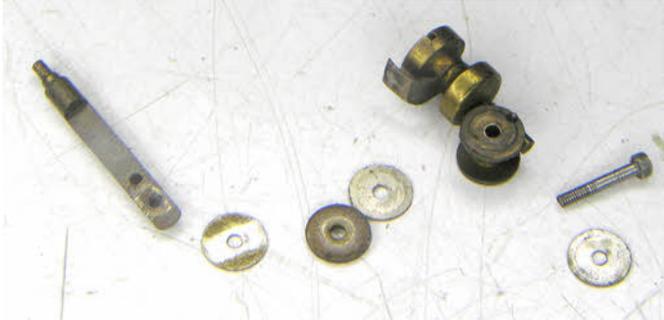
The disassembled count wheel stop return unit. This is an early version which was later replaced by two other versions before finally being replaced with the two pawl system. The only thing missing is the stud that jugged from the arm to stop the driving pawl tipping out of contact. This is easily made and will be refitted.

The two photos below show the new stud added to stop the impulse pawl from lifting.

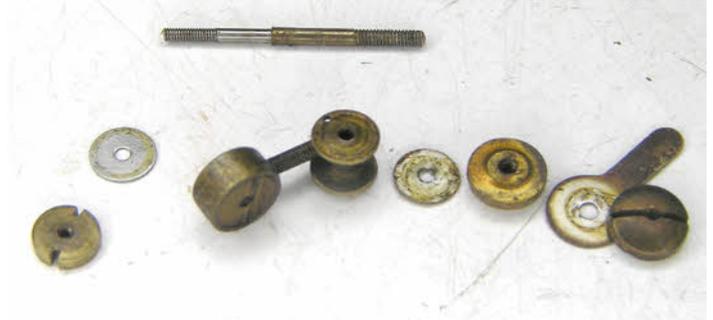
The damper and end stop unit disassembled. The damper itself is further disassembled below. Note the cord which filled the bowl. This was original dampened with a little light oil. The cord is exactly the same as that which covered the coil casing and will be replaced with fresh cord.

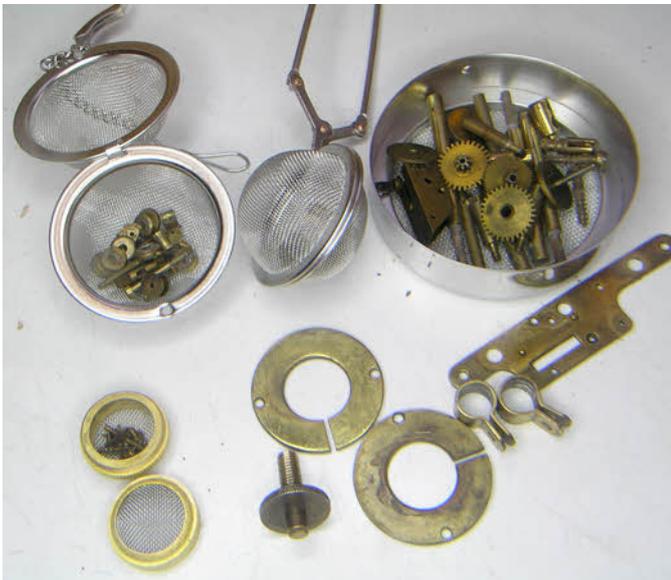
All the parts prepared for cleaning in the ultrasonic bath.

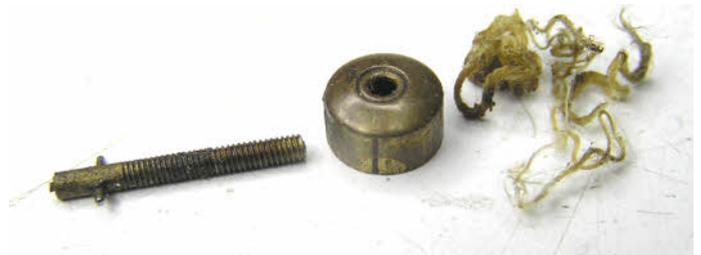
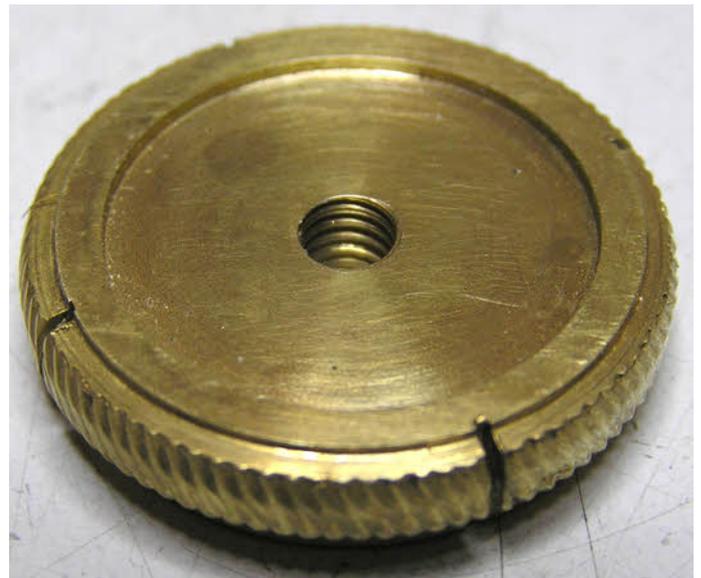
The rating nut was found to be modified by someone who didn't understand the clocks function and tried to lighten the pendulum to induce a faster rate. It will be repaired

These last two photos show the insert made to fit the rating nut. It was turned to fit the cavity and then cemented in position with Loctite 603 retainer. The existing slots were then extended across the new insert such that it is nigh on impossible to see the join. The whole nut was then polished. The thread was not in good condition so it was touched up by passing a tap through it.

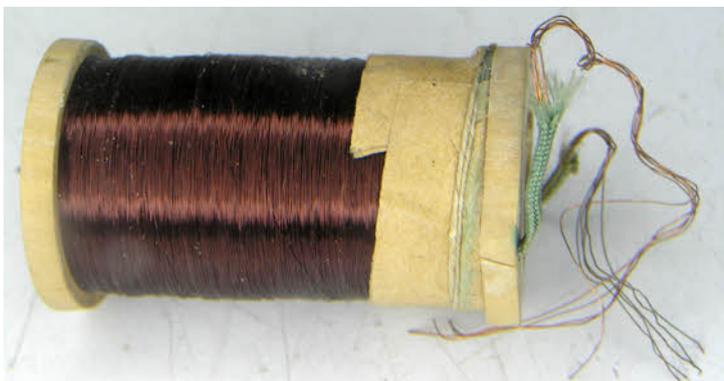
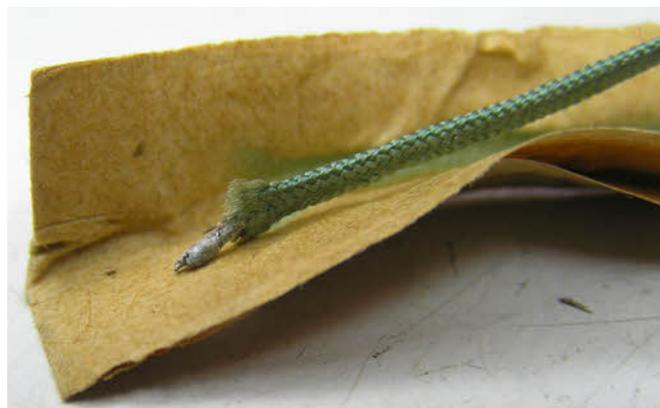
The coil was found to be dead and showed no resistance whatsoever. After pulling a few hundred turns off and rechecking, a resistance could still not be found. There was no choice therefore other than to unwind the coil completely. The fault was then found to be the end of the coil separated from the lead out wire.

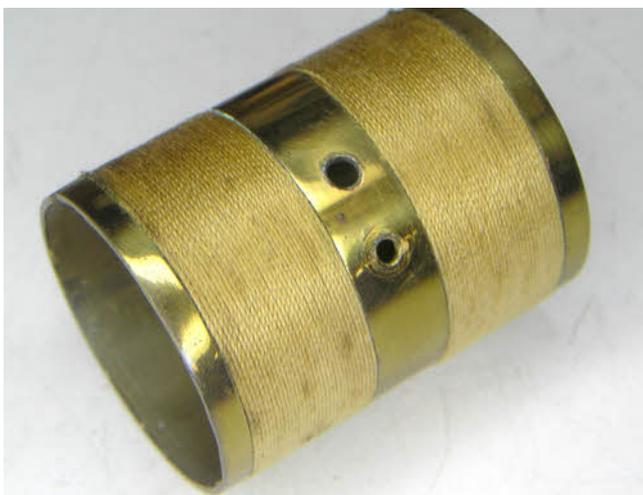
This clock is a very early example and it seemed a shame that the coil casing had the original cord removed. Now I could have wrapped it in new cord as per the original colour but I just happened to have a casing with a good cord still intact from another clock of the same year. The casings are identical.

This particular example had come from a clock that I had restored in the past but the owner had wanted a new cord covering as this one was, in his opinion, tired and straw coloured. I did not want to destroy this cord so I negotiated at the time to keep his casing and supply one bound with the replacement cord. The one supplied was again from the same year and identical in all dimensions and style. This offer was accepted. I kept the casing in case I ever came across a deserving clock. This was it. The problem is in trying to clean the brass without damaging the cord. Sometimes the cord is so fragile that falls apart at the slightest touch

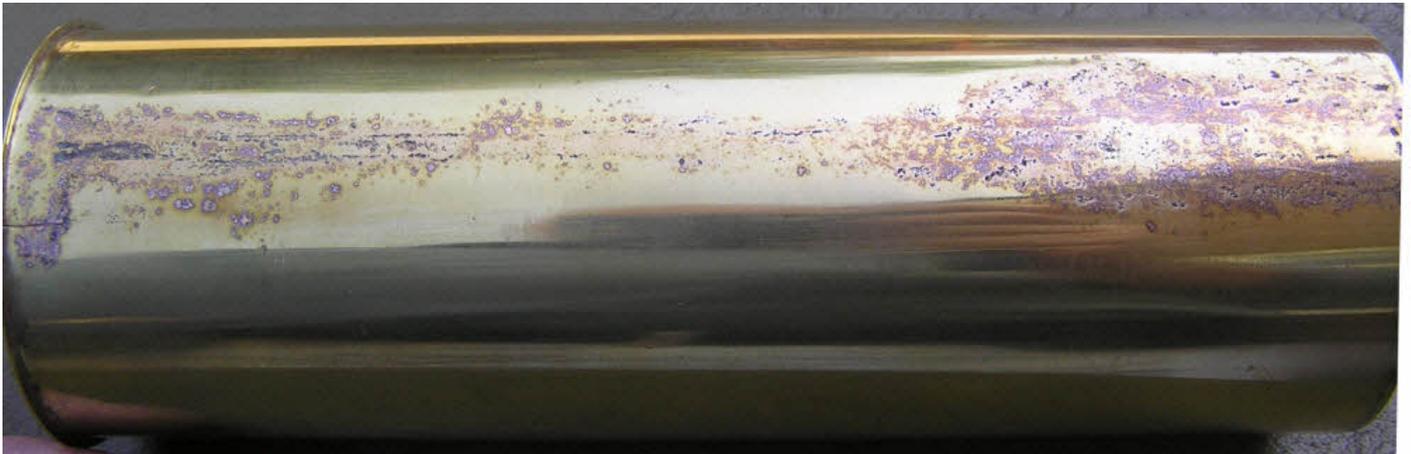
On initial cleaning of the column, the soldered seam at the rear shows signs that the zinc in the brass has been corroded to leave areas of copper and pitting. This has not been caused by acid eating from the inside. It is probably caused by the original manufacturer not cleaning off all traces of brazing fluid when the joint was soldered. The area in question is at the rear and will of course not normally be seen. It will also fade down slightly when polished. The question is do we keep it or replace it? Structurally it is sound. It will not get any worse once it has been cleaned. And it will only be visible from the back. So it will be kept as original.

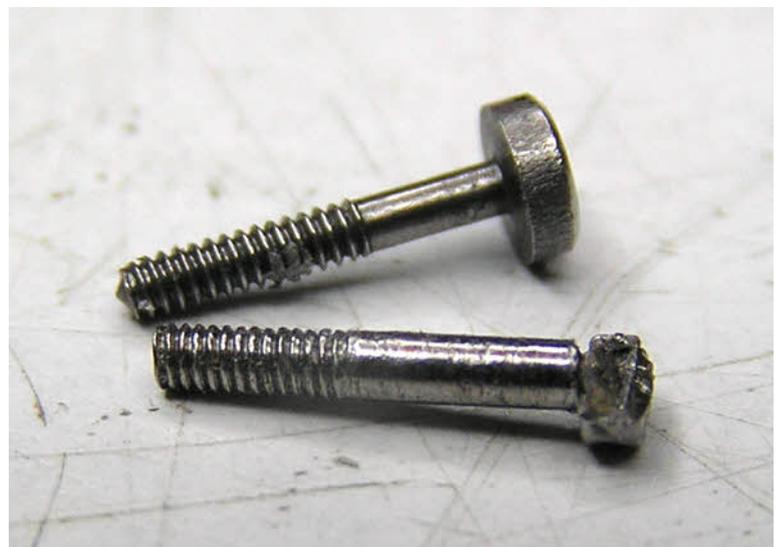
The small steel screw that holds the Isochron bracket in place was found to be fractured and broke when removing. The photo above shows its replacement.

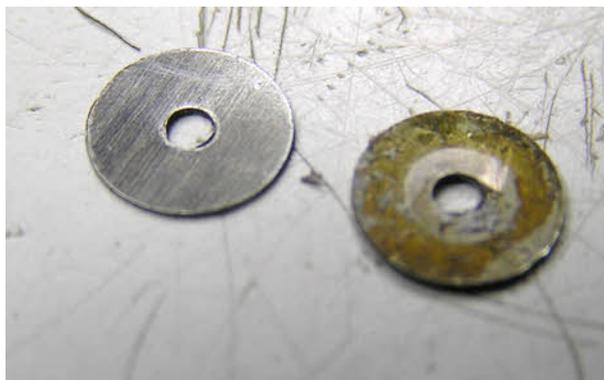
This photo at left shows that although the steel parts look corroded or rusty it is in fact just caked oil and dirt and was easily removed with acetone and a small soft rotary wire brush.

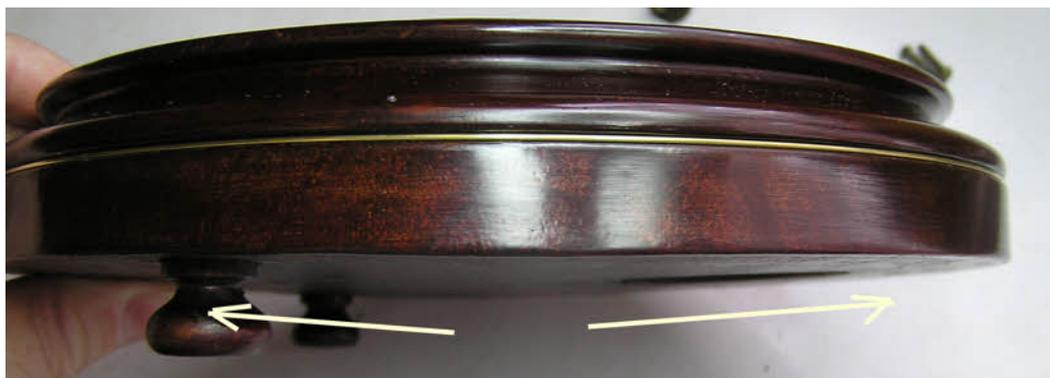
The base had shrunk such that it curved front to back as shown by the arrows. This means that a glass dome will be difficult to fit because the groove will now be slightly oval and not flat. Luckily I have a dome that is also not quite round and it fits in one direction. The photo also shows the new band in place.

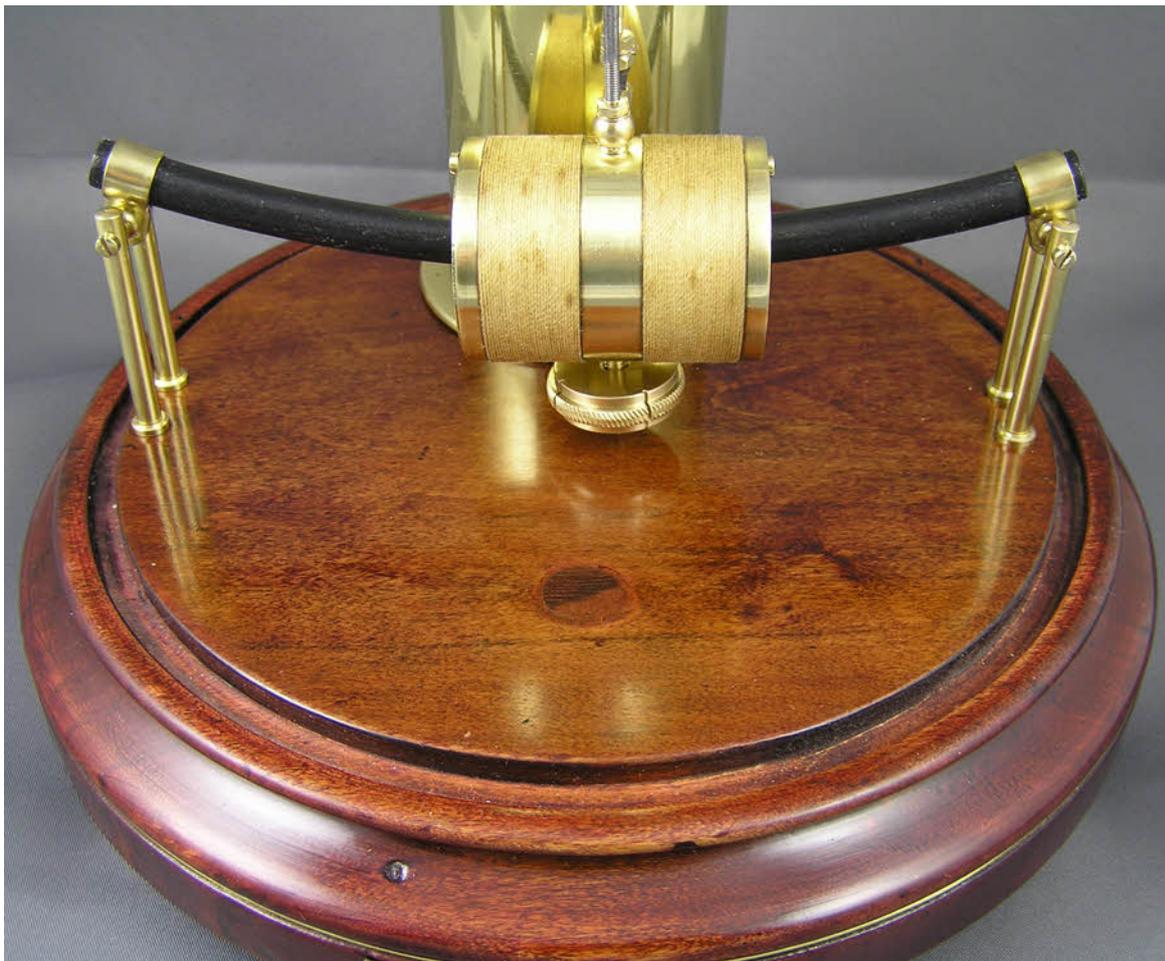
The base with magnet and pendulum . Note the 1/2 inch plug fitted at some time into a drilled hole. I still can't think of a reason for it be there. Still it's a part of the clocks history and doesn't detract from the aesthetics of the clock.

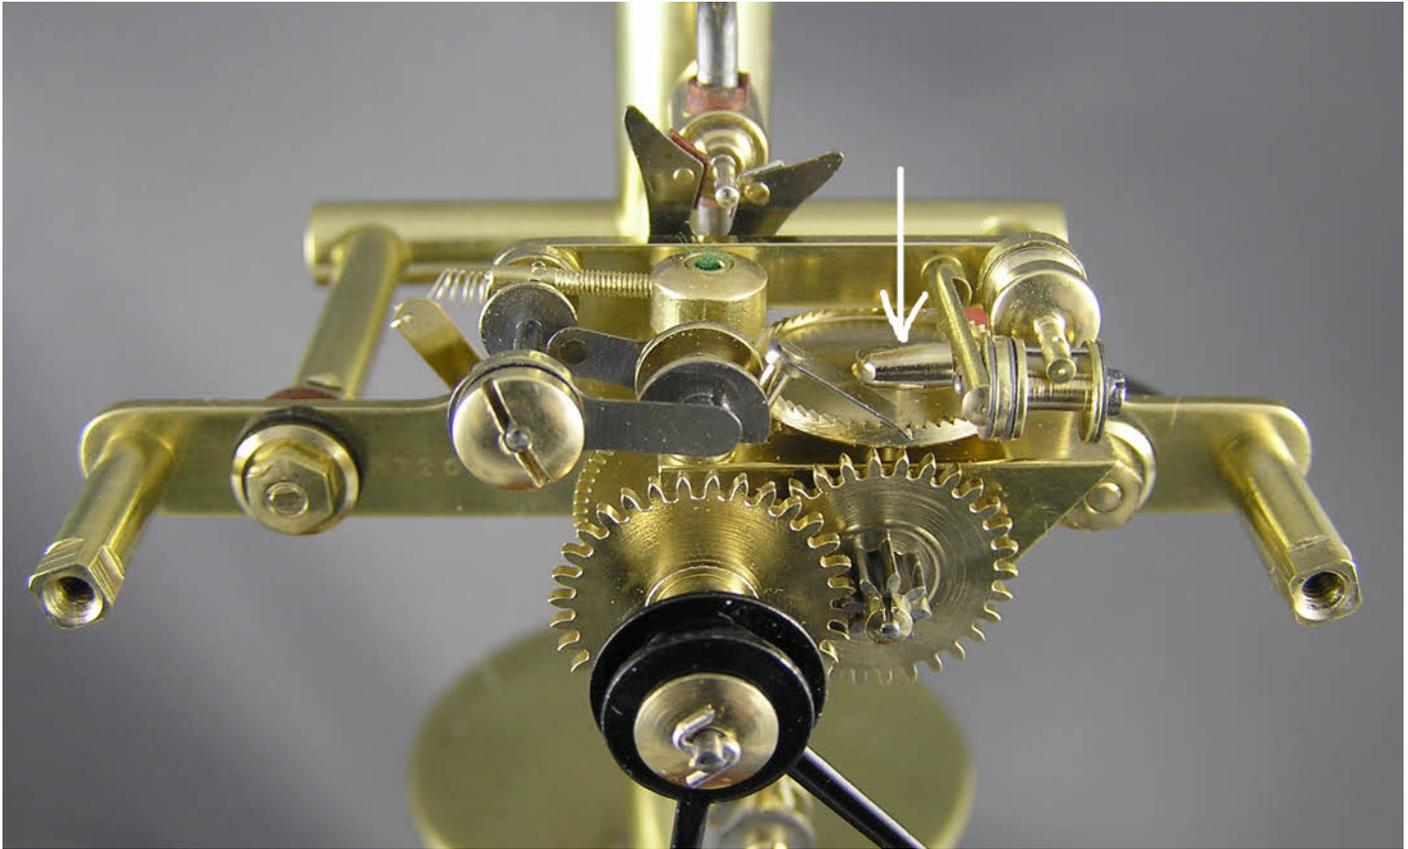
A view of the cleaned movement back in place on the frame. Note the new stud protruding to stop the driving pawl from rising (arrowed)

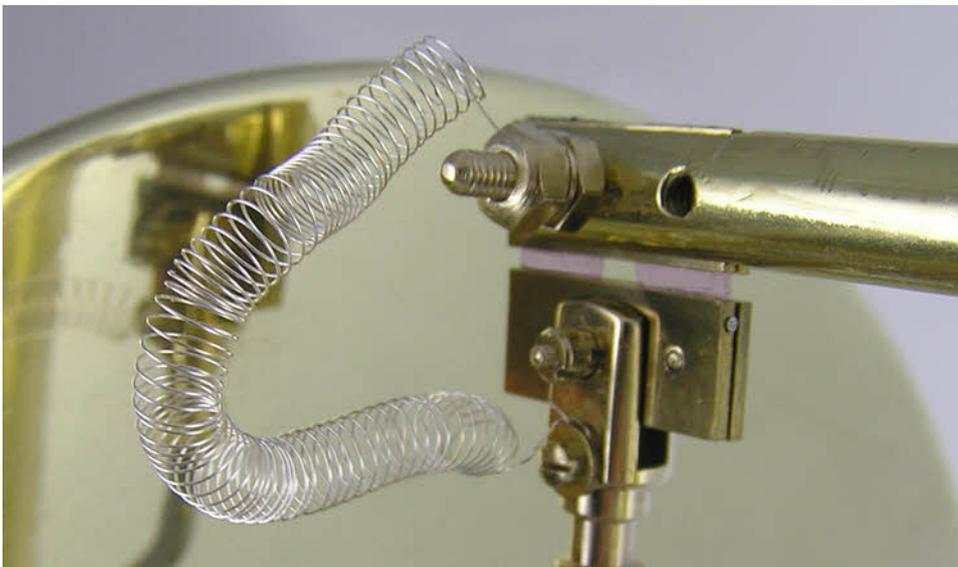
The coiled contact wire that ensures continuity of power across the silk suspension. There is some conjecture over the original method of bridging the gap, but as there are no surviving documents or photographs of an original clock that show this in sufficient detail we will have to devise our own methods bearing in mind the attachment points existing on the clock.

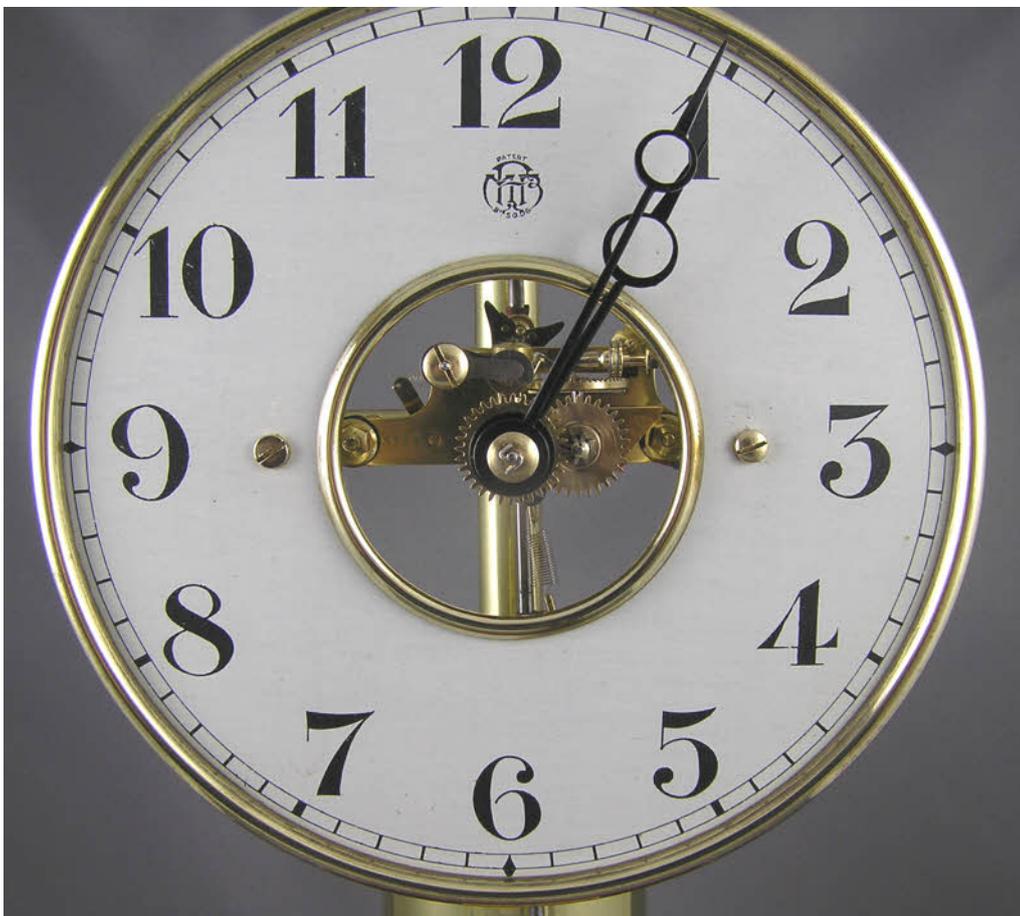
The dial is a particularly nice example with no marks or flaking.

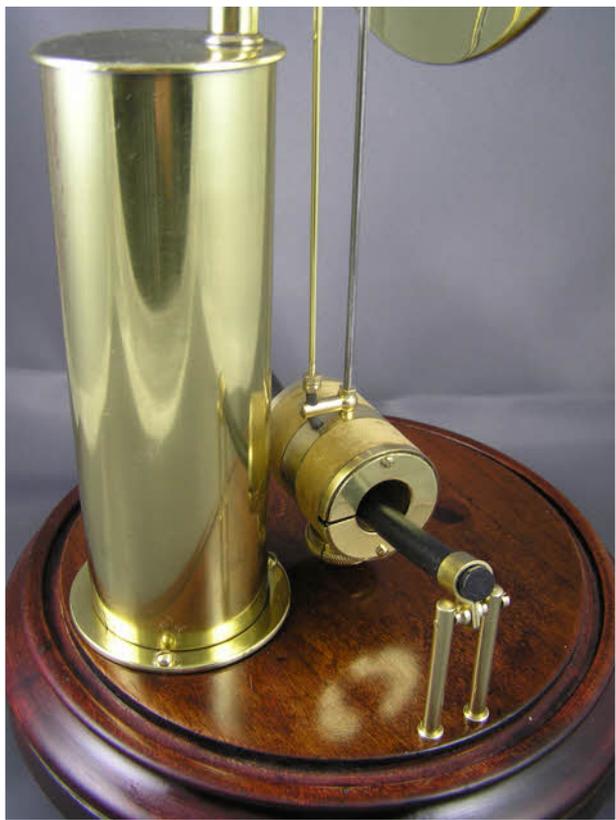
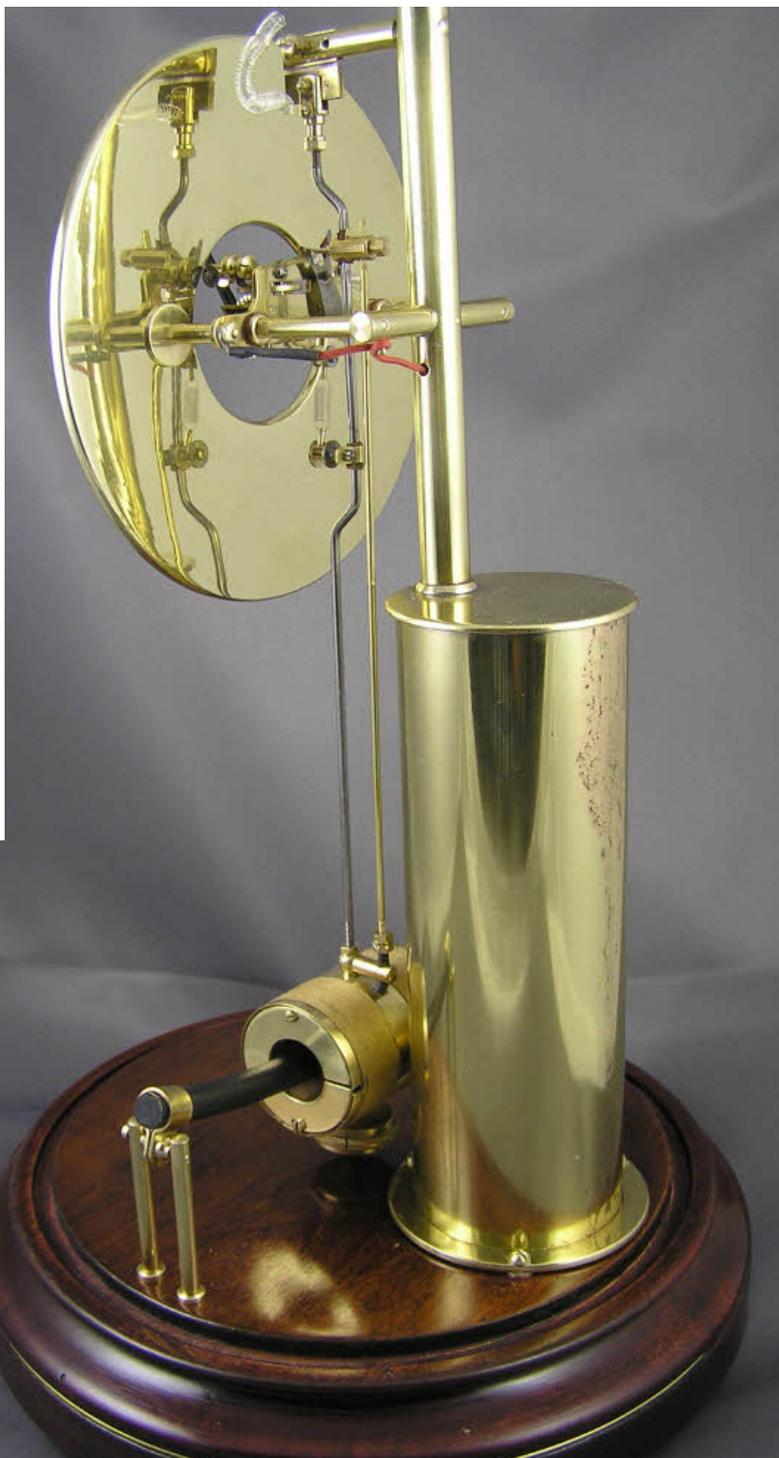
Two views of the rear of the clock. Note the pitting in the column is only apparent from the rear.
