**Bulle Clock Serial Number 6694.**

Early Battery Clock Parts & Restoration

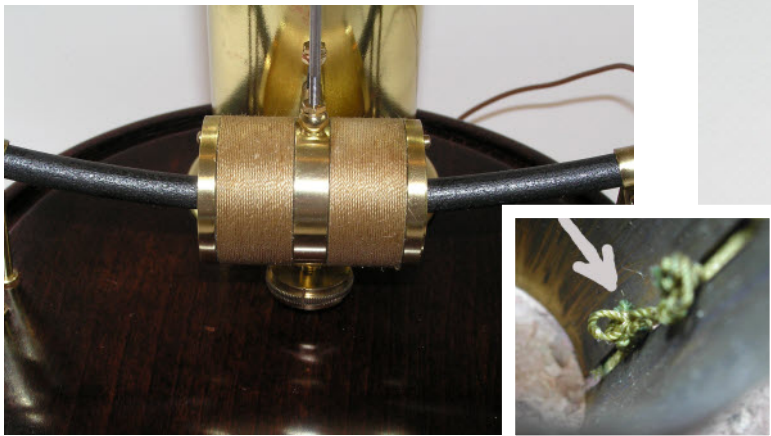
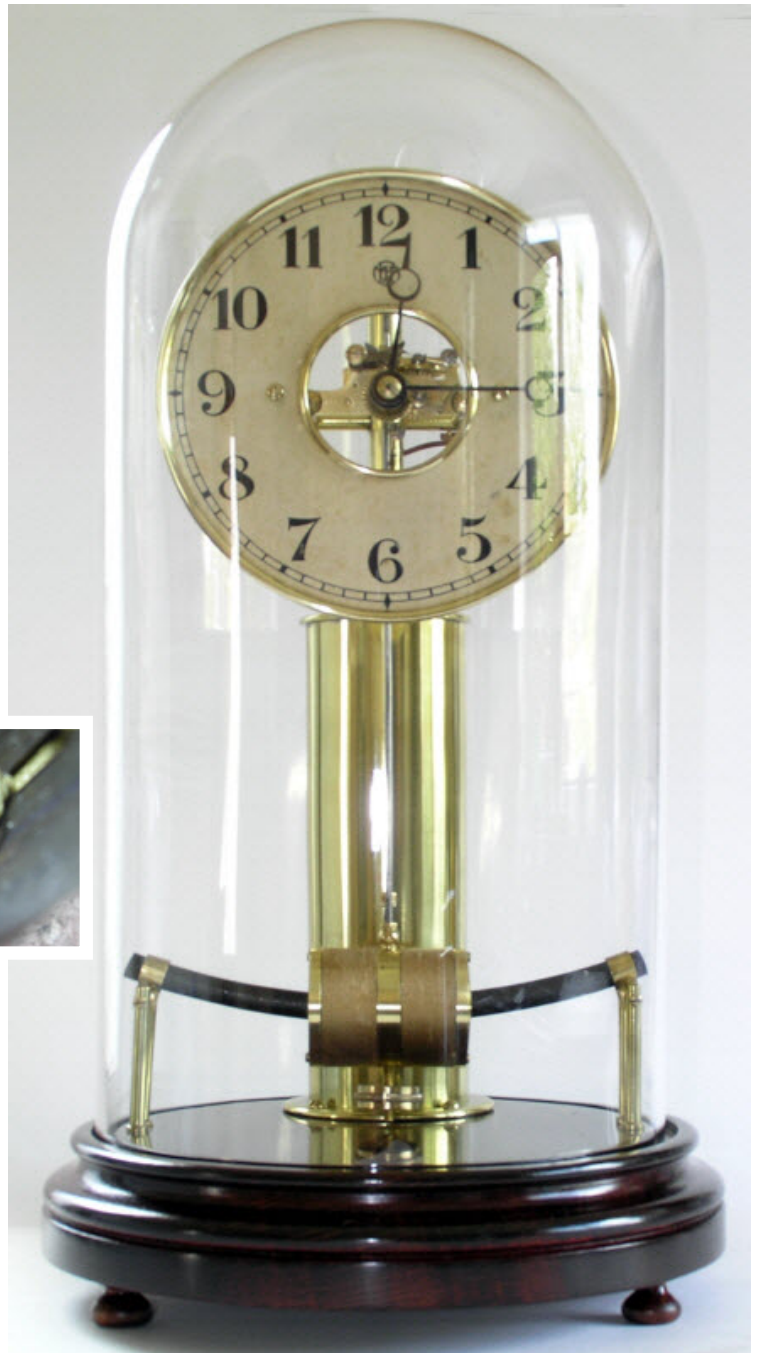
*This Bulle clock, serial number 6694, is completely restored. It is a tall movement on a Hardwood base. The cord on the pendulum was still intact on arrival and was in reasonably good condition, so I have left it in place and worked around it. The original colour of this cord was a mid to dark green. This photo shows the inside of the pendulum coil casing and clearly shows the original colour right at the tip of the cord.*

*It always strikes me as odd when I do these clocks that in 90% of the cases the cord has faded to the same degree all round the pendulum regardless of whether it has been in direct sunlight or not. The cord on this one has faded to a lovely golden straw colour. Unfortunately it makes it very difficult to clean and polish the Brass around it. One has to resort to "Q" tips.*

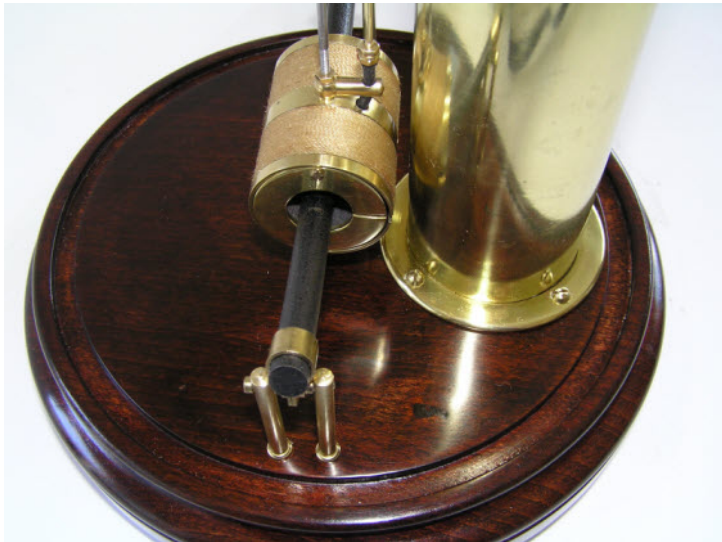
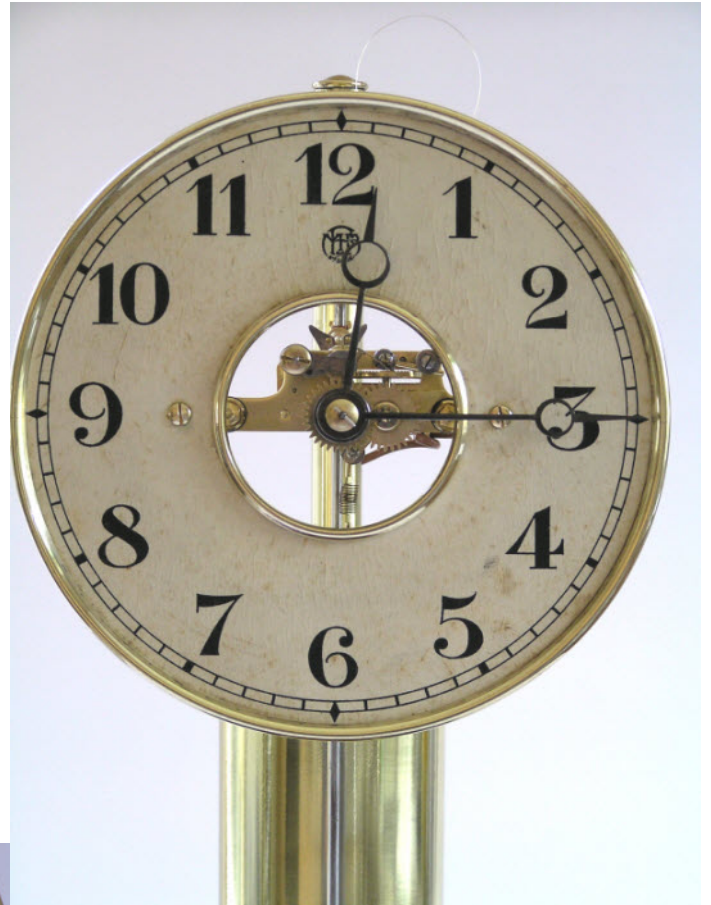
*The dial is an early card insert type and is in a lovely condition with no large distracting marks. It's almost like wood in that it has a "Aged Patina" that gives it real character. Yellowing slightly with a crazed surface where the original clear coating has cracked.*

*The brass dial surround is hard to clean because it is crimped around the insert during manufacture and bends round into contact with the face. I use a thin brass shim cover which inserts under the rim whilst cleaning with "0000" gauge wire wool. The hands have been cleaned and blued. They really set off the dial. The [Suspension](#) is a Horologix replacement.*
