Eureka Clock Serial Number 8810

*Restoration of Eureka
Clock Serial Number 8810*

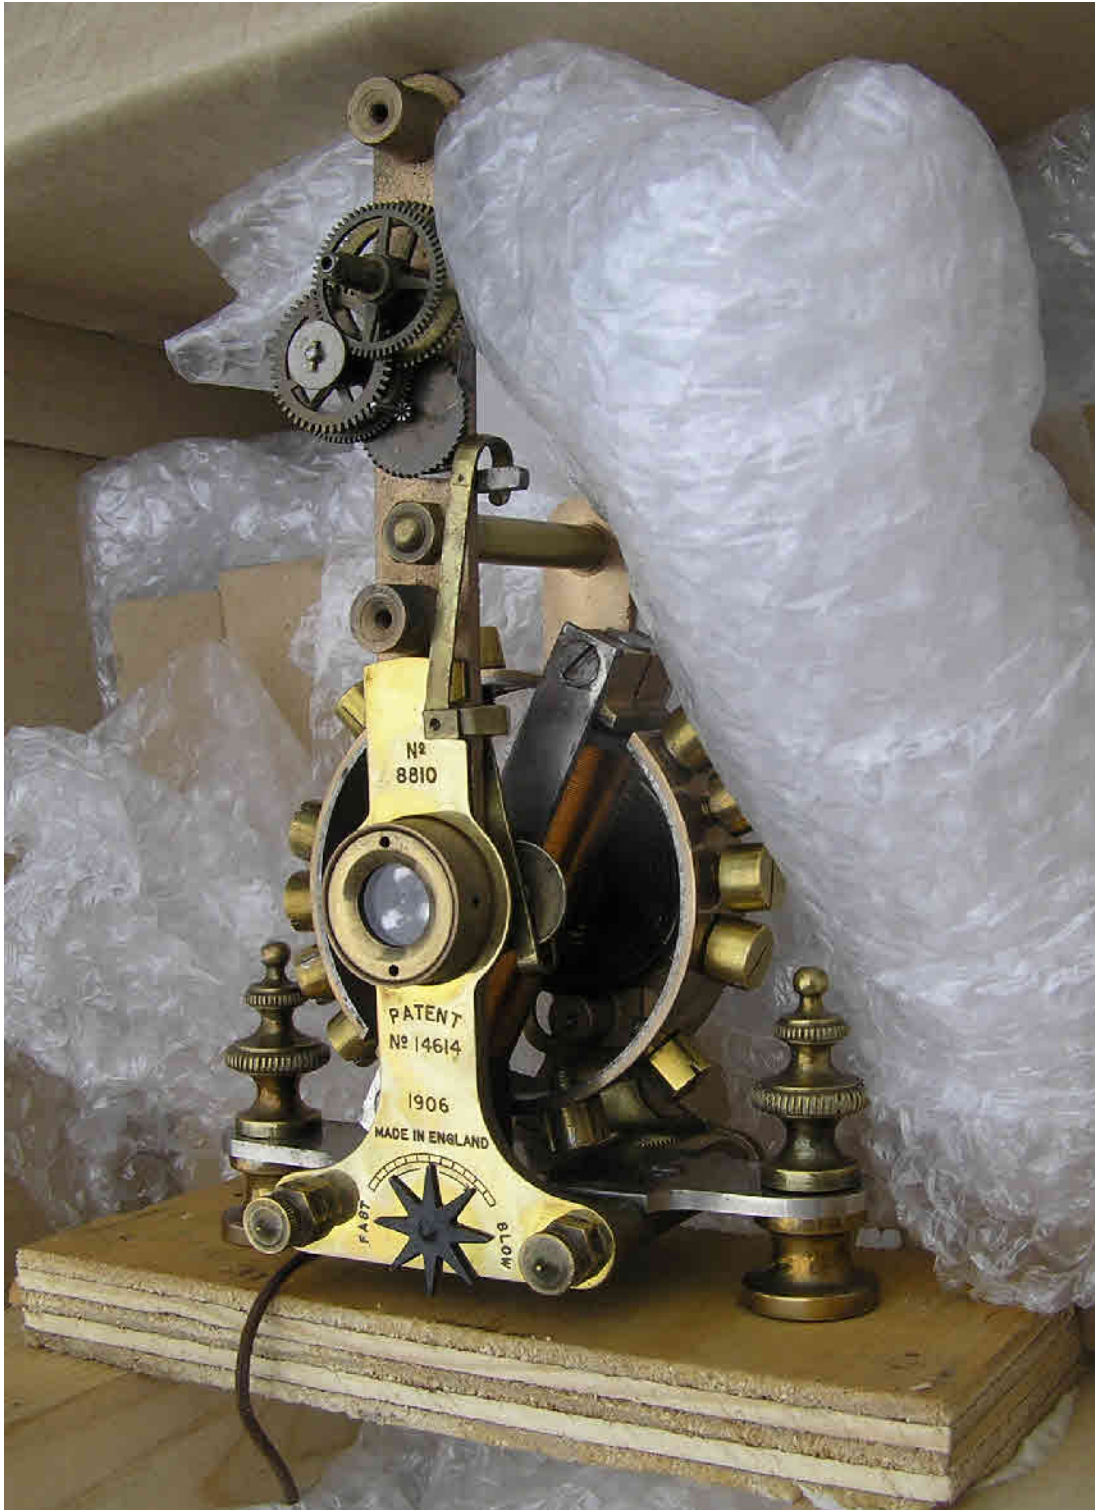
*Eureka clock 8810
as supplied.*

*This is a tall move-
ment with motion-
work above the
balance wheel. It
has a three ball
bearing pivot hos-
ing with no steel
shim. The case has
been withheld by the
owner for safe keep-
ing with the move-
ment secured to a
temporary wood
stand.*

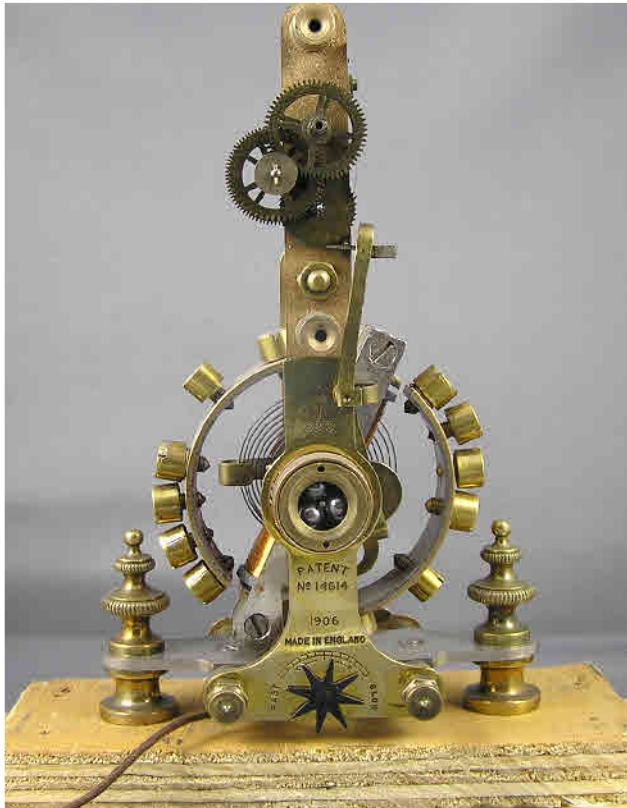
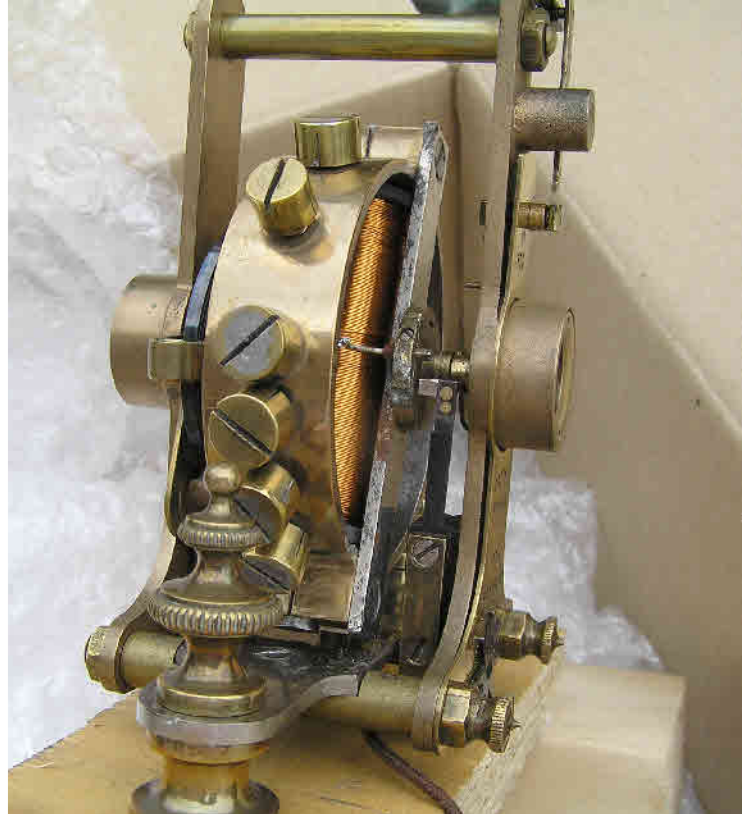
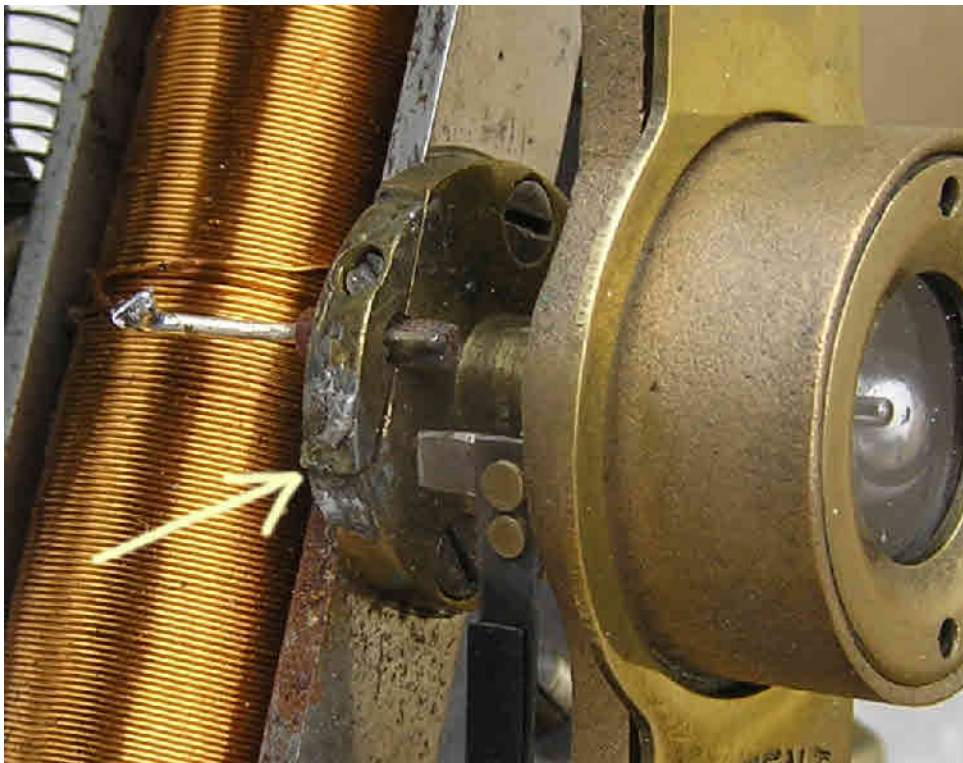
The photo top left shows the whole movement removed from it's packaging. A cursory look gives the impression that the clock is complete and in reasonable order. But close inspection reveals quite a few problem areas. The first is the front balance wheel pivot assembly. It is in a poor state and has snapped at the point where the contact pin is secured. Some solder has been applied in an effort to re-attach the broken piece. It is an awful mess and will need to be replaced. The owner has replaced the armature winding as the original was missing. It looks OK and reads a good 20 Ohms.

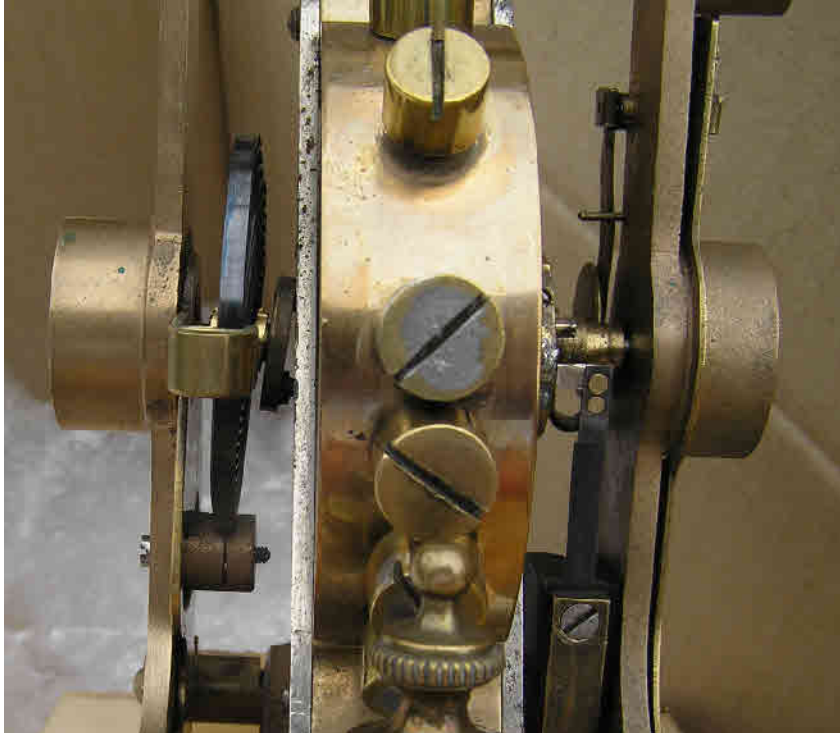
The balance wheel also shows signs of poor repairs. Note the skin of solder on the screw head. About seven of the screws show the same solder marks. Now cast your eyes to the left balance pivot assembly where the balance spring is attached. This doesn't look good at all. The assembly is at a vicious angle to the wheel. It looks as though it has been pulled away from the wheel.

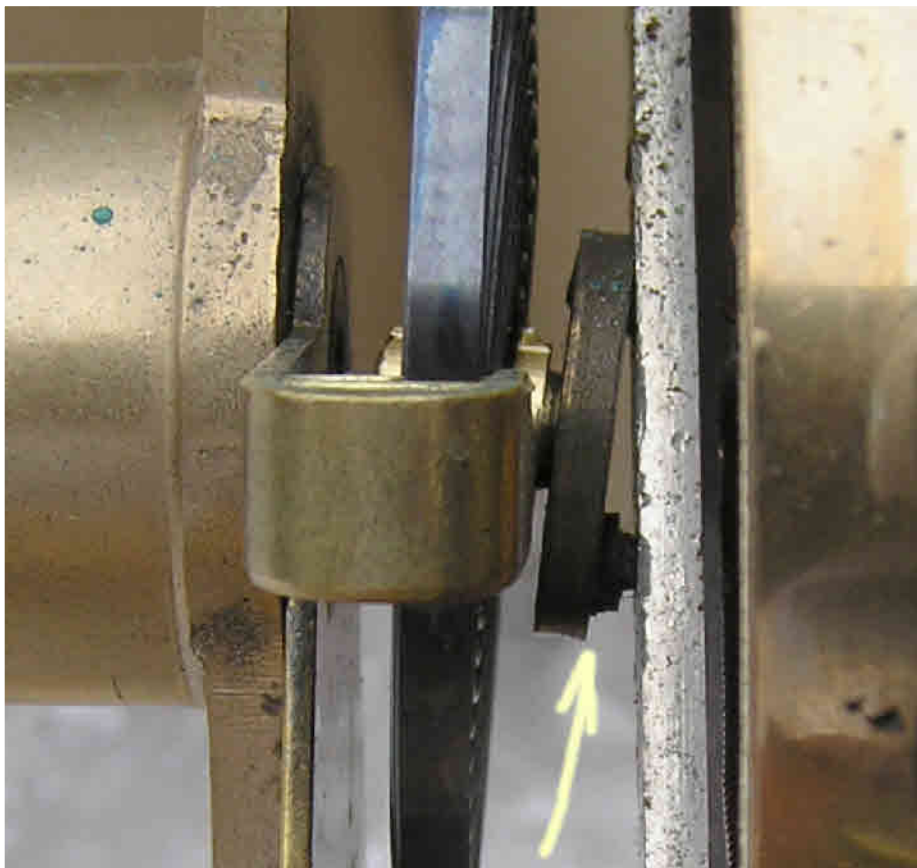
This lower photos shows the problem in more detail. It looks as though the screw has "pulled" through the assembly.

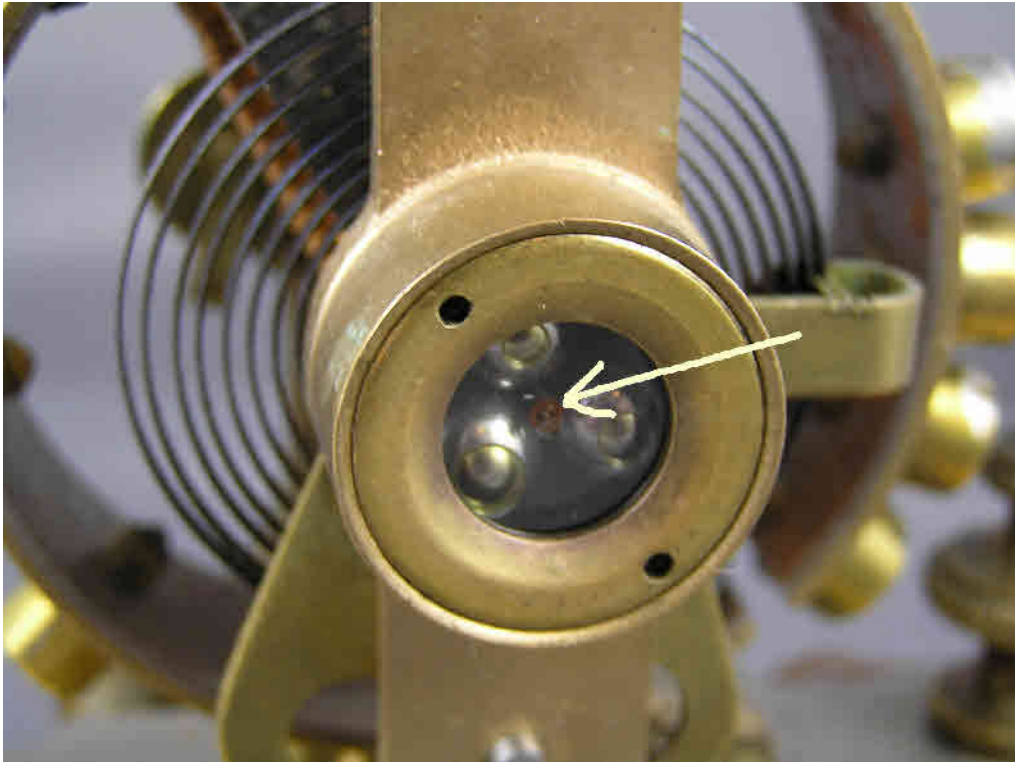
The rear pivot bearing housing also shows signs of rust with the pivot boring a hole in the glass. The impulse arm shown below, is complete if rather a little battered.

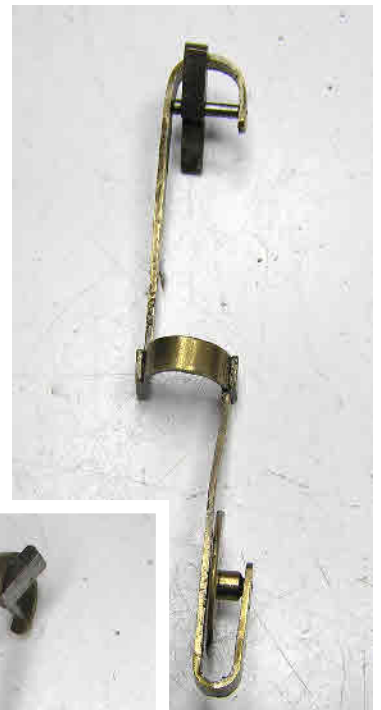
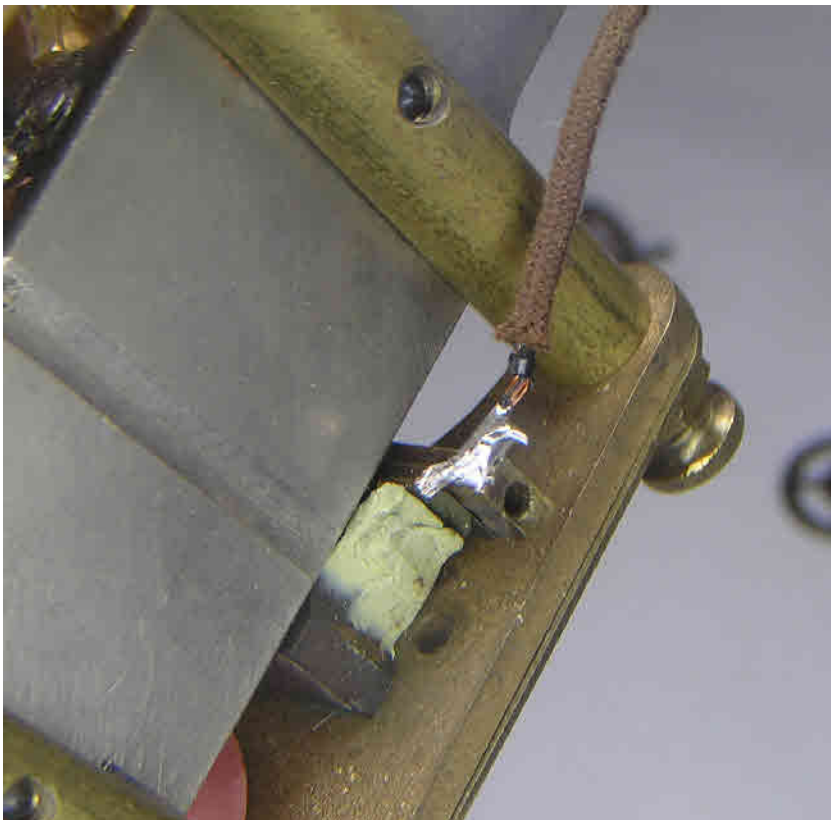
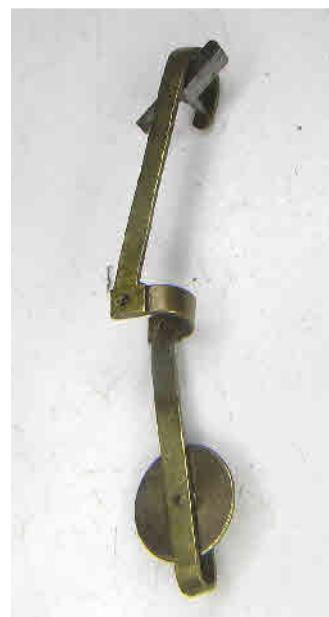
The fibre block that carries the contact flag terminal has been broken and filled with plastic filler. The soldered connection is also very poor.

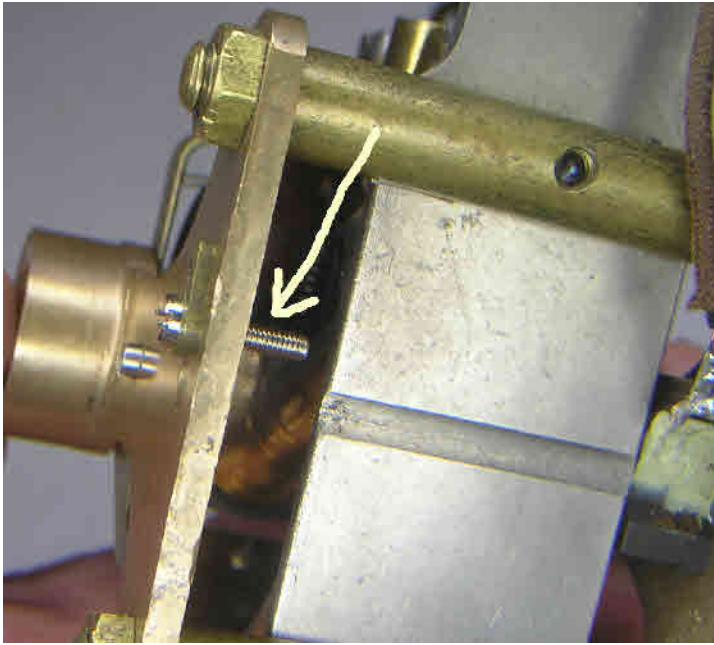
The photo above shows the over length screw holding the rear pivot of the star wheel rating arm. This will be replaced.

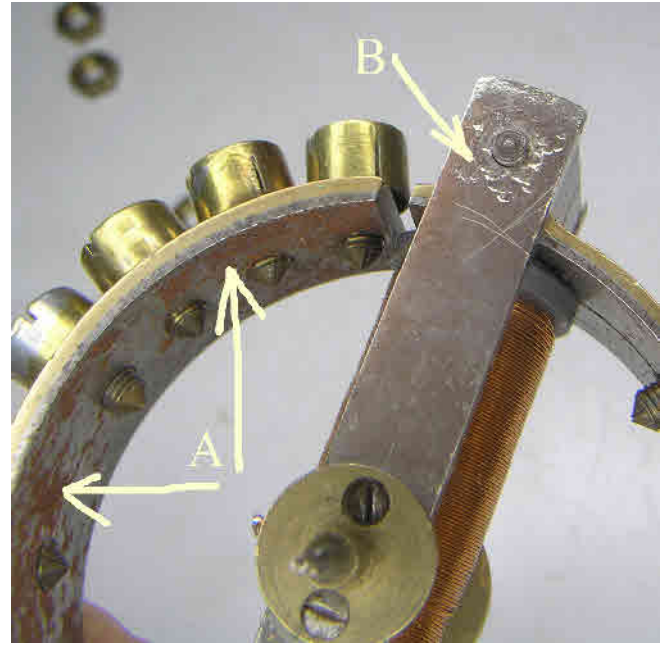
Here we see that the generally poor condition of the clock with rust on the steel rim of the balance whee "A" and the hammer marks around the screw at "B".

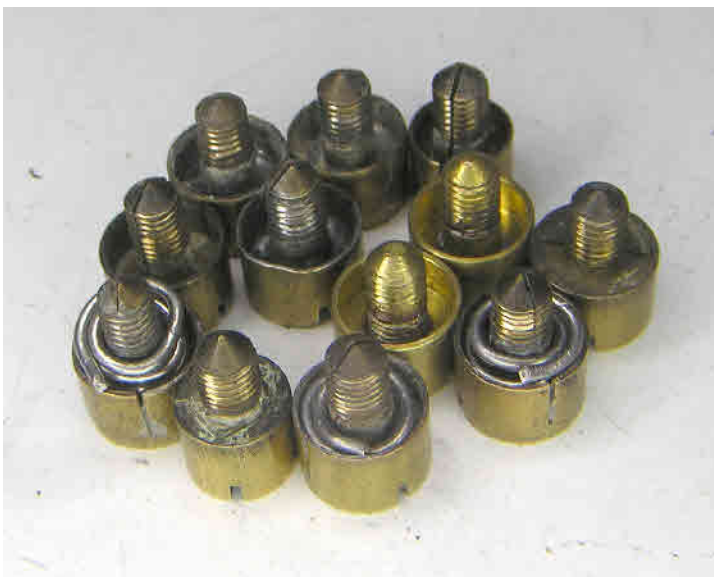
This is interesting. At least eight of the screws have either been hot soldered or have twists of solder added to them. This must be to add weight and slow the clock down. The hot soldered screws will be the most difficult to correct and clean up without leaving marks.

The motion work looks OK with no damage or teeth missing.

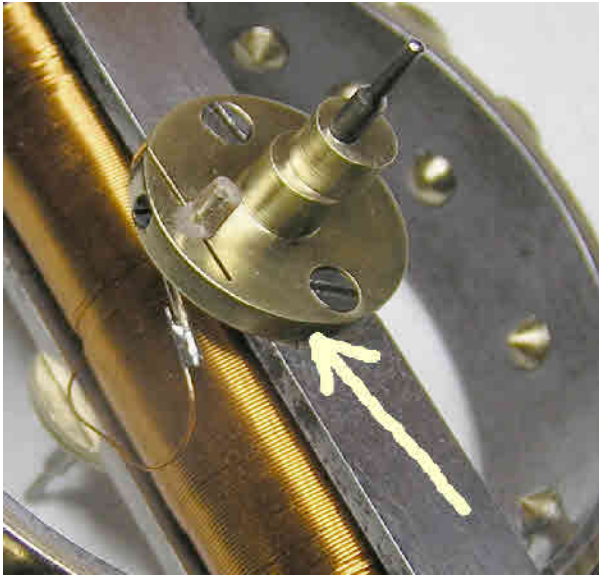
The new front pivot assembly in place on the cleaned and balanced wheel.

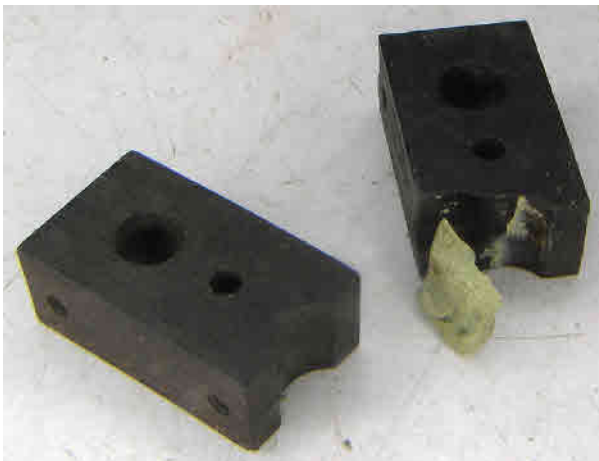
Besides the fact that it was unsightly the old mount was broken at the point where the lower contact retaining screw passed through. This meant that the flag was not pulled tight against the contact terminal and would therefore give a poor and intermittent connection.

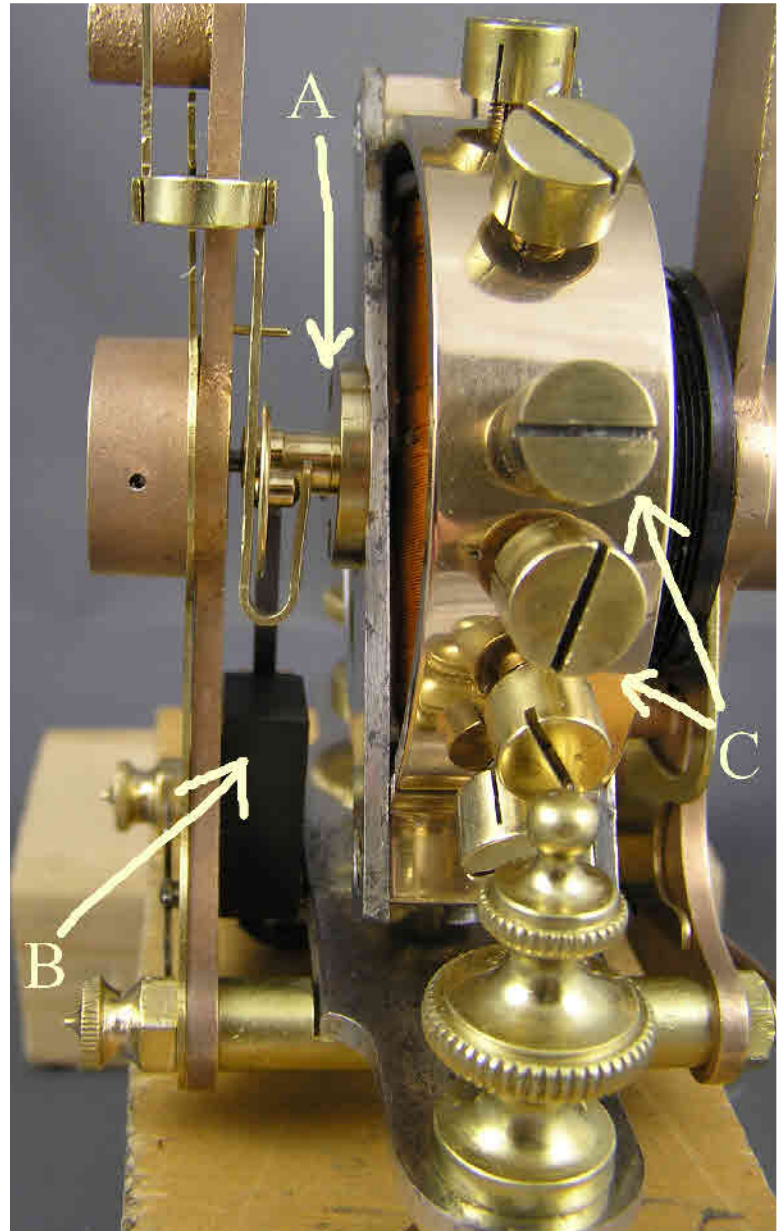
In the photo above we see A) the repaired rear pivot. B) The new fibre terminal block in place. C) All the screws have been heated to try and remove the solder, then mounted on the lathe and "touched" to try and remove the excess solder on the outside.

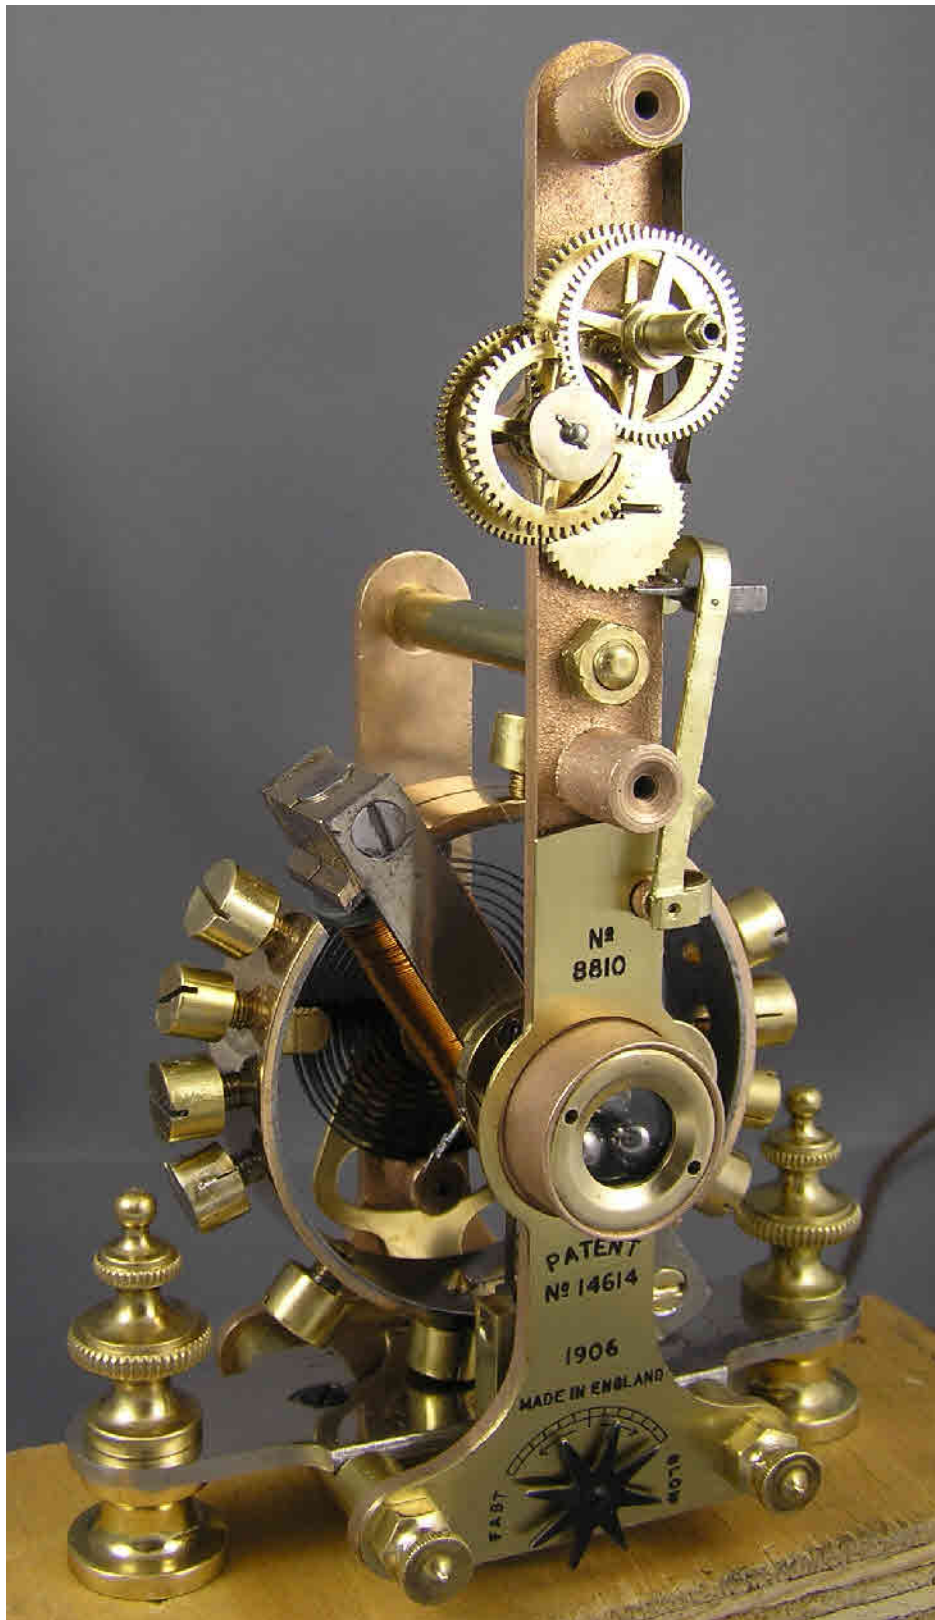
The completed clock.
